Contract #: 04-0120F4  
 Cty: SF/ALA Rte: 80 PM: 13.2/13.9  
 File #: 69.25B

## QUALITY ASSURANCE -- NON-CONFORMANCE REPORT

**Report No:** NCR-000690

**Reference Description:** Tightening the Bolts of U-Rib Splices not conforming to the approved procedure (Segment 5BW to 5CW)

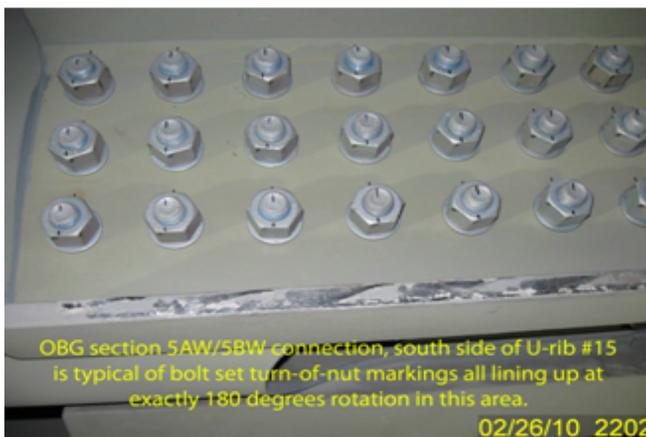
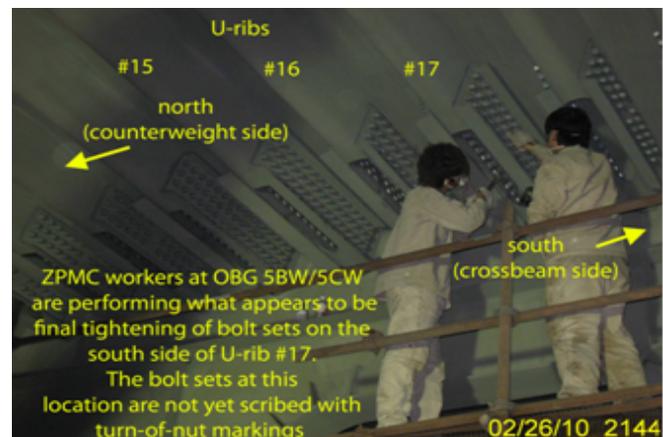
During in process inspection in OBG 5BW/5CW, Caltrans OSM Quality Assurance Inspector observed that the tightening of the bolts were not performed per the approved procedure.

- Marking bolts after final tension had been applied at U-rib #17 (see picture).
- ZPMC workers were performing final bolt tightening of ASTM A325 bolts by turn-of-nut specification of 180° to 210°.
- This issue is located at 5BW/5CW transverse seam at the deck plate U-rib stiffener splice plates.

Propose a resolution for the identified non-conformance with revised procedures to prevent future occurrences and for remedy the non-conformance on the bolting procedure for the particular U-rib for the Engineer's review. A response for the resolution of this issue is expected within 7 days.

All the bolts in U ribs on the North and South sides of #15,16, and 17 in OBG Lift 5BW/5CW were tested to ensure that they met the required torque of 435N\*M for tension verification. No nut or bolt was turned relative to its matching component by application of required torque. The verification was successful and on the approved bolting procedure and witnessed by a CT inspector, lot number B279. The proper bolting procedure has been reviewed with the bolting crew in question and ZPMC has issued an internal NCR. Based on this ZPMC requests closure of this NCR.

Contractor performed tension verification testing for said bolts. The results of tension verification testing verify bolts meet Contract specifications. An internal NCR was issued by the Contractor in regards to this matter.
