Contract #: 04-0120F4Cty: SF/ALA Rte: 80 PM: 13.2/13.9File #: 69.25B**QUALITY ASSURANCE -- NON-CONFORMANCE REPORT****Location:** Changxing Island, Shanghai, P.R. China**Report No:** NCR-000691**Prime Contractor:** American Bridge/Fluor Enterprises, a JV**Date:** 27-Feb-2010**Submitting Contractor:** Zhenhua Port Machinery Company, Ltd (ZPMC), Changxing Island**NCR #:** ZPMC-0658**Type of problem:**

Reference Description: Free hand thermal cutting over 300mm in length without Engineer's approval
(Segment 12AW and 12BW FB)

Dear: Mr. Charles Kanapicki
Job Name: SAS Superstructure

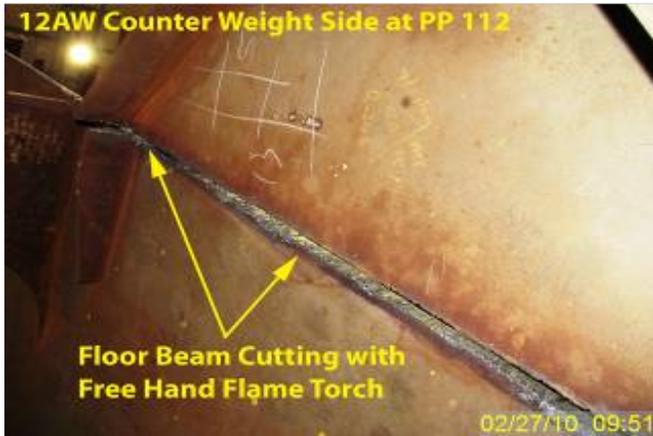
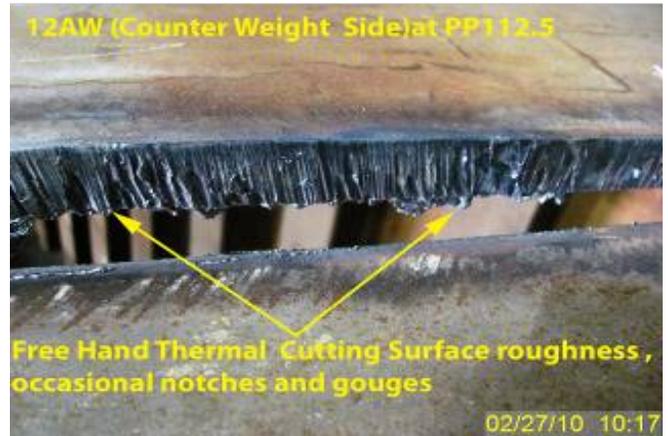
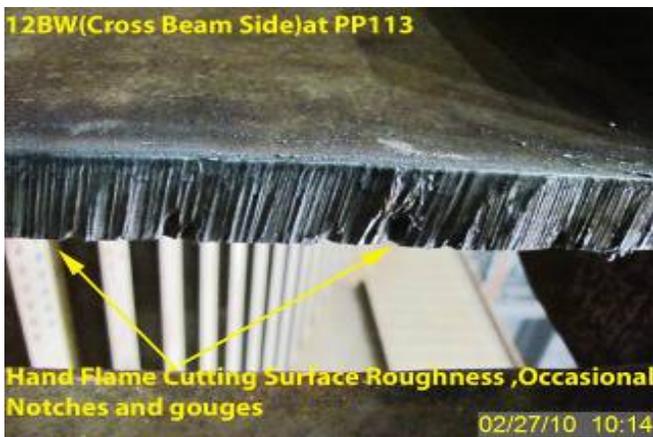
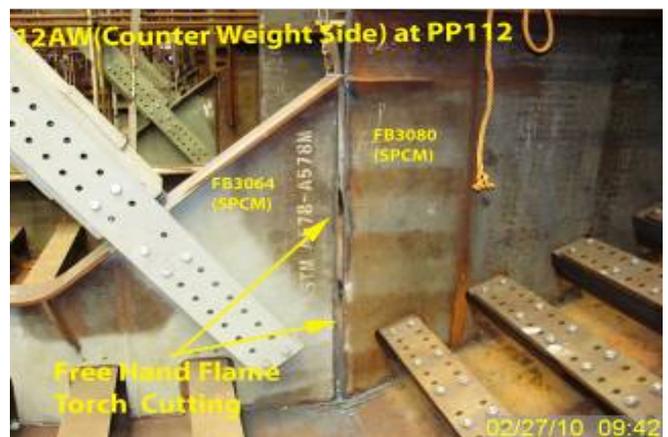
During Quality Assurance random in-process observations of the fabrication of segment 12AW and 12BW, this Quality Assurance Inspector (QA) discovered the following issue:

- ZPMC personnel have performed Free Hand Flame Cutting for more than 300mm in length at the locations listed.
- The approximate cut length for Floor Beam FB3072 plate number X3166D measured 1025mm from the Bottom Plate on panel point (PP) 111.5, Counter Weight side.

- The approximate cut length for Floor Beam FB3079 plate number X3207M measured 4700 mm from the Bottom Plate on PP111.5, Counter Weight side.
- The approximate cut length for Floor Beam FB3064 plate number X33267B (SPCM) measured 1500 mm from the Bottom Plate on PP112, Counter Weight side.

- The approximate cut length for Floor Beam FB3080 plate number X3183D (SPCM) measured 4700 mm from the Bottom Plate on PP112, Counter Weight side.
- The approximate cut length for Floor Beam FB3070 plate number X3166A measured 1025 mm from the Bottom Plate on PP112.5, Counter Weight side and 1025 mm from Bottom Plate on the Cross Beam side.

- The approximate cut length for Floor Beam FB3083 plate number X3207A measured 2000 mm from the Bottom Plate on PP112.5, Cross Beam side.
- The approximate cut length for Floor Beam FB3066 plate number X3267E measured 1500 mm from the Bottom Plate on PP113, Cross Beam side.

- The approximate cut length for Floor Beam FB3085 plate number X3181D measured 2000 mm from the Bottom Plate on PP113, Cross Beam side.
- All the Floor Beam plate materials listed above are less than 25mm in thickness.

Propose a resolution for the identified non-conformance with revised procedures to prevent future occurrence and for remedy the non-conformance to the Engineer for review. A response for the resolution of this issue is expected within 7 days.

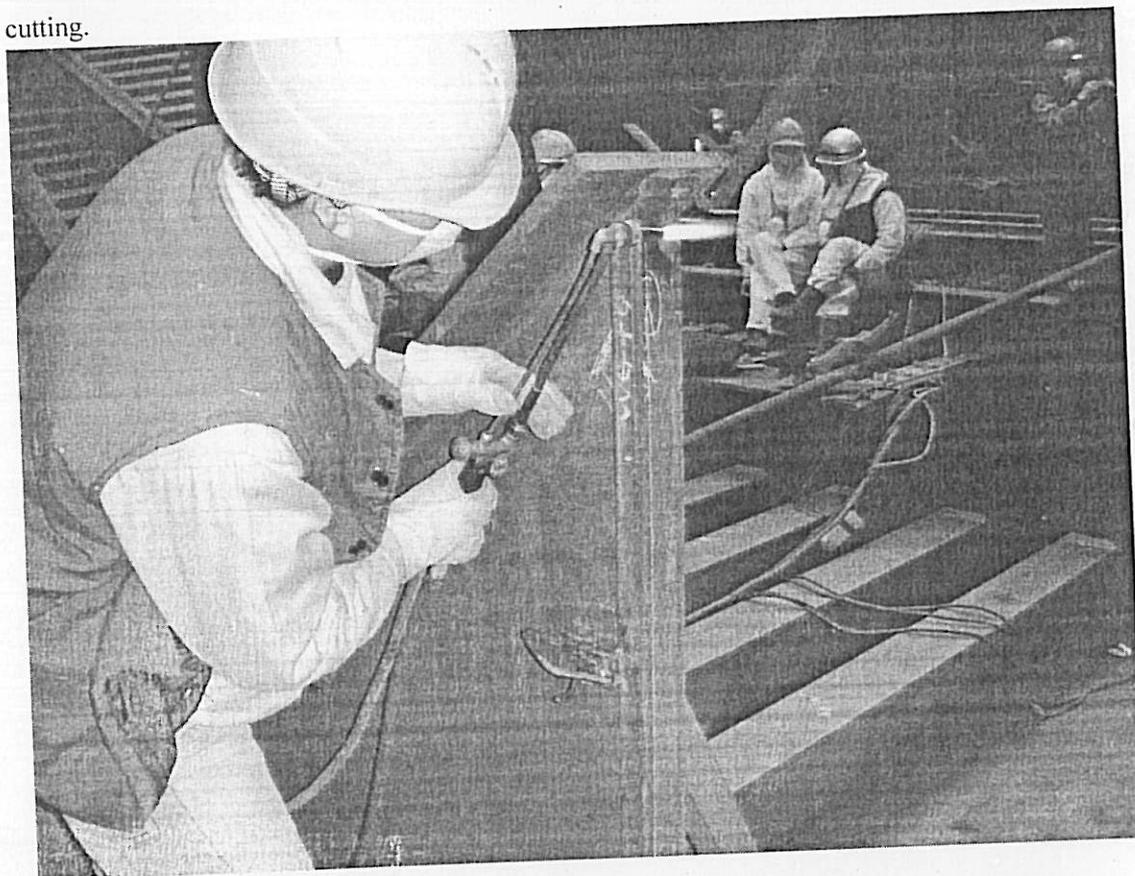
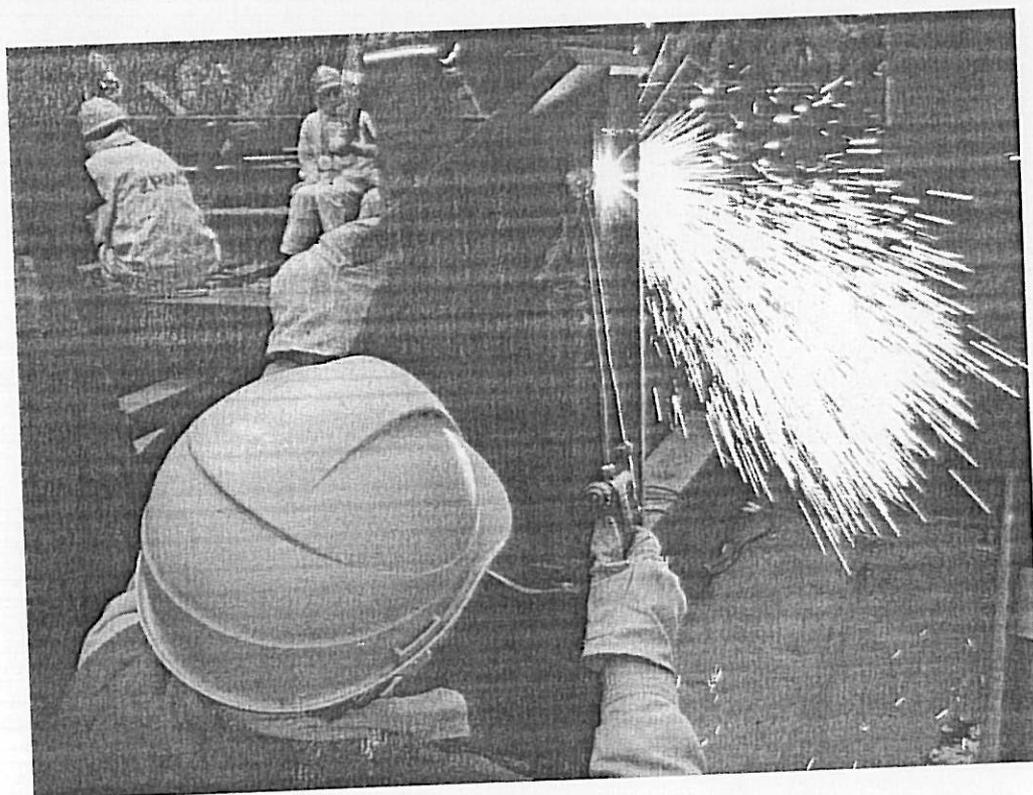
ZPMC is clarifying that there is a misunderstanding with CT's representative. Attached photos show the cutting method what ZPMC used on site. One steel bar was fixed on the web of floor beam and the frame cutting operator was cutting the allowance along with this steel bar (guide plate). After confirmed with ABF QCM, this method should not be deemed to be free hand cutting. Please also be noticed, the cut areas have been confirmed to be allowance on webs and no damage was occurred on base metal. Based on this, ZPMC is requesting closure for this NCR.

Before start frame cutting, a steel bar was fixed on web to work as the guide plate for frame cutting.

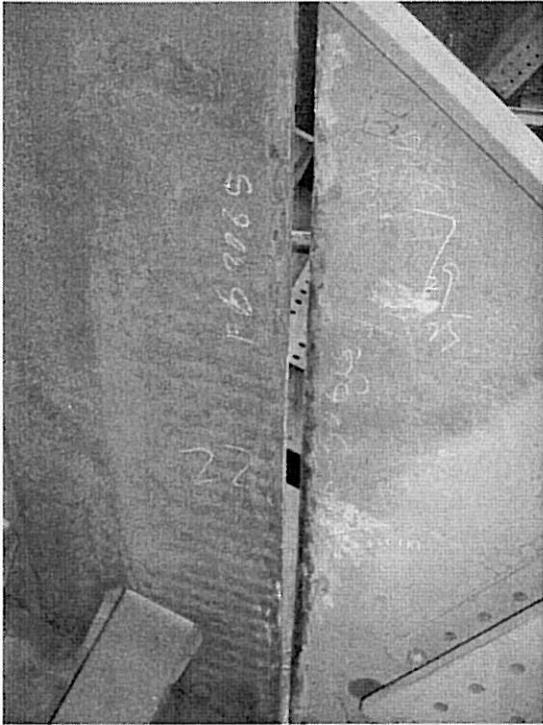
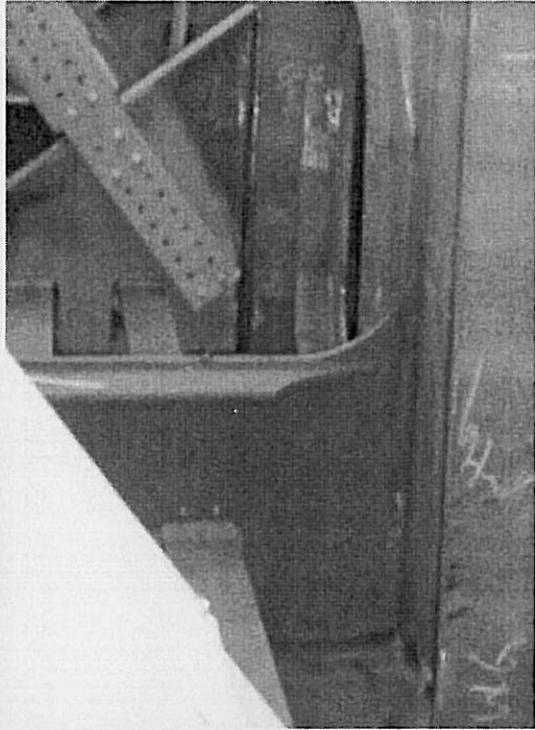
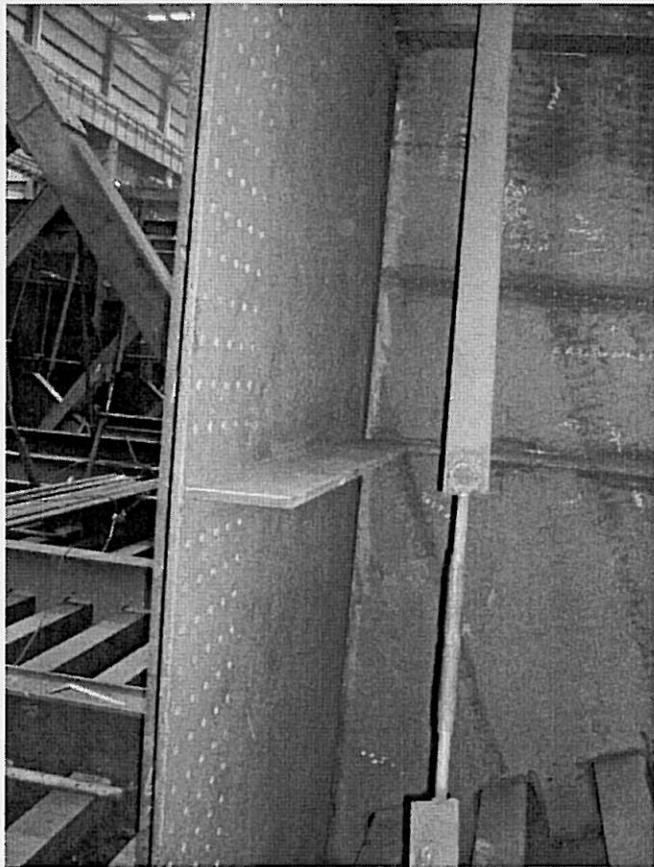
PHOTOS FOR FLOOR BEAM CUT EDGES

ZPMC acknowledged wrong cutting procedure was performed and has written an internal NCR. The approved freehand thermal cutting procedure has been released to all related department to prevent same cases' occurrences again. It was found no base metal as designed was damaged after cut, due to these cutting was performed within the allowance of material. Please review the attached photos show after grinding the cut edges are satisfactorily. Based on this, Please consider closure of this NCR.

Reference Resolution: ZPMC has ground the edges of the freehand cut plates and is providing photographs to show that the edges were acceptable prior to welding.

ZPMC has ground the edges of the freehand cut plates and is providing photographs to show that the edges were acceptable prior to welding. ZPMC QA has documented this non conformance in their own internal NCR and ensured the approved freehand thermal cutting procedure has been distributed to the relevant departments to prevent future occurrences. Based on this ZPMC request closure of this NCR.

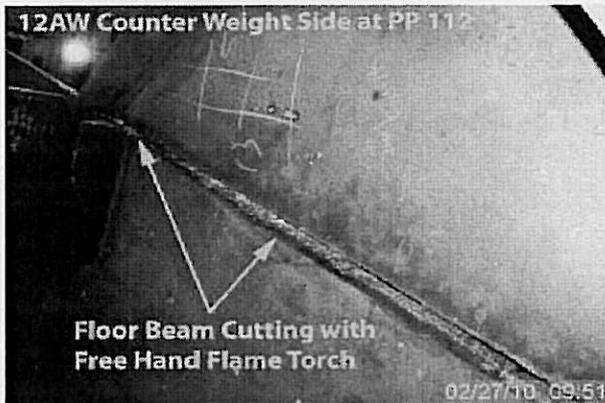
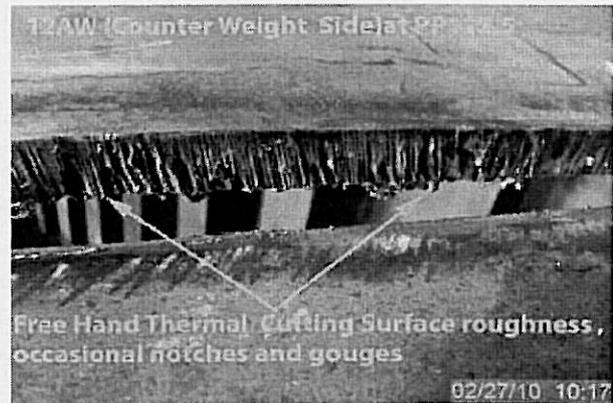
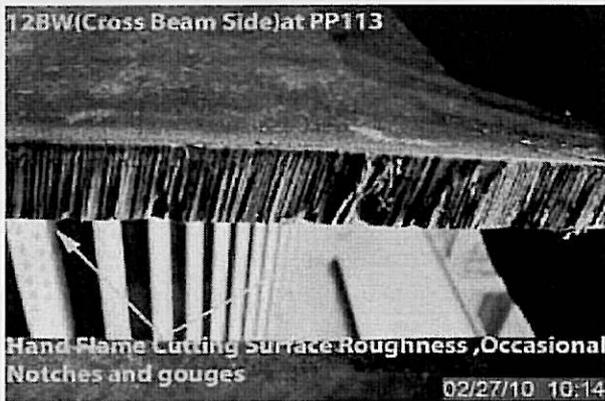
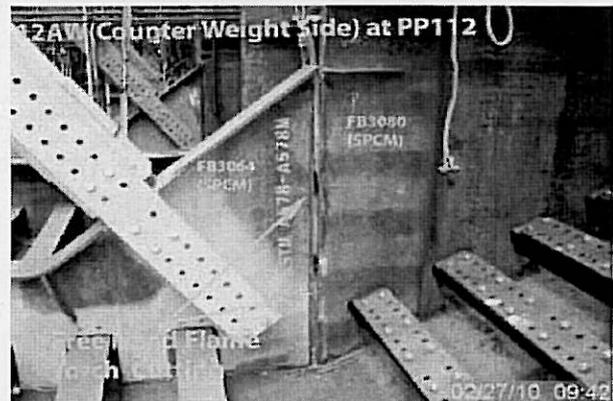
During Quality Assurance random in-process observations of the fabrication of segment 12AW and 12BW, this Quality Assurance Inspector (QA) discovered the following issue:

- ZPMC personnel have performed Free Hand Flame Cutting for more than 300mm in length at the locations listed.
- The approximate cut length for Floor Beam FB3072 plate number X3166D measured 1025mm from the Bottom Plate on panel point (PP) 111.5, Counter Weight side.

- The approximate cut length for Floor Beam FB3079 plate number X3207M measured 4700 mm from the Bottom Plate on PP111.5, Counter Weight side.
- The approximate cut length for Floor Beam FB3064 plate number X33267B (SPCM) measured 1500 mm from the Bottom Plate on PP112, Counter Weight side.

- The approximate cut length for Floor Beam FB3080 plate number X3183D (SPCM) measured 4700 mm from the Bottom Plate on PP112, Counter Weight side.
- The approximate cut length for Floor Beam FB3070 plate number X3166A measured 1025 mm from the Bottom Plate on PP112.5, Counter Weight side and 1025 mm from Bottom Plate on the Cross Beam side.

- The approximate cut length for Floor Beam FB3083 plate number X3207A measured 2000 mm from the Bottom Plate on PP112.5, Cross Beam side.
- The approximate cut length for Floor Beam FB3066 plate number X3267E measured 1500 mm from the Bottom Plate on PP113, Cross Beam side.

- The approximate cut length for Floor Beam FB3085 plate number X3181D measured 2000 mm from the Bottom Plate on PP113, Cross Beam side.
- All the Floor Beam plate materials listed above are less than 25mm in thickness.

Grind area in question smooth prior to welding.
