Contract #: 04-0120F4  
 Cty: SF/ALA Rte: 80 PM: 13.2/13.9  
 File #: 69.25B

## QUALITY ASSURANCE -- NON-CONFORMANCE REPORT

**Report No:** NCR-000693

**Reference Description:** Missed UT Indication by QC

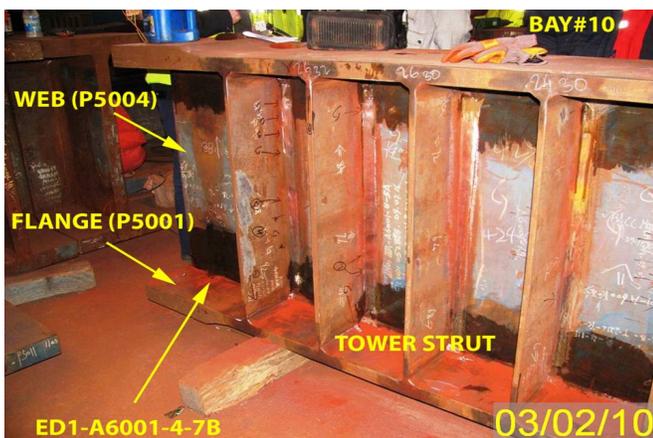
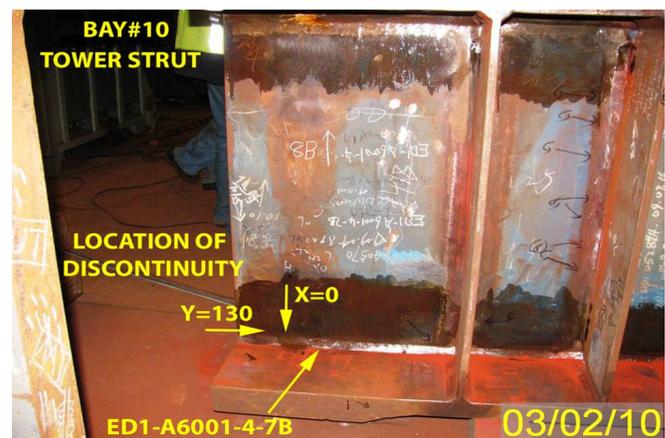
During random 10% verification Ultrasonic Testing (UT) of Tower Strut ED1-A6001-4, Caltrans (CT) Quality Assurance (QA) discovered one (1) Class "A" non-conforming longitudinal indication measuring approximately 15 mm in length.

- The weld is a complete joint penetration (CJP) joint, joining Web P5004 to Flange P5001 and is identified as ED1-A6001-4-7B.
- The discontinuity rating is +6, Class "A" reject.
- Depth of the discontinuity from face A is approximately 27 mm, and Y location was 130 mm.
- The material thickness is 32 mm.
- This member is located in fabrication Bay 10.
- The indication is in an area previously tested and accepted by ZPMC QC UT technicians.
- The Notice of Witness Inspection Number (NWIT) is 005259.

Propose a resolution for the identified non-conformance that addresses the failure of Quality Control to identify the linear indications(UT). Provide documentation of the steps taken by the Quality Control Manager to prevent future occurrences.

In addition to the Quality Control failure, propose a resolution for the identified material/workmanship non-conformance documenting that the repaired weld is in compliance with the contract requirements.

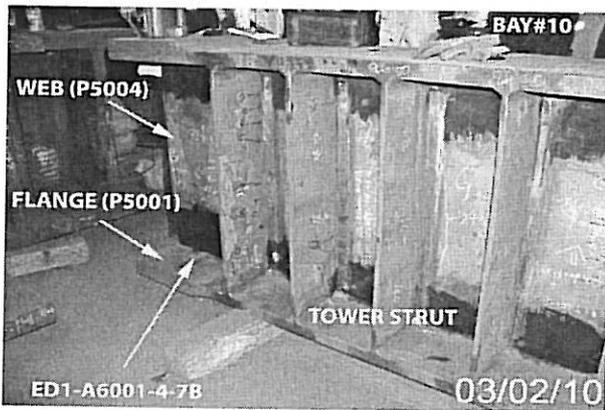
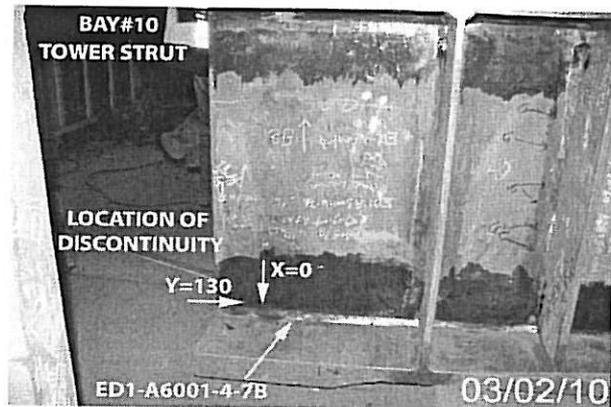
During random 10% verification Ultrasonic Testing (UT) of Tower Strut ED1-A6001-4, Caltrans (CT) Quality Assurance (QA) discovered one (1) Class "A" non-conforming longitudinal indication measuring approximately 15 mm in length.

- The weld is a complete joint penetration (CJP) joint, joining Web P5004 to Flange P5001 and is identified as ED1-A6001-4-7B.
- The discontinuity rating is +6, Class "A" reject.
- Depth of the discontinuity from face A is approximately 27 mm, and Y location was 130 mm.
- The material thickness is 32 mm.
- This member is located in fabrication Bay 10.
- The indication is in an area previously tested and accepted by ZPMC QC UT technicians.
- The Notice of Witness Inspection Number (NWIT) is 005259.

Repair weld and verify with NDT.

Weld was repaired and verified with NDT. QA VT, MT, and UT was performed on 3/13/2010 (NWIT 5335) and the weld was green tagged (Tag #11727).

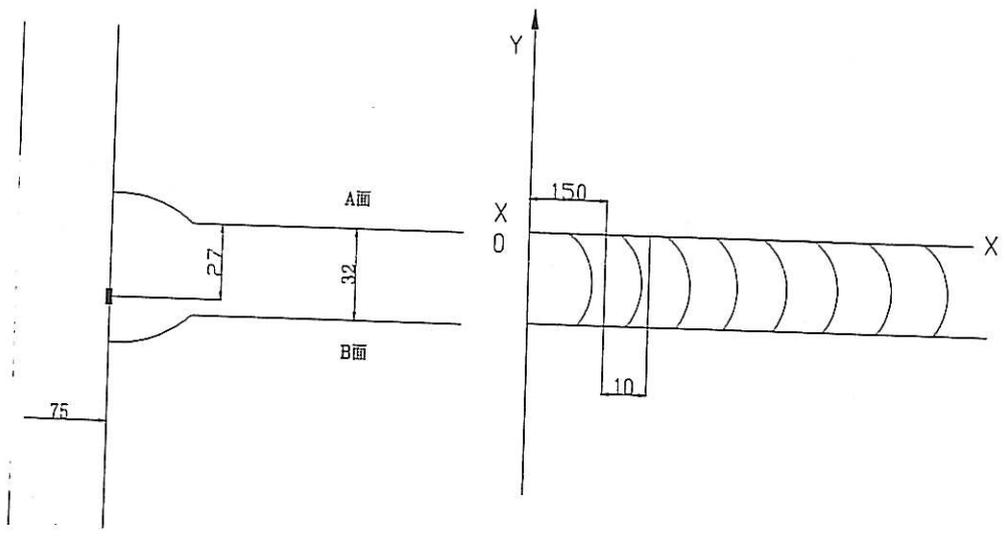
WELD NUMBER: ED1-A6001-4-7A/B

Rejected indication found by ultrasonic inspection is less than the maximum allowance aggregate length.

- 1、 碳刨后,焊接接头没有有效打磨;
  - 2、 起弧和收弧没有交错布置,以将焊渣减少到最少;
  - 3、 焊道间没有有效的清理.
- 1.The weld joint was not ground sufficiently after arc-gouging.
  2. The arc starts and stops were not staggered to minimize slag entrapment.
  3. Interpass cleaning was not performed properly.

1. Grind repair area smoothly, VT to verify repair area is free of all defects.
2. QC will monitor and direct welder and grinder doing repair;
3. QC shall monitor all welding passes being deposited;
4. QC shall ensure all slag has been removed prior the deposition of next pass;
5. Preheat and maintain interpass temperature control in accordance with the WPS ;
6. Perform VT, MT and UT accordance with the drawing & contract requirements

- 1、碳刨后的接头位置打磨圆滑过渡，保证每道焊缝的接头可以交错布置；
  - 2、认真仔细检查每道焊缝和加强焊道的清理；
  3. 焊缝中所有的焊渣全部去除后，表面的缺陷全部打磨干净。
1. The joint shall be ground to a smooth transition to ensure that arc starts and stops are in a staggered Arrangement.
  2. QC shall inspect the weld passes more carefully and enforcing interpass cleaning.
  3. All weld slag shall be removed and surface defects ground during interpass cleaning.
