Contract #: 04-0120F4Cty: SF/ALA Rte: 80 PM: 13.2/13.9File #: 69.25B**QUALITY ASSURANCE -- NON-CONFORMANCE REPORT****Location:** Changxing Island, Shanghai, P.R. China**Report No:** NCR-000694**Prime Contractor:** American Bridge/Fluor Enterprises, a JV**Date:** 10-Mar-2010**Submitting Contractor:** Zhenhua Port Machinery Company, Ltd (ZPMC), Changxing Island**NCR #:** ZPMC-0661**Type of problem:**

Reference Description: Missed UT indication by QC on Segment 9AE Side Panel**Description of Non-Conformance:**

To:	AMERICAN BRIDGE/FLUOR, A JV 375 BURMA ROAD OAKLAND CA 95607	Date:	14-Mar-2010
Dear:	Mr. Charles Kanapicki	Contract No:	04-0120F4 04-SF-80-13.2 / 13.9
Attention:	Mr. Thomas Nilsson Project/Fabrication Manager	Job Name:	SAS Superstructure
Subject:	NCR No. ZPMC-0661	Document No:	05.03.06-000651

Contract #: 04-0120F4Cty: SF/ALA Rte: 80 PM: 13.2/13.9File #: xx.25A**QUALITY ASSURANCE -- NON-CONFORMANCE RESOLUTION****Location:** Changxing Island, Shanghai, P.R. China**Report No:** NCS-000583**Prime Contractor:** American Bridge/Fluor Enterprises, a JV**Date:** 15-Apr-2010**Submitting Contractor:** Zhenhua Port Machinery Company, Ltd (ZPMC), Changxing Island **NCR #:** ZPMC-0661*

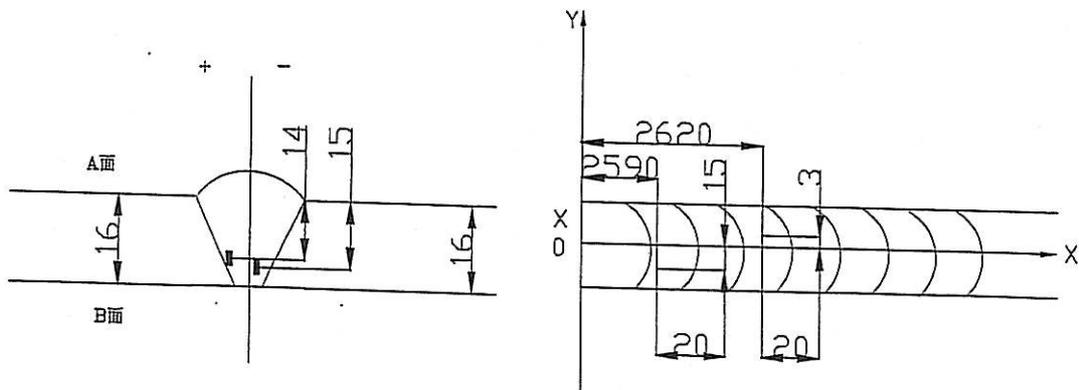
WELD NUMBER: SEG050A-003

Rejected indication found by ultrasonic inspection is less than the maximum allowance aggregate length.

(UT探伤发现的缺陷总长度小于最大允许长度。) SEG050A-003

1、焊道未及时处理干净。

1. Did not clear the weld pass completely in time.

1. Gouge or grind from nearer side from metal edge ($D \leq 0.65T$, "D" is depth of defects, "T" is thickness of metal) to remove all defects;

2. Follow repair WPS for joint preparation, preheat, and weld deposit;

3. Verify with VT no defects remain in the weld joint prior to welding;

4. Grind the repaired area flush with base metal or the adjacent weld;

5. Check the welds according to the working drawings.

1. 加强焊接监控和道间清理。
1. Improve monitoring of welding and interpass cleaning.
