DEPARTMENT OF TRANSPORTATION
 DIVISION OF ENGINEERING SERVICES
 Office of Structural Materials
 Quality Assurance and Source Inspection

Contract #: 04-0120F4
 Cty: SF/ALA Rte: 80 PM: 13.2/13.9
 File #: 69.25B

QUALITY ASSURANCE -- NON-CONFORMANCE REPORT

Report No: NCR-000695

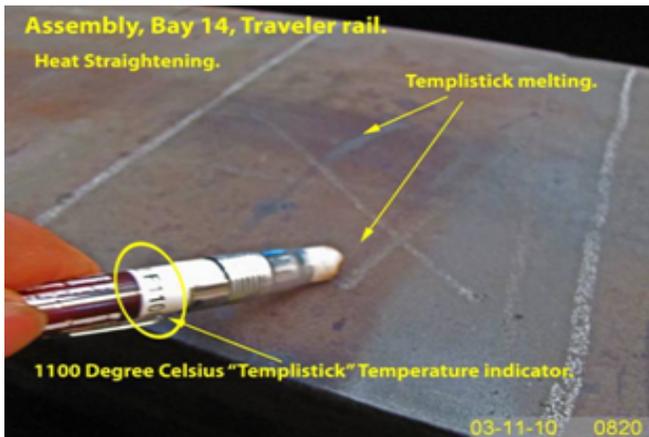
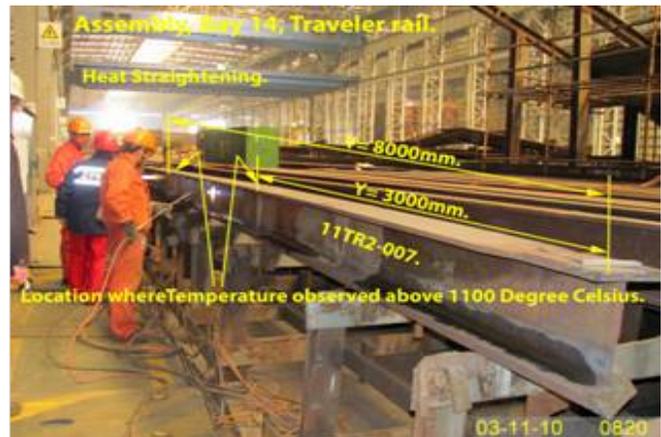
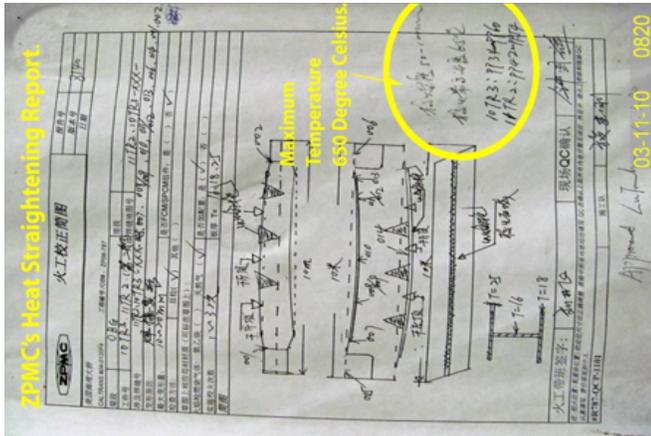
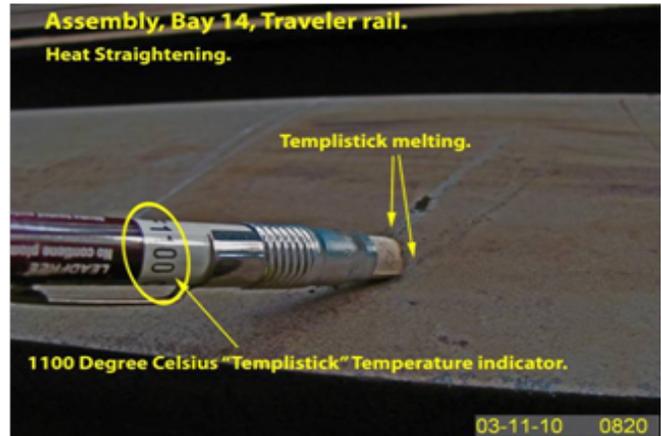
- Temperature of the heat straightened traveler rail was beyond the allowable 650 Degree Celsius in two locations.
- Per ZPMC heat straightening report (HSR) maximum temperature limit is 650 Degree Celsius.
- The 1100 Degree Celsius rating "templistick" was melted when check was made against the metal surface.
- "Y" location of the spots identified as 3000mm & 8000mm at the flange.
- The Traveler Rail is identified as 11TR2-007.

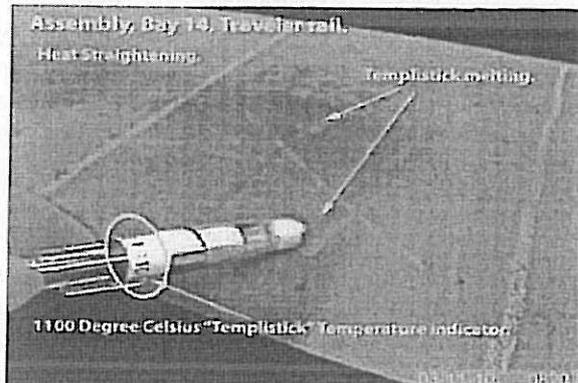
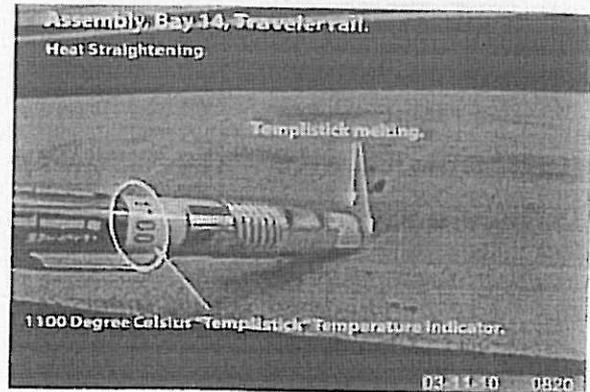
- Temperature of the heat straightened traveler rail was beyond the allowable 650 Degree Celsius in two locations.
- Per ZPMC heat straightening report (HSR) maximum temperature limit is 650 Degree Celsius.
- The 1100 Degree Celsius rating "templistick" was melted when check was made against the metal surface.
- "Y" location of the spots identified as 3000mm & 8000mm at the flange.
- The Traveler Rail is identified as 11TR2-007.

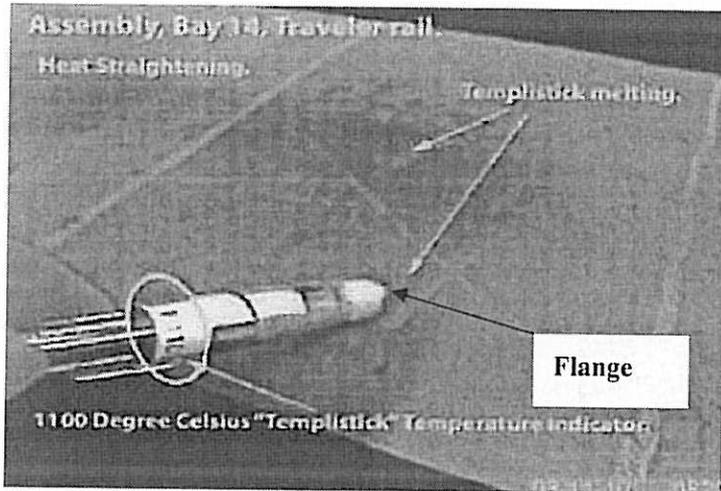
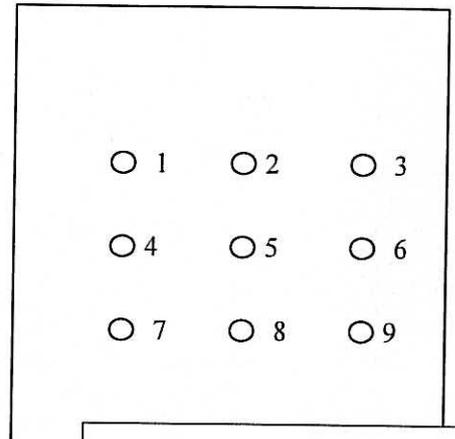
Hardness testing 11TR2-007

Tested points were located by 50mm * 50mm Square on the HS surface & compare area

Flange			
HS Area (3000~3150mm)		No HS Area (1950~2100mm)	
Location	Data	Location	Data
1	148	1	165
2	156	2	171
3	164	3	161
4	134	4	134
5	142	5	140
6	166	6	152
7	151	7	193
8	149	8	158
9	151	9	157

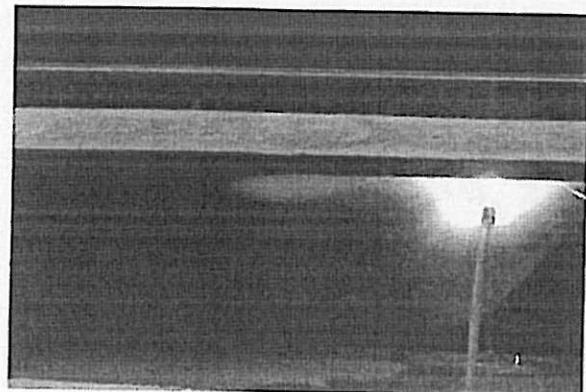
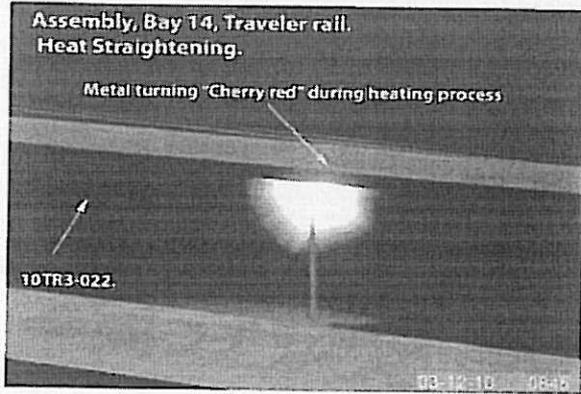
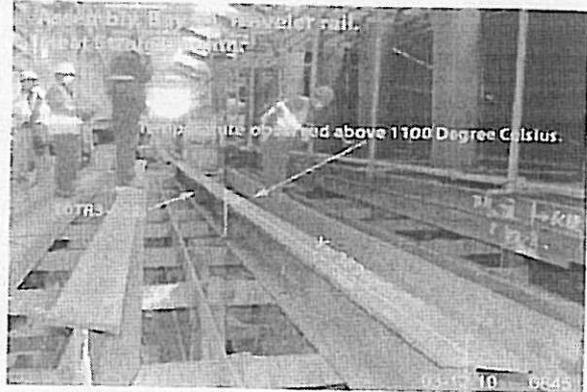
- Temperature of the heat straightened traveler rail was beyond the allowable 650 Degree Celsius.
- Metal color turns into "cherry red" after it was heat straightened.
- Per ZPMC heat straightening report (HSR) maximum temperature limit is 650 Degree Celsius.
- The 1100 Degree Celsius rating "templistick" was melted when check was made against the metal surface.
- "Y" location of the spot identified was 3890 mm and it is at the flange to web joint.
- The Traveler Rail is identified as 10TR3-022.

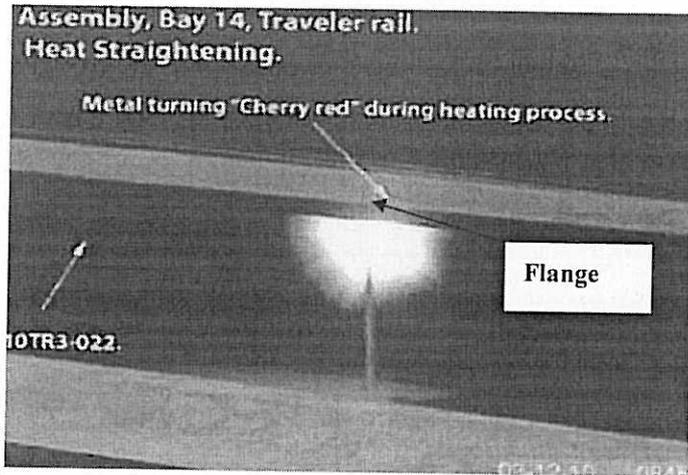
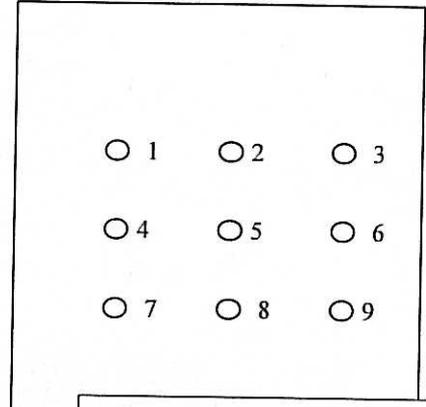
Hardness testing 10TR3-002

Tested points were located by 50mm * 50mm Square on the HS surface & compare area

Flange			
HS Area (3800~4000mm)		No HS Area (3000~3200mm)	
Location	Data	Location	Data
1	157	1	153
2	191	2	146
3	147	3	141
4	160	4	160
5	144	5	144
6	149	6	139
7	148	7	138
8	144	8	153
9	149	9	149

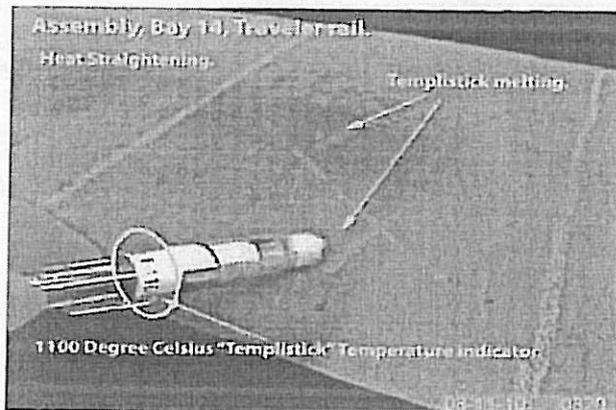
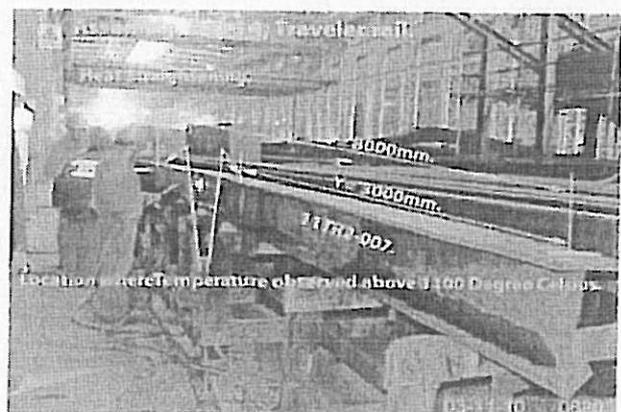
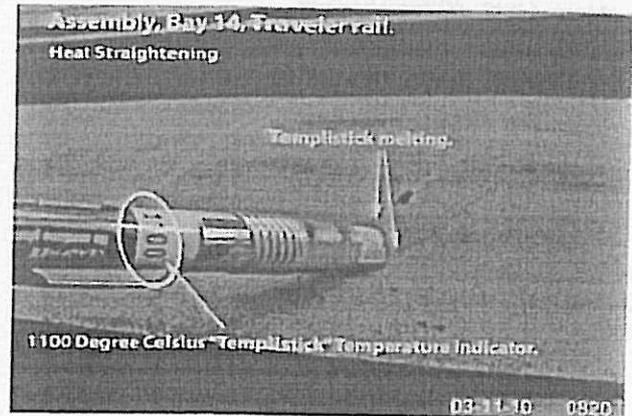
- Temperature of the heat straightened traveler rail was beyond the allowable 650 Degree Celsius in two locations.
- Per ZPMC heat straightening report (HSR) maximum temperature limit is 650 Degree Celsius.
- The 1100 Degree Celsius rating "templstick" was melted when check was made against the metal surface.
- "Y" location of the spots identified as 3000mm & 8000mm at the flange.
- The Traveler Rail is identified as 11TR2-007.

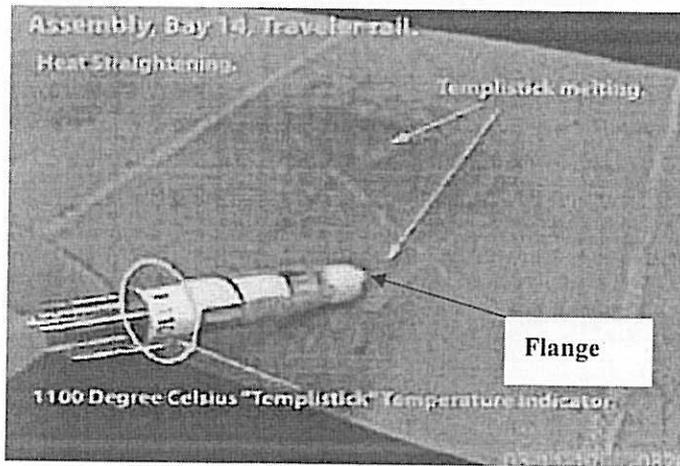
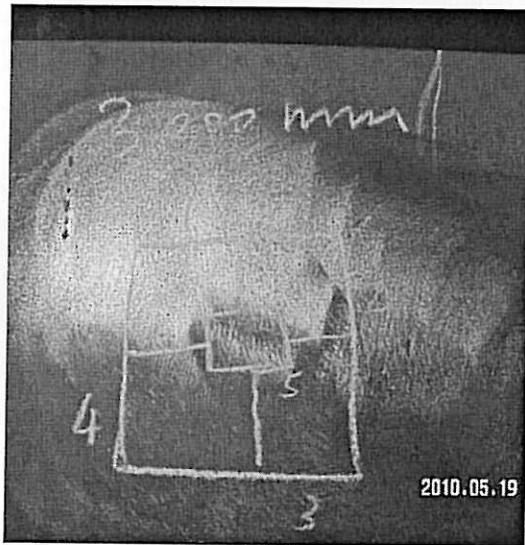
11TR2-007 Flange at 3000mm Hardness Testing Result

Area \ Value	a	b	c	d	e	Average Value
1	203	242	218	243	208	223
2	184	201	195	193	166	191
3	189	267	219	200	196	205
4	225	197	197	201	208	202
5	239	190	200	200	196	199

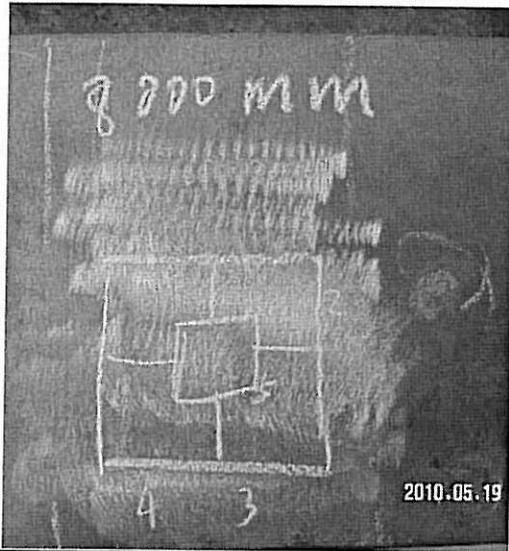
11TR2-007 Flange at 8000mm Hardness Testing Result

Area \ Value	a	b	c	d	e	Average Value
1	181	180	191	192	196	188
2	212	213	178	189	196	199
3	216	221	209	194	217	214
4	210	225	198	234	217	217
5	212	199	195	209	194	201

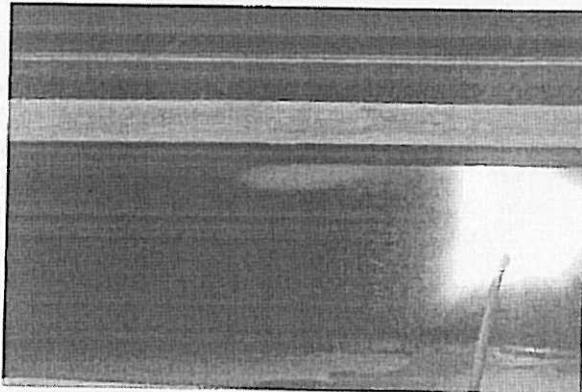
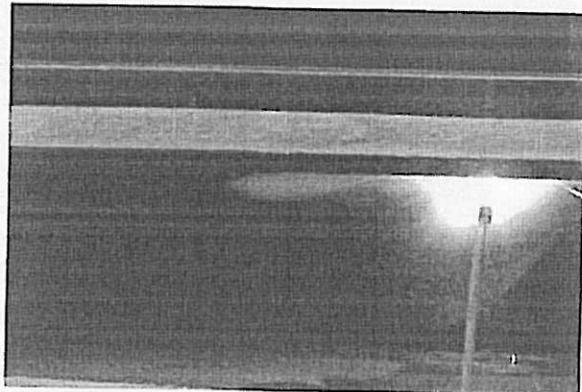
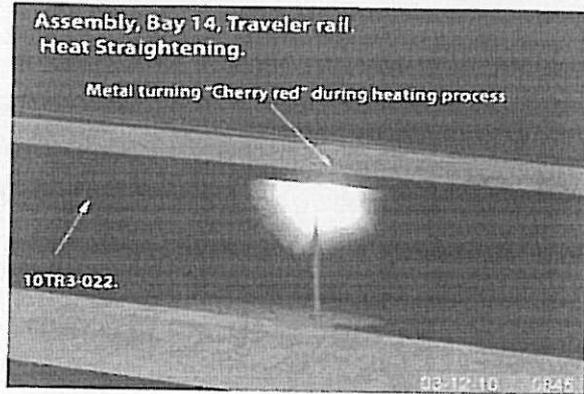
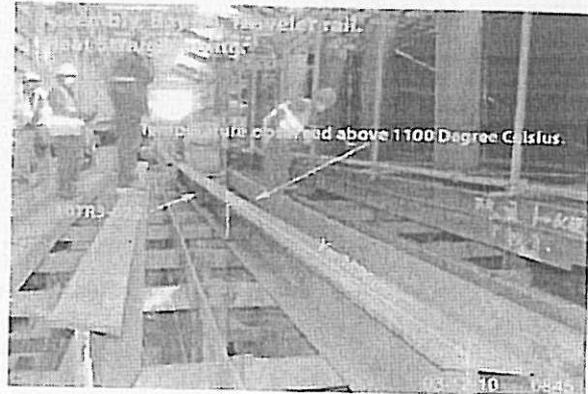
- Temperature of the heat straightened traveler rail was beyond the allowable 650 Degree Celsius.
- Metal color turns into "cherry red" after it was heat straightened.
- Per ZPMC heat straightening report (HSR) maximum temperature limit is 650 Degree Celsius.
- The 1100 Degree Celsius rating "templstick" was melted when check was made against the metal surface.
- "Y" location of the spot identified was 3890 mm and it is at the flange to web joint.
- The Traveler Rail is identified as 10TR3-022.

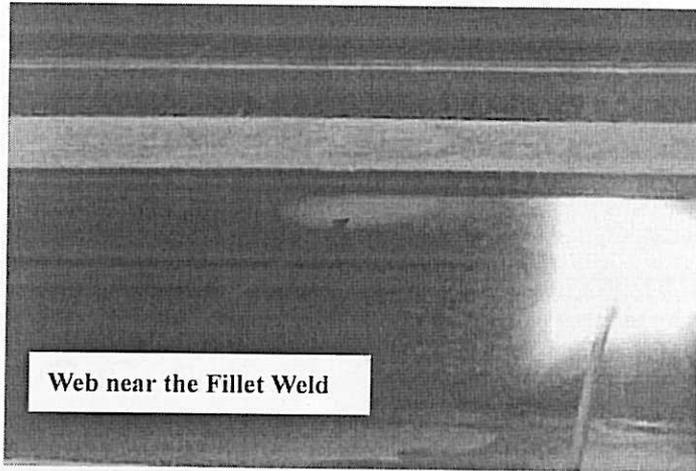
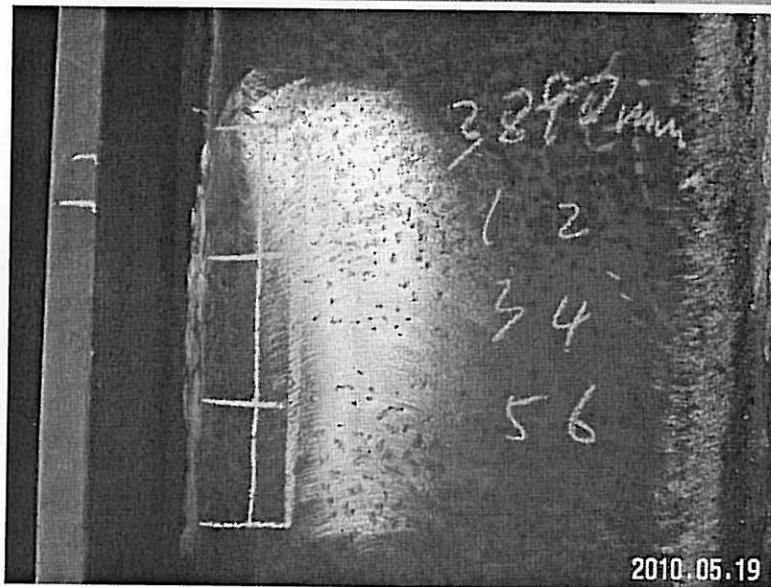
10TR3-022 Web Hardness Testing Result

Area \ Value	a	b	c	d	e	Average Value
1	175	177	172	175	196	176
2	180	183	185	184	184	184
3	175	180	178	180	181	179
4	186	178	186	179	178	181
5	179	182	172	168	171	174
6	179	182	172	168	171	174

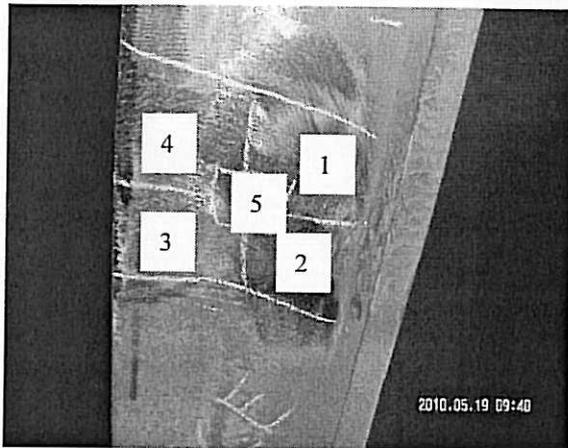
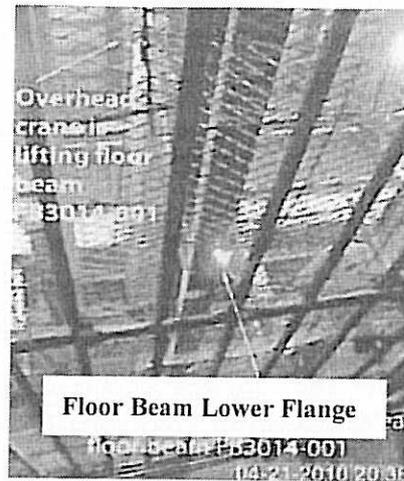
Floor Beam Lower Flange Hardness Testing Result

Area \ Value	a	b	c	d	e	Average Value
1	161	129	159	181	186	167
2	165	159	152	169	159	161
3	128	151	179	161	166	159
4	166	183	173	173	166	171
5	169	181	179	182	195	181

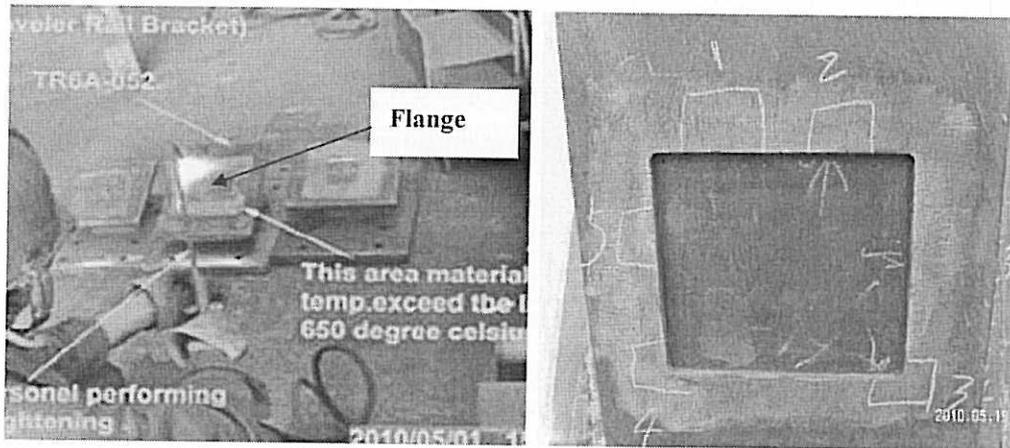
TR6A-052 Flange Hardness Testing Result

Area \ Value	a	b	c	d	e	Average Value
1	177	187	184	199	232	190
2	194	186	177	207	177	186
3	188	195	202	196	190	194
4	186	193	208	192	204	196
5	186	201	188	192	181	189

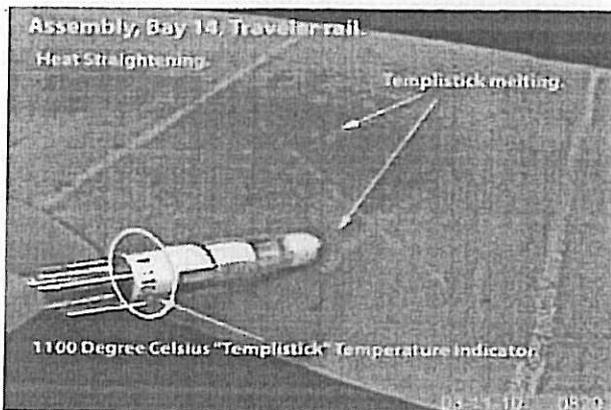
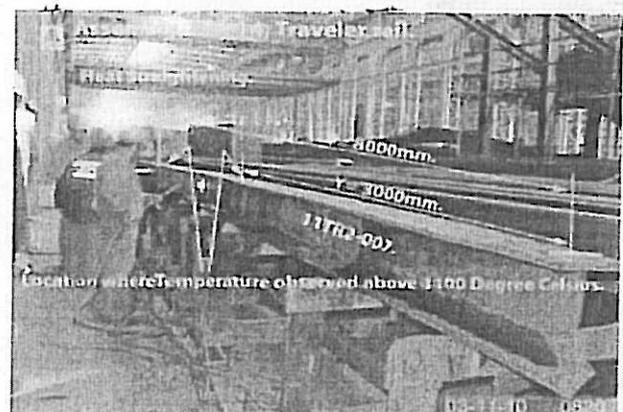
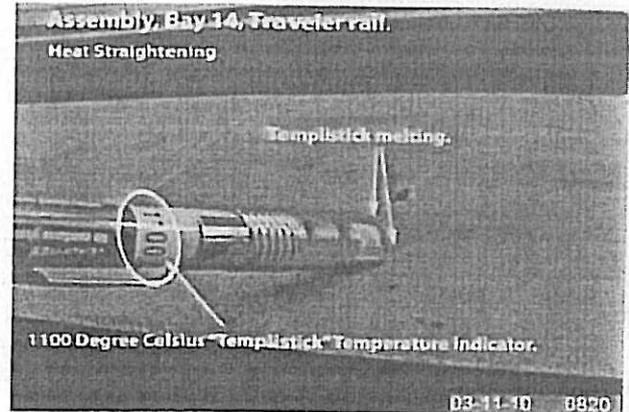
- Temperature of the heat straightened traveler rail was beyond the allowable 650 Degree Celsius in two locations.
- Per ZPMC heat straightening report (HSR) maximum temperature limit is 650 Degree Celsius.
- The 1100 Degree Celsius rating "templistick" was melted when check was made against the metal surface.
- "Y" location of the spots identified as 3000mm & 8000mm at the flange.
- The Traveler Rail is identified as 11TR2-007.

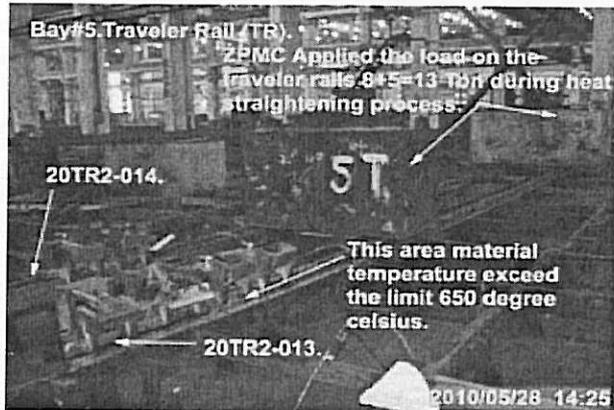
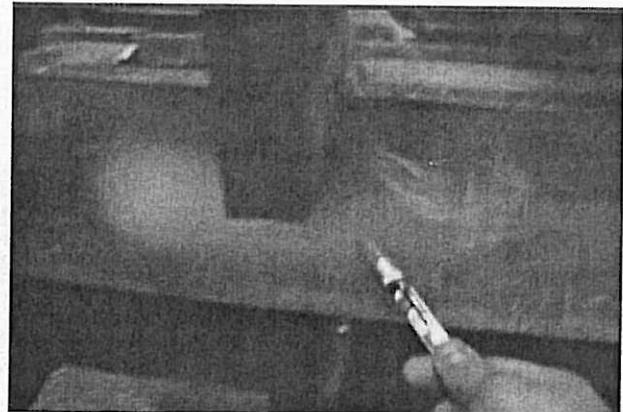
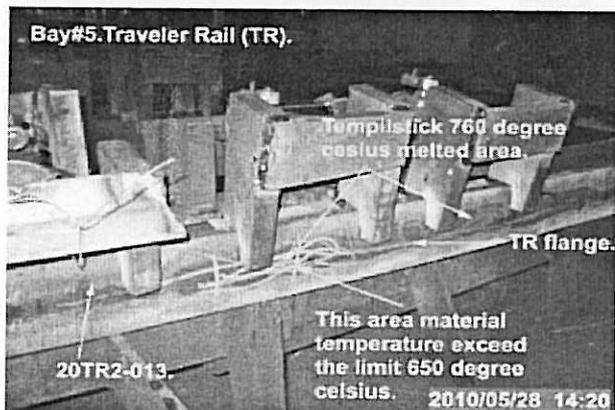
- ZPMC personnel performed heat straightening of the traveler rail flange base plate. The material was heated to a bright red condition and the temperature is above 650°C.

- This QA Inspector observed the 760°C Tempilstik was melted when struck against the red base metal.
- A temperature indicating crayon, digital temperature measurement gauge, or other similar means of monitoring the temperature was not utilized by ZPMC QC and the actual maximum attained temperature was not measured.

- Additionally, this QA Inspector observed ZPMC apply a 13 Tons load on the Traveler rail.
- ZPMC HSR1 Report doesn't specify the exact weight or weight range to be applied on the TR during heat straightening process.

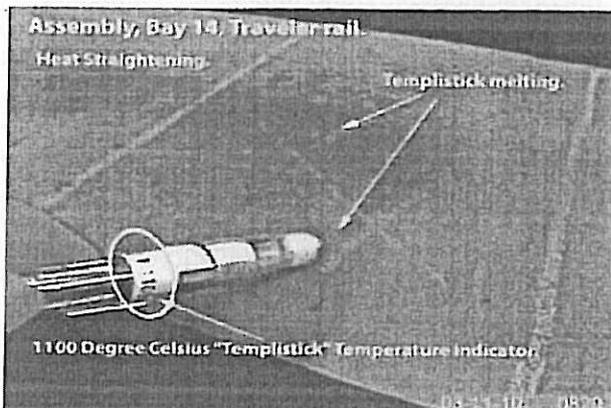
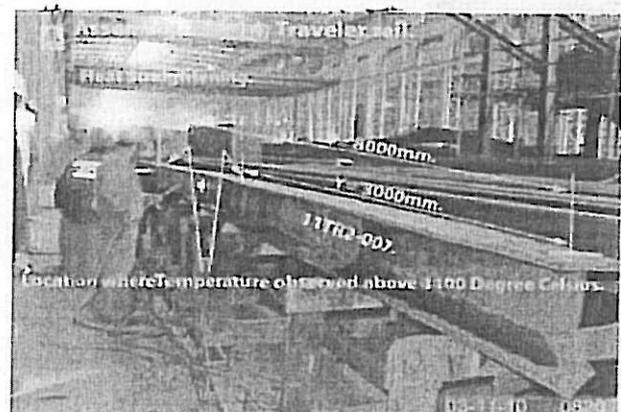
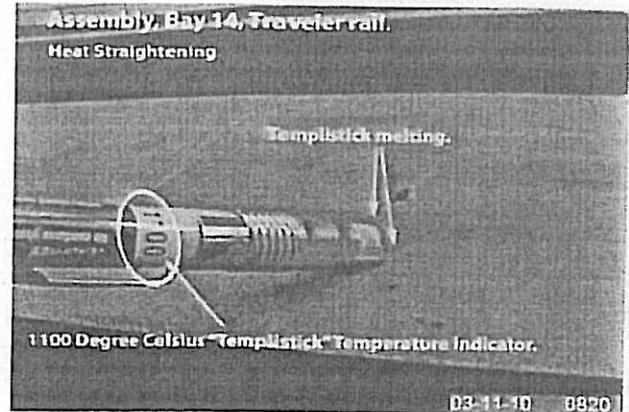
- Temperature of the heat straightened traveler rail was beyond the allowable 650 Degree Celsius in two locations.
- Per ZPMC heat straightening report (HSR) maximum temperature limit is 650 Degree Celsius.
- The 1100 Degree Celsius rating "templistick" was melted when check was made against the metal surface.
- "Y" location of the spots identified as 3000mm & 8000mm at the flange.
- The Traveler Rail is identified as 11TR2-007.
