Contract #: 04-0120F4
 Cty: SF/ALA Rte: 80 PM: 13.2/13.9
 File #: 69.25B

QUALITY ASSURANCE -- NON-CONFORMANCE REPORT

Report No: NCR-000697

Reference Description: Welding was performed with improperly stored electrode for Segment 11DW FL3 Bottom Plate

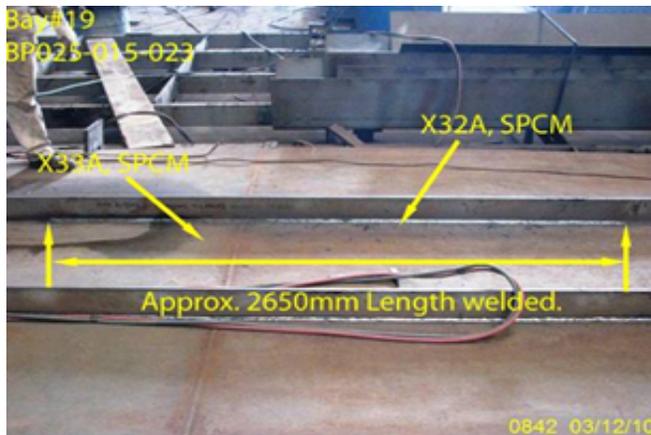
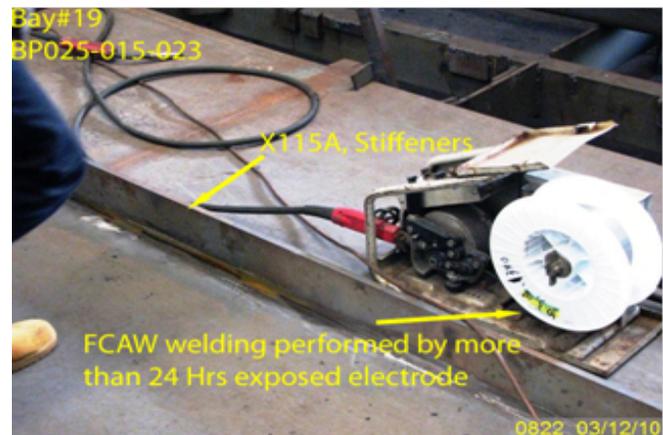
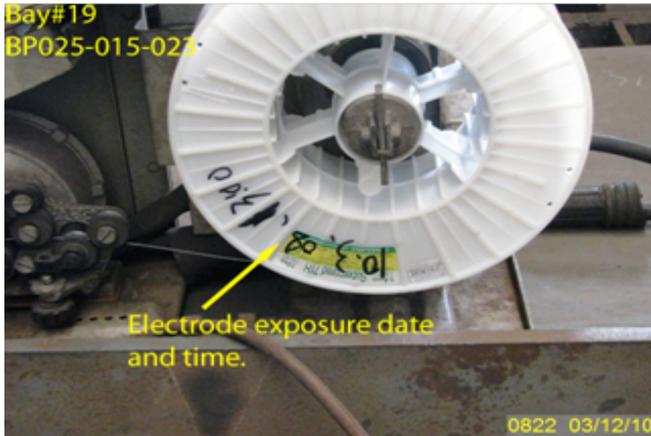
- Flux Cored Arc Welding (FCAW) performed on Bottom Plate BP025-015; ZPMC personal welded utilizing electrode wire that has been exposed for more than 24 hours.
- This electrode was exposed and not properly stored since 03-08-10.
- Approximately 2650mm length of weld was welded by this electrode.
- The weld is identified as: BP025-015-023.
- This weld is a 6mm fillet weld type joining BP X32A (SPCM), X33A (SPCM) to the X115A Stiffener.
- This weld is designated as Seismic Performance Critical Member (SPCM) on the approved drawing (BP025B).
- This component is located in OBG fabrication shop Bay #19.

AWS D1.5-2002 section 12.6.7.4 Electrode Storage: When welding is to be suspended for more than 8 hours, electrodes shall be removed from the machines and stored in airtight coverings or placed in a storage or drying oven maintained at a temperature of 120 degree C – 290 degree C [250 degree F- 550 degree F] or as recommended by the manufacturer. Electrodes not consumed within 24 hours of accumulated exposure outside sealed or heated storage shall be re- dried by baking as described in 12.6.7.6. Electrodes shall be identified to facilitate monitoring of total atmospheric exposure time.

WQCP Section 12.4.8.5: Electrodes shall be identified by marking the time exposed to the atmosphere to facilitate monitoring the total atmospheric exposure time. Electrode that is not consumed within 24 hours of accumulated exposure shall be removed and cannot be used for welding SPCMs.

Reference Resolution: ZPMC has completely removed the weld material that was unacceptable and has rewelded. Attached is the NDT to show that weld is acceptable. Based on this ZPMC requests closure of this NCR.

Partial length of weld what was finished by utilizing unacceptable electrode wire has been removed by gouging. After gouging, MT was performed to ensure no deflection at base metal. ZPMC will pay more attentions on the storage of electrode especially for SPCM welding. ZPMC is providing the MT report after gouging and requesting closure of this NCR.

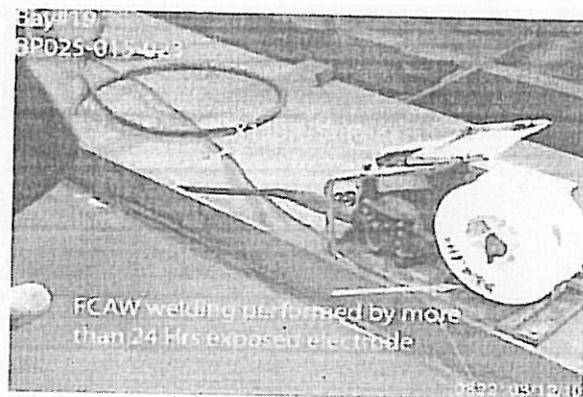
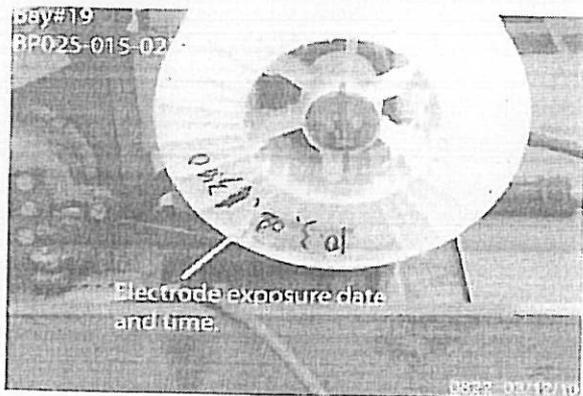
- Flux Cored Arc Welding (FCAW) performed on Bottom Plate BP025-015; ZPMC personal welded utilizing electrode wire that has been exposed for more than 24 hours.
- This electrode was exposed and not properly stored since 03-08-10.
- Approximately 2650mm length of weld was welded by this electrode.
- The weld is identified as: BP025-015-023.
- This weld is a 6mm fillet weld type joining BP X32A (SPCM), X33A (SPCM) to the X115A Stiffener.
- This weld is designated as Seismic Performance Critical Member (SPCM) on the approved drawing (BP025B).
- This component is located in OBG fabrication shop Bay #19.

AWS D1.5-2002 section 12.6.7.4 Electrode Storage: When welding is to be suspended for more than 8 hours, electrodes shall be removed from the machines and stored in airtight coverings or placed in a storage or drying oven maintained at a temperature of 120 degree C - 290 degree C [250 degree F - 550 degree F] or as recommended by the manufacturer. Electrodes not consumed within 24 hours of accumulated exposure outside sealed or heated storage shall be re-dried by baking as described in 12.6.7.6. Electrodes shall be identified to facilitate monitoring of total atmospheric exposure time.

WQCP Section 12.4.8.5: Electrodes shall be identified by marking the time exposed to the atmosphere to facilitate monitoring the total atmospheric exposure time. Electrode that is not consumed within 24 hours of accumulated exposure shall be removed and cannot be used for welding SPCMs.

Remove said weld, reweld and perform NDT required to verify weld quality.

Contractor submitted post repair NDT documentation verifying weld is now in conformance with Contract specifications.
