Contract #: 04-0120F4Cty: SF/ALA Rte: 80 PM: 13.2/13.9File #: 69.25B**QUALITY ASSURANCE -- NON-CONFORMANCE REPORT****Location:** Changxing Island, Shanghai, P.R. China**Report No:** NCR-000701**Prime Contractor:** American Bridge/Fluor Enterprises, a JV**Date:** 24-Mar-2010**Submitting Contractor:** Zhenhua Port Machinery Company, Ltd (ZPMC), Changxing Island**NCR #:** ZPMC-0668**Type of problem:****Welding****Concrete****Other****Welding****Curing****Procedural****Bridge No:** 34-0006**Joint fit-up****Coating****Other****Component:** Traveler Rail Bracket for Lift 5E**Procedural****Procedural****Description:**

Reference Description: Tightening the Bolts of U-Rib Splices not conforming to the approved procedure
(Traveler Rail Bracket for Lift 5E)

QUALITY ASSURANCE -- NON-CONFORMANCE REPORT

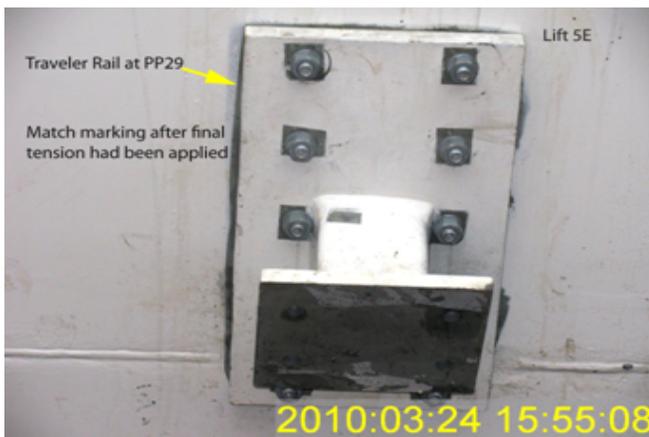
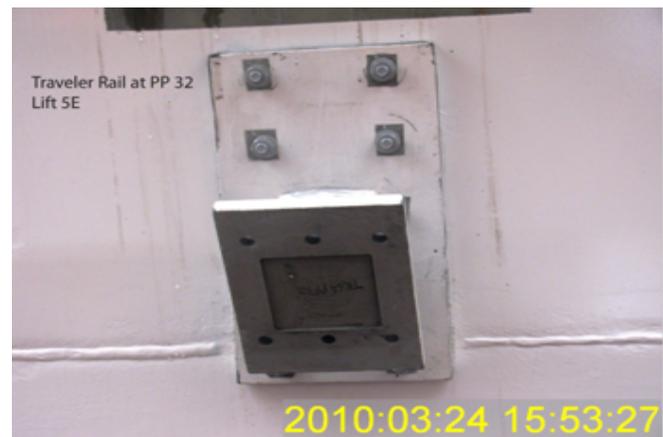
-ZPMC personnel were observed match marking A325 High Strength (HS) nut and bolt combinations after final tensioning had been performed.

-The applicable contract documents specify that the contractor use the "turn of the nut" method to tension A325 HS bolts. See applicable reference below for details.

-The effected traveler rail brackets are located on lift 5E, between "E" lines 2 and 3 (bike path side) @ Panel Points (PP) 029, 030, 031, 032, 033, 034, 035 and 036.

Perform tension verification testing on bolts in question.

Contractor performed tension verification testing on traveler rail bracket bolts at the specified torque. None of the nuts or bolts turned relative to their matching component by application of the required torque.
