QUALITY ASSURANCE -- NON-CONFORMANCE REPORT

Location: Changxing Island, Shanghai, P.R. China**Report No:** NCR-000703**Prime Contractor:** American Bridge/Fluor Enterprises, a JV**Date:** 25-Mar-2010**Submitting Contractor:** Zhenhua Port Machinery Company, Ltd (ZPMC), Changxing Island**NCR #:** ZPMC-0670**Type of problem:**

Reference Description: Missed UT indication by QC on Segment 9BW BP to BP CJP Joint**Description of Non-Conformance:**

Job Name: SAS Superstructure

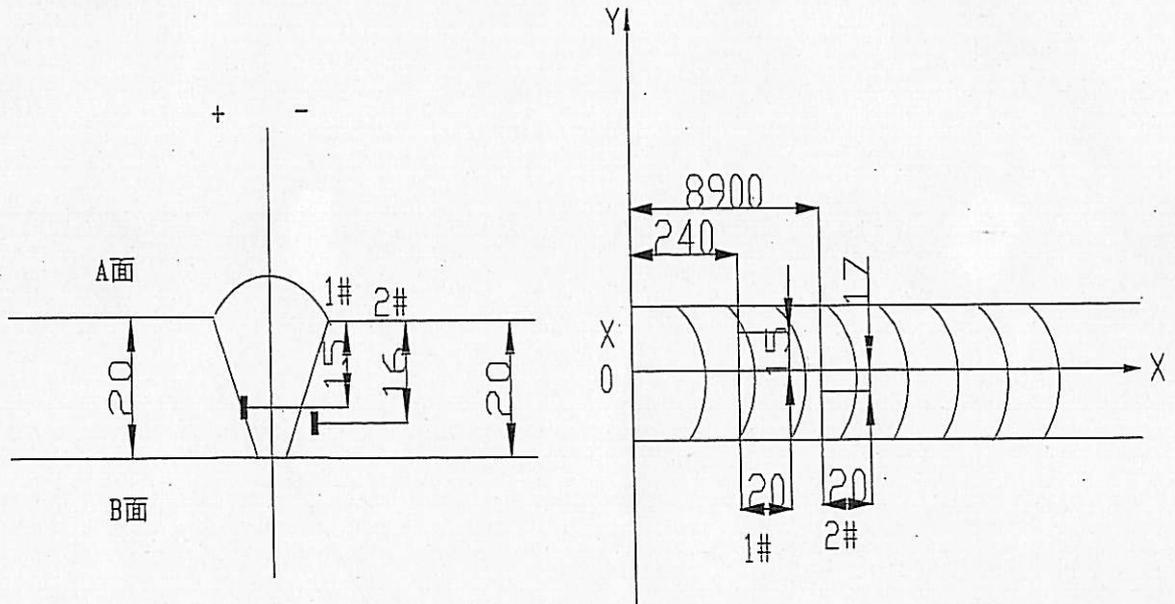
WELD NUMBER: SEG051A-003

Rejected indication found by ultrasonic inspection is less than the maximum allowance aggregate length.

(UT探伤发现的缺陷总长度小于最大允许长度。) SEG051A-003

1. 焊道未及时处理干净。
1. Did not clear the weld pass completely in time.

1. 从缺陷距离端面较近一侧 ($D \leq 0.65T$, D 为缺陷深度, T 为板厚) 采用碳刨或打磨的方法去除焊缝缺陷;
 2. 参照返修焊接工艺规程 (WPS) 准备正确的接头型式, 预热和焊接;
 3. 焊前对修补区域进行VT检测保证缺陷完全被消除;
 4. 将修补区域打磨到与母材或邻近焊缝平齐;
 5. 对焊缝进行UT检测, 检测范围为返修区域以及其两端各延长50mm.
-
1. Gouge or grind from nearer side from metal edge ($D \leq 0.65T$, "D" is depth of defects, "T" is thickness of metal) to remove all defects;
 2. Follow repair WPS for joint preparation, preheat, and weld deposit;
 3. Verify with VT no defects remain in the weld joint prior to welding;
 4. Grind the repaired area flush with base metal or the adjacent weld;
 5. Perform UT inspection to the weld along with 50mm on each end of the repair area;

1. Improve monitoring of welding and interpass cleaning.
