Contract #: 04-0120F4Cty: SF/ALA Rte: 80 PM: 13.2/13.9File #: 69.25B**QUALITY ASSURANCE -- NON-CONFORMANCE REPORT****Location:** Changxing Island, Shanghai, P.R. China**Report No:** NCR-000707**Prime Contractor:** American Bridge/Fluor Enterprises, a JV**Date:** 07-Apr-2010**Submitting Contractor:** Zhenhua Port Machinery Company, Ltd (ZPMC), Changxing Island**NCR #:** ZPMC-0674**Type of problem:**

Reference Description: Missed UT indication by QC on Segment 9CE Bottom Plate to Bottom Plate Weld**Description of Non-Conformance:**

Job Name: SAS Superstructure
Document No: 05.03.06-000663

焊缝返修报告
Welding Repair Report

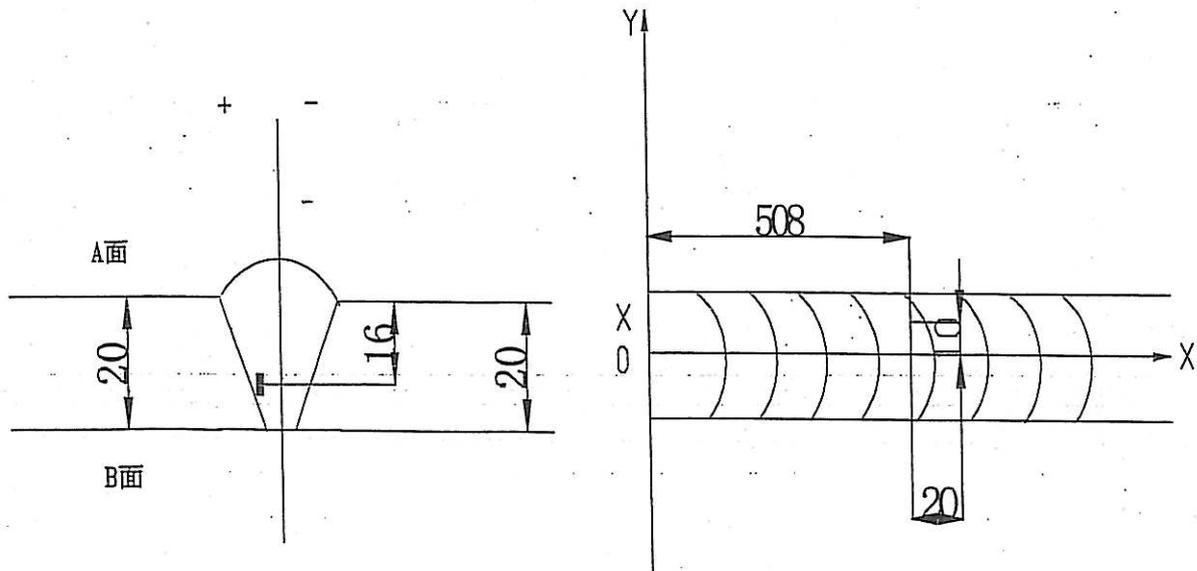
WELD NUMBER: SEG054A-006

Rejected indication found by ultrasonic inspection is less than the maximum allowance aggregate length.

(UT探伤发现的缺陷总长度小于最大允许长度。) SEG054A-006

1、焊道未及时处理干净。

1. Did not clear the weld pass completely in time.

1. 从缺陷距离端面较近一侧 ($D \leq 0.65T$, D为缺陷深度, T为板厚) 采用碳刨或打磨的方法去除焊缝缺陷;
2. 参照返修焊接工艺规程 (WPS) 准备正确的接头型式, 预热和焊接;
3. 焊前对修补区域进行VT检测保证缺陷完全被清除;
4. 将修补区域打磨到与母材或邻近焊缝平齐;
5. 对焊缝进行UT检测, 检测范围为返修区域以及其两端各延长50mm。

1. Gouge or grind from nearer side from metal edge ($D \leq 0.65T$, "D" is depth of defects, "T" is thickness of metal) to remove all defects;
2. Follow repair WPS for joint preparation, preheat, and weld deposit;
3. Verify with VT no defects remain in the weld joint prior to welding;
4. Grind the repaired area flush with base metal or the adjacent weld;
5. Perform UT inspection to the weld along with 50mm on each end of the repair area;

1. 加强焊接监控和道间清理。
1. Improve monitoring of welding and interpass cleaning.
