Contract #: 04-0120F4Cty: SF/ALA Rte: 80 PM: 13.2/13.9File #: 69.25B**QUALITY ASSURANCE -- NON-CONFORMANCE REPORT****Location:** Changxing Island, Shanghai, P.R. China**Report No:** NCR-000710**Prime Contractor:** American Bridge/Fluor Enterprises, a JV**Date:** 15-Apr-2010**Submitting Contractor:** Zhenhua Port Machinery Company, Ltd (ZPMC), Changxing Island**NCR #:** ZPMC-0677**Type of problem:**

Reference Description: Welding Without Approved WPS, Insufficient QC Coverage**Description of Non-Conformance:**

Job Name: SAS Superstructure
Document No: 05.03.06-000667

Reference Description: Welding Without Approved WPS, Insufficient QC Coverage/ Towe / Tower Skirt

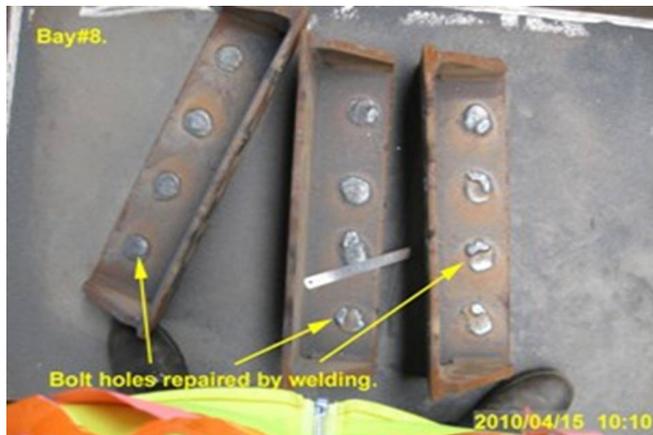
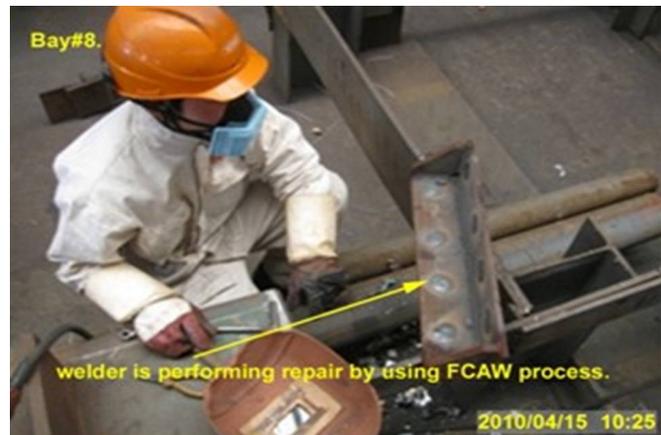
During Quality Assurance (QA) random in-process observations of the fabrication of Tower skirt connection angles Caltrans QA discovered the following:

- ZPMC Personnel performing plug welded restoration of the material with mis-located drilled bolt holes without approved repair Weld Procedure Specification (WPS).
- ZPMC Certified Welding Inspector (CWI)/Quality Control Inspector (QC) were not observed as being present during the welding process from 10:00 to 11:00 hours.
- The welding was being performed by using Flux Cored Arc Welding (FCAW) process.
- The members are identified as Tower skirt connection angles.
- Total number of skirt angles repaired: 22 No's.
- These members are located in Bay #8.

AWS D1.5:2002, Sec. 1.9: "All production welding shall be performed in conformance with the provision of an approved Welding Procedure Specification (WPS)..."

AWS D1.5 2002, Sec. 3.7.7.1: "Base metal not subjected to dynamic tensile stress may be restored by welding, provided the Contractor prepares and follows a repair WPS. The repair weld soundness shall be verified by UT or RT as approved by the Engineer."

Propose a resolution for the identified non-conformance, documenting that the plug welded restorations are in compliance with the contract requirements. Documentation provided for the Engineer's review of the acceptability of the weld repairs shall at a minimum include the procedure utilized and the NDT results.

In addition to the material/workmanship non-conformance, address the failure by both Production and Quality Control in proceeding with work without proper WPS. Provide documentation of the steps/actions taken by Production and Quality Control to prevent future occurrences.

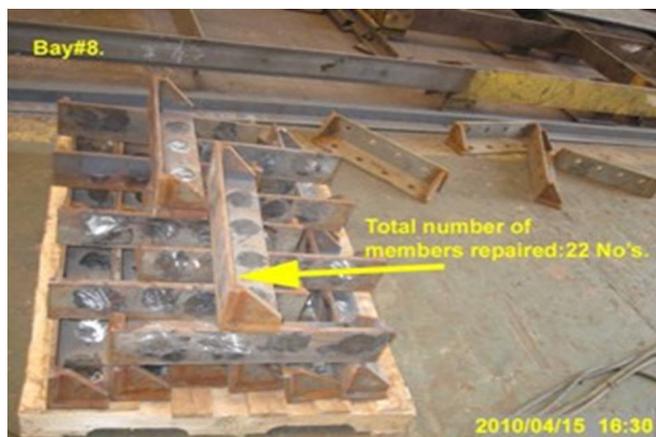
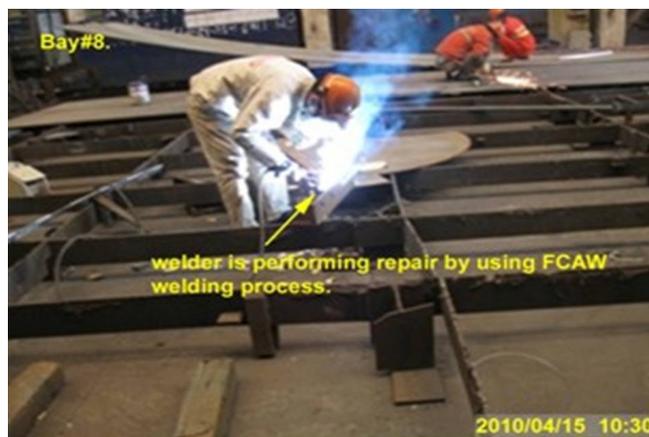
Caltrans Special Provision Section 8-3.01: "QC inspections shall be provided to ensure continuous inspection when any welding is being performed. Continuous inspection, as a minimum, shall include (1) having QC Inspectors continually present on the shop floor or project site when any welding operation is being performed, and (2) having a QC Inspector within such close proximity of all welders or operators so that inspections by the QC Inspector of each operation, at each welding location, shall not lapse for a period exceeding 30 minutes."

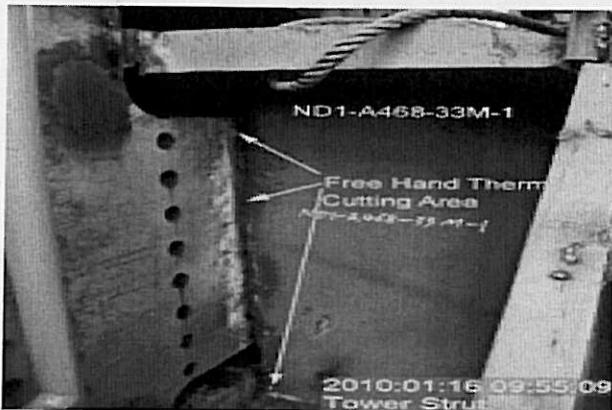
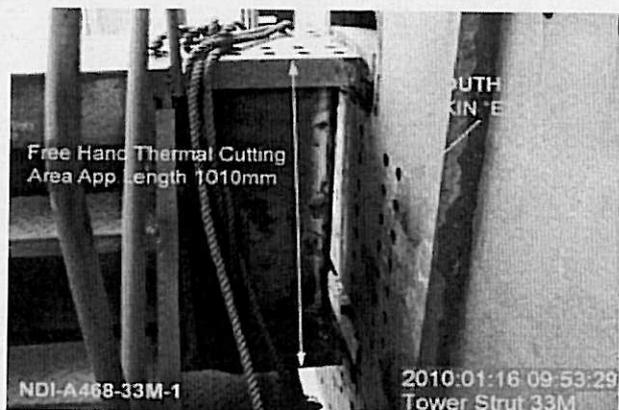
During the random Quality Assurance(QA) in process verification of Tower strut, this QA Inspector observed the following issues:

- Free hand thermal cutting were carried out on edges of the strut plate towards South Tower side without Engineer's approval.
- The strut is identified as ND1-A468-33M-1 at elevation level 33M.
- The thermal cut area is measured approximately 1010 mm.
- The material is designated as Seismic Performance Critical Member (SPCM).
- The member is located at Tower assembly area (Jetty Area).

AWS D1.5 (02) Section 3.2.3: "Steel and weld metal may be thermally cut, provided a smooth and regular surface free from cracks and notches is secured, and provided that an accurate profile is secured by the use of a mechanical guide. Freehand thermal cutting shall be done only where approved by the Engineer."

Propose a resolution for the identified non-conformance, documenting that the affected plate edges have been brought in compliance with the contract requirements.

In addition, to the material/workmanship non-conformance, propose a resolution for the identified non-conformance that addresses the failure of Quality Control to identify the deficiency.

Provide documentation of the steps/actions taken by the Quality Control Manager with regard to both Production and Quality Control to prevent future occurrences.

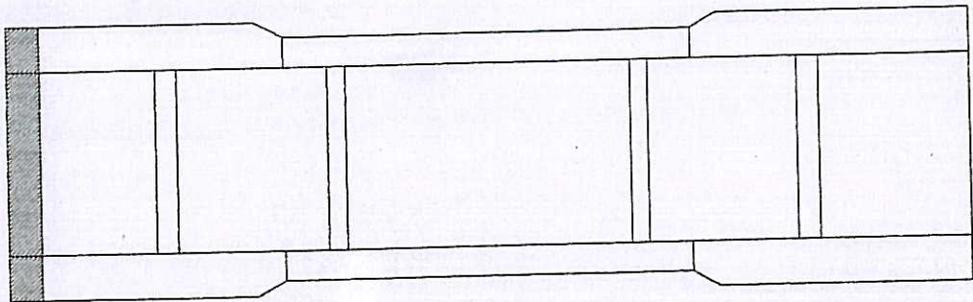
焊缝缺陷描述:
Description of welding discontinuity:
 南塔E面33米联系梁总拼时由于塔柱之间干涉, 对联系梁端部进行修割, 割除部分约5-13毫米, 现在要求堆焊处理, 堆焊长度约5-13毫米。具体如下图所示:
 During splice South tower Skin E 33m strut plate and tower, trim strut plate 5-13mm, and needed to build up 5-13mm, the detail sees the following draft.

注: 阴影部分为堆焊区域
 Remark: repair area in shadow.

Weld distortion and fabricate error.

1. QC/CWI shall monitor and direct all grinding and welding during the repair procedure.
2. Grind the repair area smooth
3. Verify that no defects are present by VT and MT prior to welding
4. Apply backing bar and weld
5. Preheat and maintain interpass temperature control according to the approved WPS
6. QC shall ensure all slag has been removed prior the deposition of next pass
7. The weld size should be greater than theoretical size by about 2 to 3mm.
8. Remove backing bar and grind the weld area smooth after buttering
9. Perform VT, MT and UT inspection on the repaired area

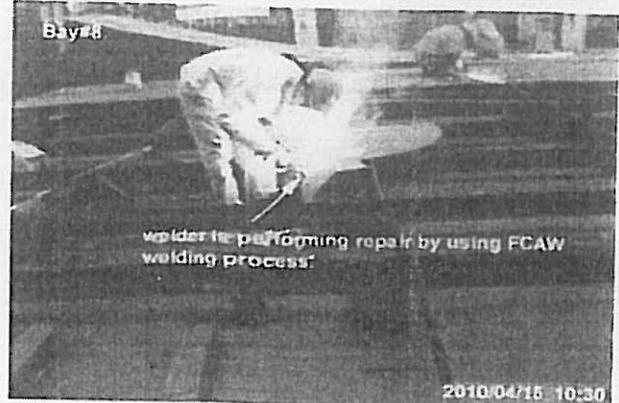
- ZPMC Personnel performing plug welded restoration of the material with mis-located drilled bolt holes without approved repair Weld Procedure Specification (WPS).
- ZPMC Certified Welding Inspector (CWI)/Quality Control Inspector (QC) were not observed as being present during the welding process from 10:00 to 11:00 hours.
- The welding was being performed by using Flux Cored Arc Welding (FCAW) process.
- The members are identified as Tower skirt connection angles.
- Total number of skirt angles repaired: 22 ea.
- These members are located in Bay #8.

AWS D1.5 2002, Sec. 3.7.7.1: "Base metal not subjected to dynamic tensile stress may be restored by welding, provided the Contractor prepares and follows a repair WPS. The repair weld soundness shall be verified by UT or RT as approved by the Engineer."

Propose a resolution for the identified non-conformance, documenting that the plug welded restorations are in compliance with the contract requirements. Documentation provided for the Engineer's review of the acceptability of the weld repairs shall at a minimum include the procedure utilized and the NDT results.

In addition to the material/workmanship non-conformance, address the failure by both Production and Quality Control in proceeding with work without proper WPS. Provide documentation of the steps/actions taken by Production and Quality Control to prevent future occurrences.

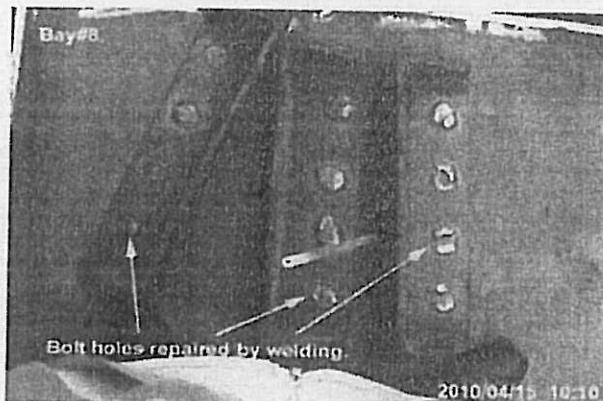
During Quality Assurance (QA) random in-process observations of the fabrication of Tower skirt connection angles Caltrans QA discovered the following:

- ZPMC Personnel performing plug welded restoration of the material with mis-located drilled bolt holes without approved repair Weld Procedure Specification (WPS).
- ZPMC Certified Welding Inspector (CWI)/Quality Control Inspector (QC) were not observed as being present during the welding process from 10:00 to 11:00 hours.
- The welding was being performed by using Flux Cored Arc Welding (FCAW) process.
- The members are identified as Tower skirt connection angles.
- Total number of skirt angles repaired: 22 No's.
- These members are located in Bay #8.

Contractor will fabricate new pieces of connection angles to replace the mis-drilled connection angles. Contractor will issue an internal NCR to the QC. Contractors will address issue with their staff to improve the performance.

Contractor fabricated new pieces of connection angle to replace the mis-drilled components. Internal NCR issued to the QC and the issue has been addressed with the staff concerned.
