Contract #: 04-0120F4Cty: SF/ALA Rte: 80 PM: 13.2/13.9File #: 69.25B**QUALITY ASSURANCE -- NON-CONFORMANCE REPORT****Location:** Changxing Island, Shanghai, P.R. China**Report No:** NCR-000712**Prime Contractor:** American Bridge/Fluor Enterprises, a JV**Date:** 20-Apr-2010**Submitting Contractor:** Zhenhua Port Machinery Company, Ltd (ZPMC), Changxing Island**NCR #:** ZPMC-0679**Type of problem:**

**Reference Description:** Missed MT Indication by QC, East Tower, Lift 1, Skin C, Cable Tray Support**Description of Non-Conformance:**

**Job Name:** SAS Superstructure  
**Document No:** 05.03.06-000669

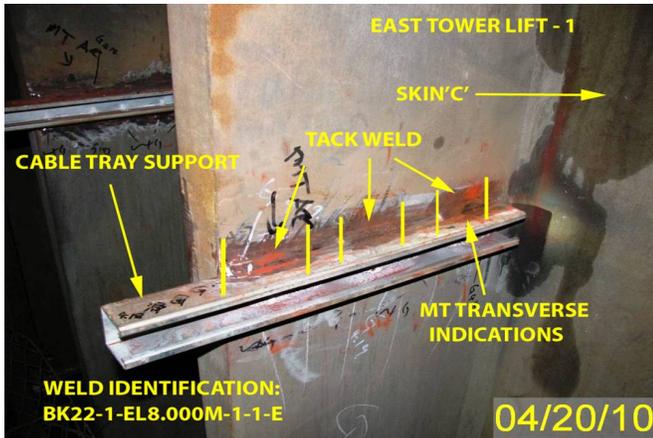
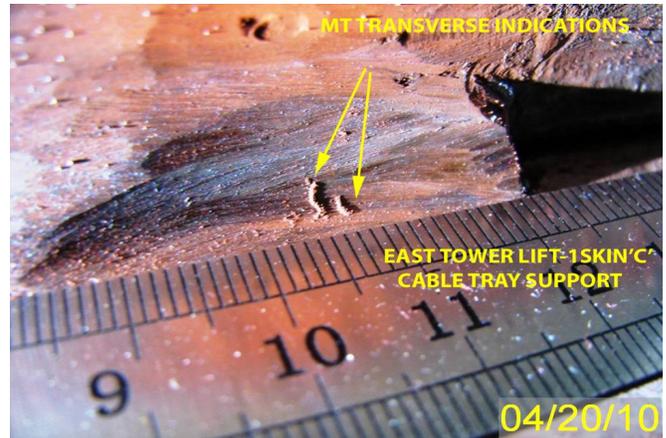
During Magnetic Particle Testing (MT) review of welds on East Tower, Lift-1, Skin 'C' Cable Tray Support, Caltrans Quality Assurance (QA) discovered the following issue:

-Two (2) transverse linear indication measuring approximately 5mm and 3mm in length.

-The member is identified as Cable Tray Support BK22-1-EL8.000M-1.

-The weld is identified as BK22-1-EL8.000M-1-1-E.

-The weld is a Tack weld (fillet) T-joint joining the cable tray support to the stiffener of skin 'C'.

The Notice of Witness Inspection Number (NWIT) is 005558. The indication is located inside the area that has been previously tested and accepted by ZPMC Quality Control (QC) personnel. ZPMC's QC personnel are required to perform 100% MT inspection of this weld.

AWS D1.5 (02) Section 6.26.2 – “Welds that are subject to MT in addition to visual inspection shall have no cracks.”

1. 火焰加热时, 水汽没有完全的去掉或者这个区域预热不够;
1. Moisture wasn't completely removed during drying operation (preheating) or the area wasn't preheated sufficiently.

Propose a resolution for this non-conformance that addresses the failure of Quality Control to identify the linear indications during magnetic particle testing of the welds. Provide documentation of the steps/actions taken by the Quality Control Manager to prevent future occurrences.

1. QC/CWI shall monitor and direct all grinding and welding during the repair procedure.
2. Grind the repair area smooth
3. Verify that no defects are present by VT and MT prior to welding
4. Weld according to the approved WPS;
5. Preheat and maintain interpass temperature control according to the approved WPS
6. QC shall monitor all welding passes being deposited;
7. QC shall ensure all slag has been removed prior the deposition of next pass;
8. Perform VT, MT and UT inspection on the repaired areas.

1. QC shall verify sufficient preheat has been applied, to remove moisture, prior to welding.

Weld was repaired on 4/22/2010 (T-WR3205) and verified by MT (T787-MT-8828).
