Contract #: 04-0120F4Cty: SF/ALA Rte: 80 PM: 13.2/13.9File #: 69.25B**QUALITY ASSURANCE -- NON-CONFORMANCE REPORT****Location:** Changxing Island, Shanghai, P.R. China**Report No:** NCR-000713**Prime Contractor:** American Bridge/Fluor Enterprises, a JV**Date:** 21-Apr-2010**Submitting Contractor:** Zhenhua Port Machinery Company, Ltd (ZPMC), Changxing Island**NCR #:** ZPMC-0680**Type of problem:**

Reference Description: Heat straightening utilizing excessive heat and performing the work with no written procedure to show QA and QC on Floorbeam FB3014-001

Job Name: SAS Superstructure

Subject: NCR No. ZPMC-0680

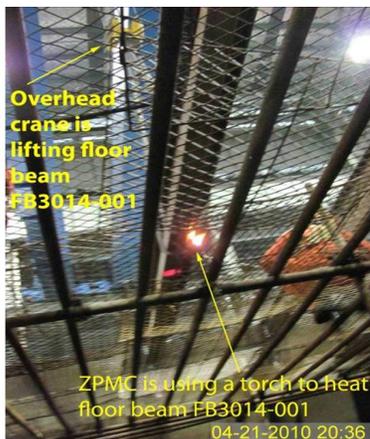
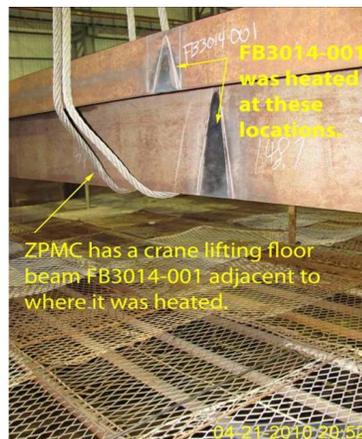
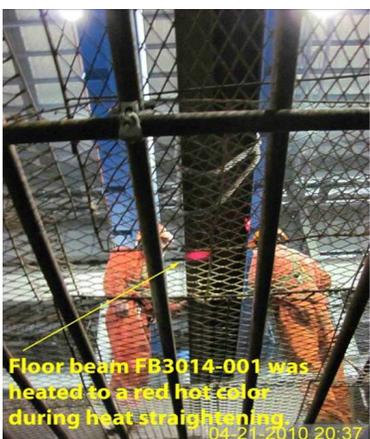
- Heat straightening was performed on Floorbeam FB3014-001 without an approved heat straightening document.
- ZPMC had a crane lifting upward with an unknown amount of uplifting force on the Floorbeam while heat straightening the Floorbeam base metal to a bright cherry-red color.

- The AWS D1.5 Section 3.7.3 states that the heated steel shall not exceed 650°C, which gives a dull red color.
- ZPMC QC Certified Welding Inspector (CWI) Geng Wei and the ABF representative Yang Chao were not aware that this heat straightening was taking place.

- A temp stick, digital temperature measurement gauge, or other similar means of monitoring the heat input was not utilized by ZPMC personnel and the actual maximum attained temperature was not measured.

- Floorbeam FB3014-001 is welded in place at OBG segment 12CE near panel point PP115.5.

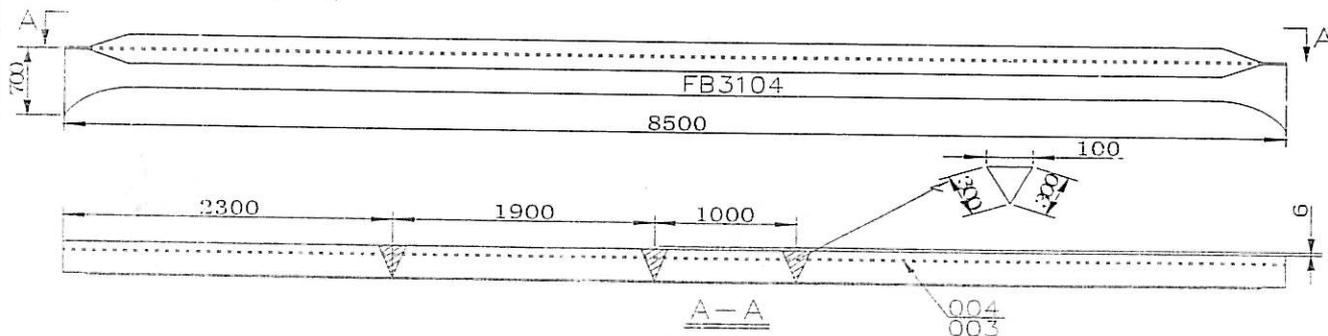
简图 Sketch

注: 最大变形量约6mm

Note: The max deformation is about 6mm.

Note: All repair work shall be performed in accordance with applicable CALTRANS approved procedures, contract specifications and AWS D1.5 2002

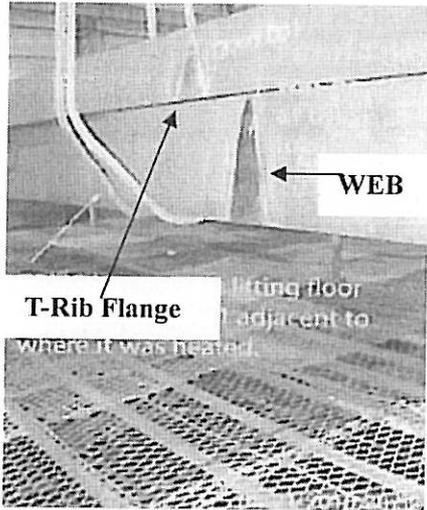
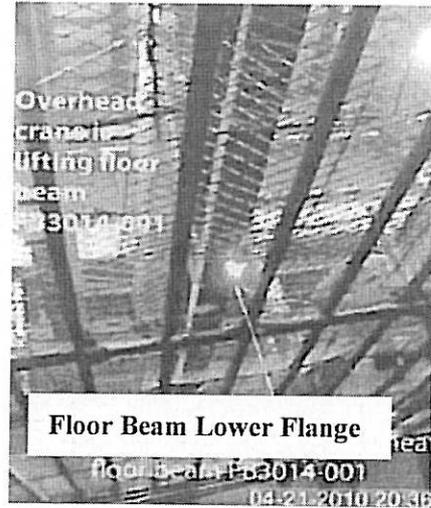
Hardness testing for FB3014-001 @ PP115.5 12CE

WEB			
HS Area		No HS Area	
Location	Data	Location	Data
1	138	1	190
2	152	2	188
3	154	3	206
4	144	4	174
5	178	5	212
6	151	6	173
T-Rib Flange			
HS Area		No HS Area	
Location	Data	Location	Data
1	134	1	196
2	139	2	148
3	146	3	162
4	131	4	163
5	145	5	166
6	137	6	154

Floor Beam Lower Flange			
HS Area		No HS Area	
Location	Data	Location	Data
1	145	1	171
2	154	2	160
3	151	3	139
4	157	4	161
5	141	5	156
6	140	6	143
7	142	7	166
8	133	8	165
9	146	9	133

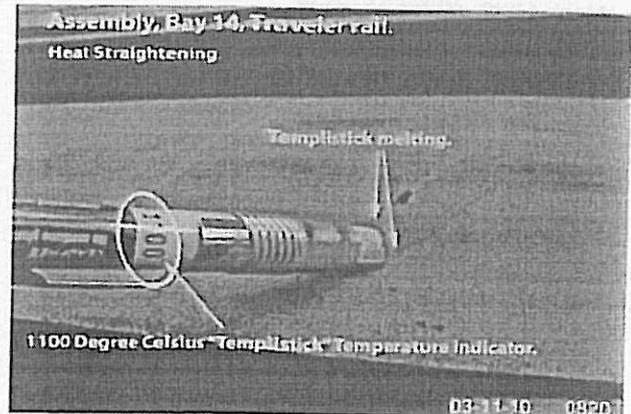
- Temperature of the heat straightened traveler rail was beyond the allowable 650 Degree Celsius in two locations.
- Per ZPMC heat straightening report (HSR) maximum temperature limit is 650 Degree Celsius.
- The 1100 Degree Celsius rating "templstick" was melted when check was made against the metal surface.
- "Y" location of the spots identified as 3000mm & 8000mm at the flange.
- The Traveler Rail is identified as 11TR2-007.

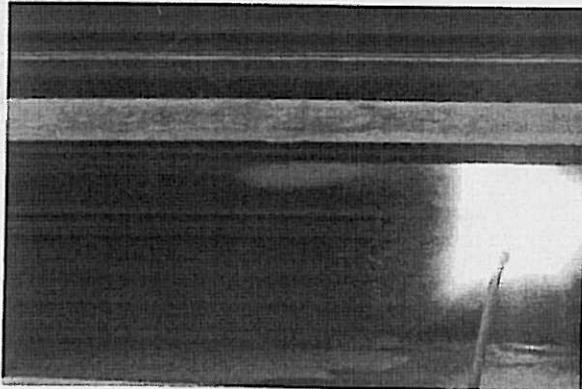
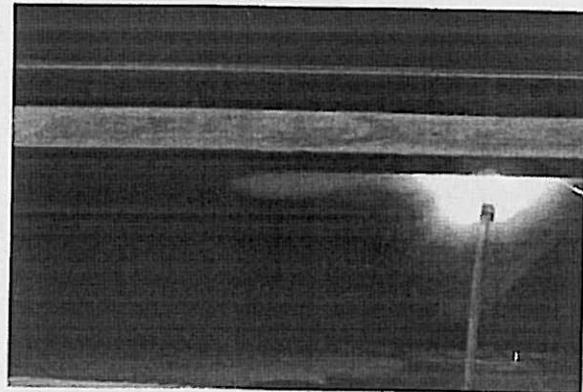
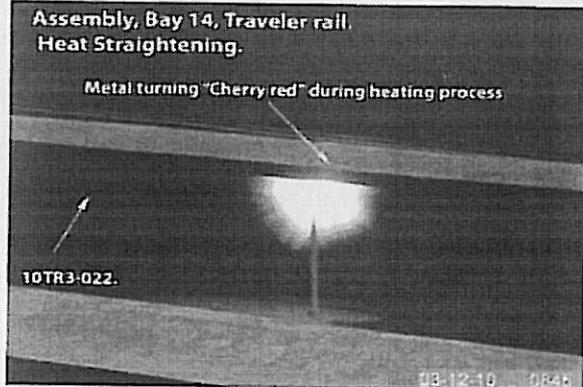
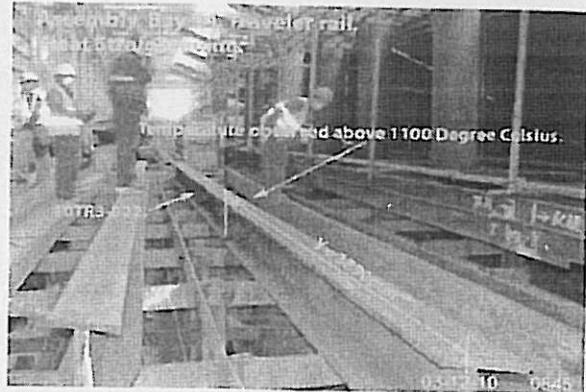
- Temperature of the heat straightened traveler rail was beyond the allowable 650 Degree Celsius.
- Metal color turns into "cherry red" after it was heat straightened.
- Per ZPMC heat straightening report (HSR) maximum temperature limit is 650 Degree Celsius.
- The 1100 Degree Celsius rating "templstick" was melted when check was made against the metal surface.
- "Y" location of the spot identified was 3890 mm and it is at the flange to web joint.
- The Traveler Rail is identified as 10TR3-022.
