Contract #: 04-0120F4Cty: SF/ALA Rte: 80 PM: 13.2/13.9File #: 69.25B**QUALITY ASSURANCE -- NON-CONFORMANCE REPORT****Location:** Changxing Island, Shanghai, P.R. China**Report No:** NCR-000715**Prime Contractor:** American Bridge/Fluor Enterprises, a JV**Date:** 23-Apr-2010**Submitting Contractor:** Zhenhua Port Machinery Company, Ltd (ZPMC), Changxing Island**NCR #:** ZPMC-0682**Type of problem:**

Reference Description: Fabrication of Segment 9DE Floorbeam cope holes not according to the approved shop drawings

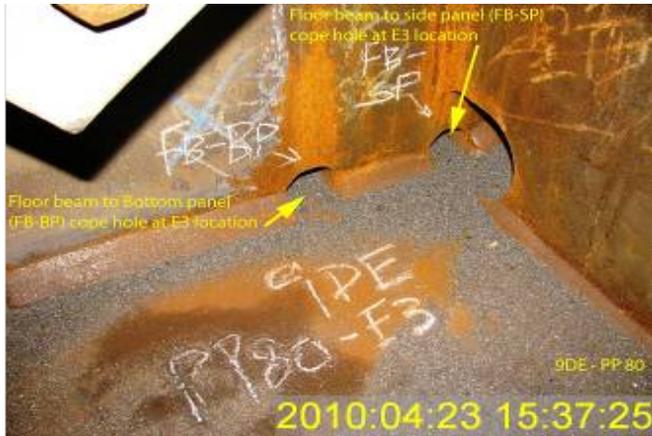
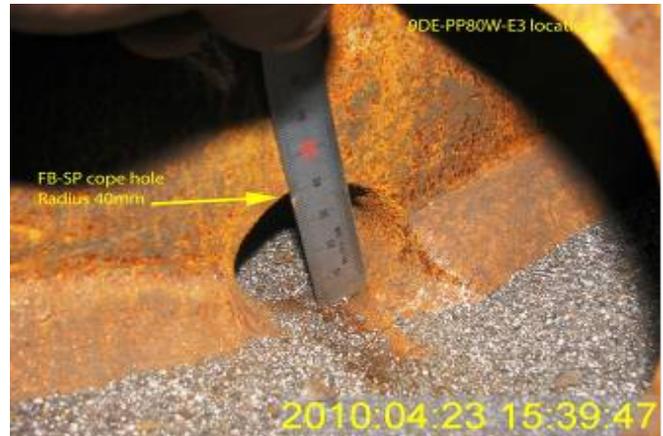
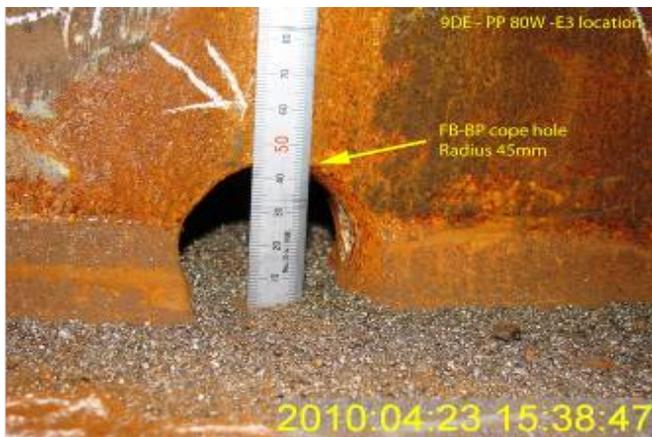
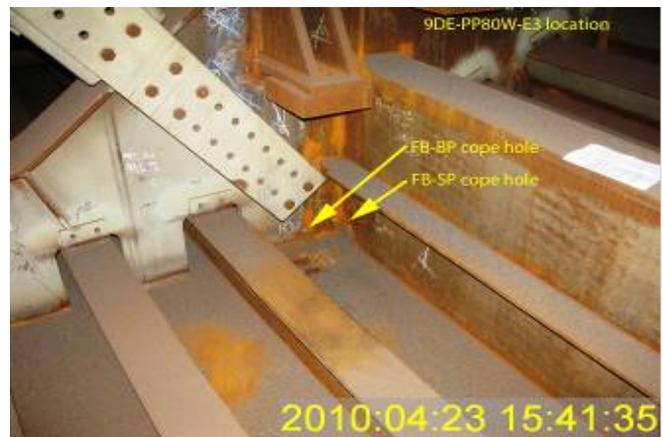
During in-process inspection of Segment 9DE, Caltrans Quality Assurance Inspector found the following issues while measuring the size of the cope holes:

-Some cope holes at the below floorbeam locations are found to be oversized, not fabricated according to approved shop drawings which indicate a radius of 25mm.

- Panel Point (PP) 80, Working Point E3, Floorbeam (FB) to Bottom Panel (BP) cope, 45mm radius
- PP80, Working Point E3, FB to Side Panel (SP) cope, 40mm radius
- PP80, Working Point E4, FB to BP cope, 45mm radius
- PP81, Working Point E3, FB to BP cope, 44mm radius
- PP81, Working Point E3, FB to SP cope, 43mm radius
- PP81, Working Point E4, FB to BP cope, 40mm radius
- PP82, Working Point E3, FB to BP cope, 44mm radius
- PP82, Working Point E3, FB to SP cope, 44mm radius
- PP82, Working Point E4, FB to BP cope, 45mm radius

Contractor requested cope holes be accepted as is as they were ground to achieve a smooth transition and workers misunderstood the size requirement.

ABF performs dimensional inspections of cope holes. These cope hole inspections are forwarded to CT for review. The cope holes listed on the NCR are slightly oversize, however, ZPMC/ABF prefer to leave these cope holes as is. Further repair by welding to reduce the size of cope holes will undoubtedly cause significant problems with weld quality in these difficult to access areas. The root cause of the oversize holes is over grinding by production personnel not completely understanding the tolerance issues involved. Production personnel were trying to achieve a visually acceptable weld terminations within the cope holes and smooth transitions, which, as shown by the photos, is well within acceptable limits. ABF has met with ZPMC to discuss ways to prevent over grinding of cope holes so as to prevent future occurrences of these types of nonconformances.

Cope holes were found to be acceptable as is.
