Contract #: 04-0120F4
 Cty: SF/ALA Rte: 80 PM: 13.2/13.9
 File #: 69.25B

QUALITY ASSURANCE -- NON-CONFORMANCE REPORT

Report No: NCR-000718

Reference Description: Missed MT Transverse Indication by QC on Segment 9EE Floor Beam Flange to Deck Diaphragm Weld

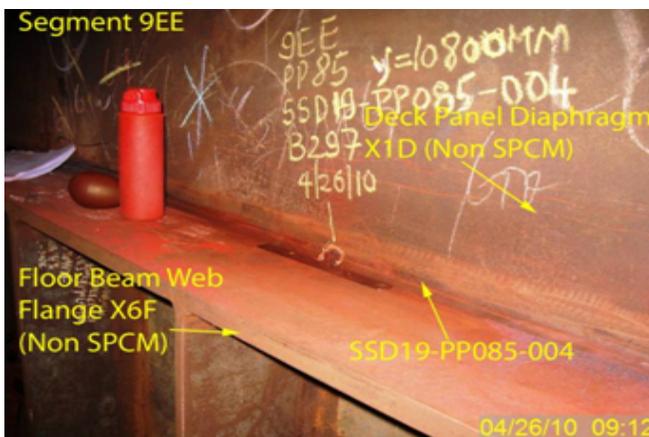
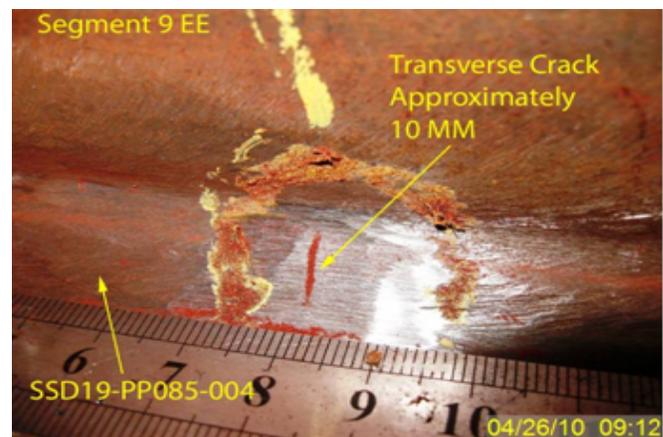
During the Quality Assurance (QA) Magnetic Particle Testing (MT) review of welds located on Segment 9EE, this QA Inspector discovered the following issues:

- One (1) transverse crack measuring approximately 10mm in length in the fillet weld joining the Deck Panel Diaphragm (X1D) to Floor Beam Web Flange (X6F) at panel point 85.
- The Y location is 10800mm from the termination of the weld on the crossbeam side.
- The indication is clearly marked near the weld.
- The weld is identified as: SSD19-PP085-004.
- OBG segment 9EE is located north of the blast shop.
- The Notice of Witness Inspection Number (NWIT) is 005583. The indication is located within the area that has been previously tested and accepted by ZPMC Quality Control (QC) personnel.

AWS D1.5 (02) Section 6.26.2 – “Welds that are subject to MT in addition to visual inspection shall have no cracks.

Propose a resolution for the identified non-conformance with revised procedures to prevent future occurrences. A response for the resolution of this issue is expected within 7 days.

ZPMC has repaired the welds in question and is providing NDT documentation to show that the welds are acceptable. Based on this ZPMC requests closure of this NCR.

This proposed resolution is acceptable. The documentation received is sufficient and the Department concurs that Non-Conformance ZPMC-0685 is closed.

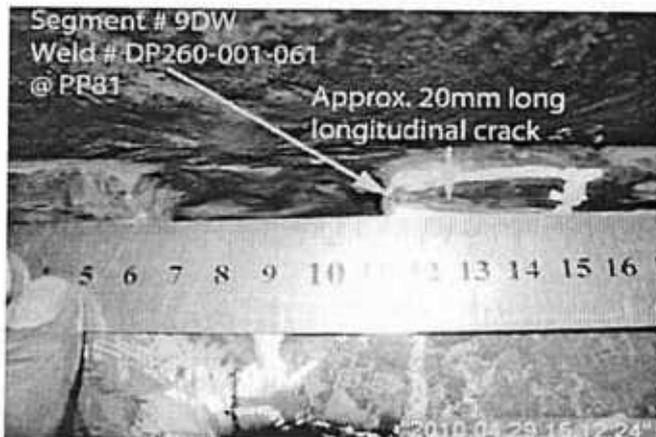
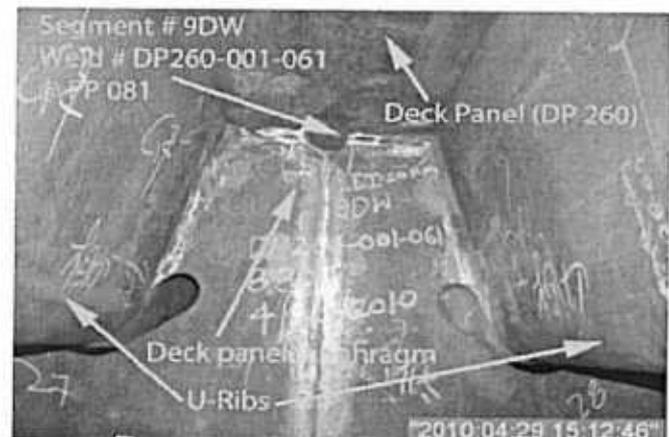
During the Quality Assurance (QA) Magnetic Particle Testing (MT) review of welds located on Segment 9DW, this QA Inspector discovered the following issue:

- One (1) Longitudinal linear crack like indication measuring approximately 20 mm in length.
- The weld is identified as DP260-001-061 @ Panel Point 081.
- The weld is a Fillet Weld T-joint joining the Deck Plate to Deck Panel Diaphragm plate.
- The plate number for Deck Plate is identified as PL307A (Non SPCM).
- Deck panel diaphragm plate is identified as X1E (Non SPCM).
- The indication is clearly marked on the material near the weld.
- OBG Segment 9DW is located at the back side of OBG Bay #14.
- The Notice of Witness Inspection Number (NWIT) is 005616. The indication is located inside the area that has been previously tested and accepted by ZPMC Quality Control (QC) personnel. Per the contract documents ZPMC's QC personnel are required to perform 100% MT inspection of this weld.

AWS D1.5 (02) Section 6.26.2 – “Welds that are subject to MT in addition to visual inspection shall have no cracks.
