Contract #: 04-0120F4
 Cty: SF/ALA Rte: 80 PM: 13.2/13.9
 File #: 69.25B

QUALITY ASSURANCE -- NON-CONFORMANCE REPORT

Report No: NCR-000723

Reference Description: Missed MT indication by QC on Segment 9DW Deck Panel to Diaphragm

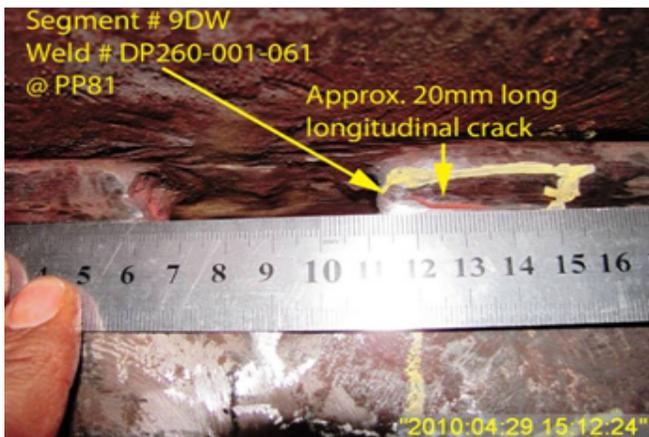
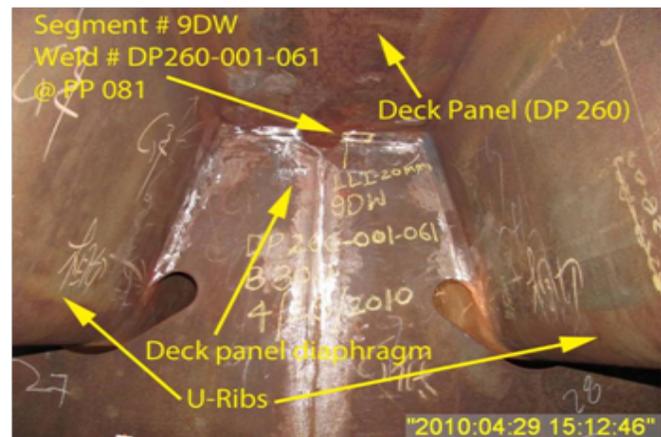
During the Quality Assurance (QA) Magnetic Particle Testing (MT) review of welds located on Segment 9DW, this QA Inspector discovered the following issue:

- One (1) Longitudinal linear crack like indication measuring approximately 20 mm in length.
- The weld is identified as DP260-001-061 @ Panel Point 081.
- The weld is a Fillet Weld T-joint joining the Deck Plate to Deck Panel Diaphragm plate.
- The plate number for Deck Plate is identified as PL307A (Non SPCM).
- Deck panel diaphragm plate is identified as X1E (Non SPCM).
- The indication is clearly marked on the material near the weld.
- OBG Segment 9DW is located at the back side of OBG Bay #14.
- The Notice of Witness Inspection Number (NWIT) is 005616. The indication is located inside the area that has been previously tested and accepted by ZPMC Quality Control (QC) personnel. Per the contract documents ZPMC's QC personnel are required to perform 100% MT inspection of this weld.

Propose a resolution for the identified non-conformance with revised procedures to prevent future occurrences. A response for the resolution of this issue is expected within 7 days.

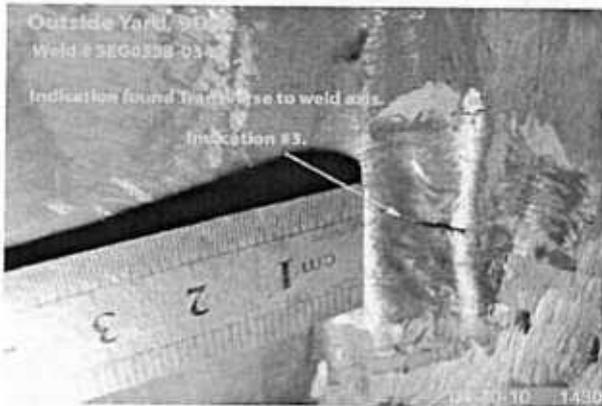
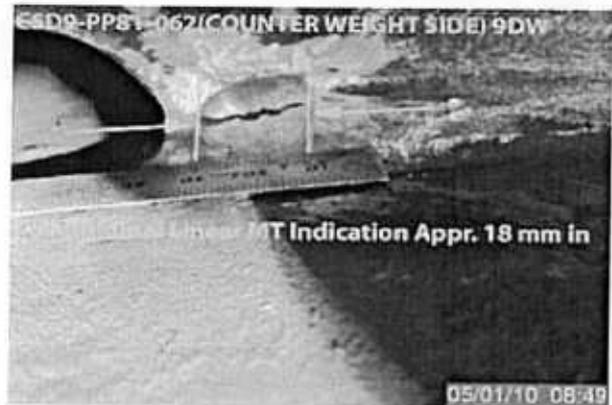
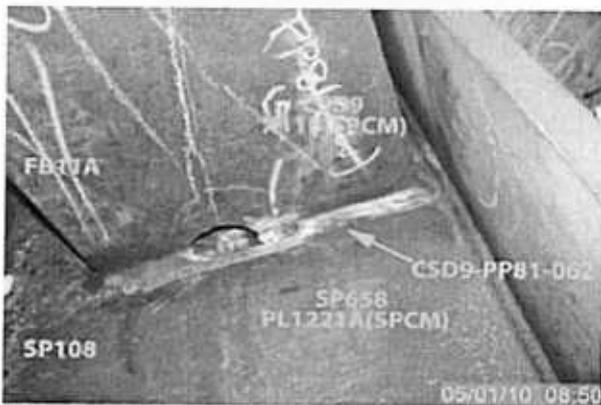
- Three transverse linear indications, one measuring approximately 9mm and two indications measuring approximately 5mm in length at Longitudinal Diaphragm (LD) LD3A to Floor beam (FB) FB11A.
- Weld is identified as SEG055B-034 and designated as a Fracture Critical Weld (FCW).
- The weld is a 14mm Complete Joint Penetration (CJP) T-joint joining LD 3A shear plate identified as X39B to FB web plate identified as X47C (Seismic Performance Critical Material SPCM).
- The indications are clearly marked on the material.
