Contract #: 04-0120F4Cty: SF/ALA Rte: 80 PM: 13.2/13.9File #: 69.25B**QUALITY ASSURANCE -- NON-CONFORMANCE REPORT****Location:** Changxing Island, Shanghai, P.R. China**Report No:** NCR-000725**Prime Contractor:** American Bridge/Fluor Enterprises, a JV**Date:** 01-May-2010**Submitting Contractor:** Zhenhua Port Machinery Company, Ltd (ZPMC), Changxing Island**NCR #:** ZPMC-0688**Type of problem:**

**Reference Description:** Missed MT Indications by QC in OBG Segment 9DW**Description of Non-Conformance:**

**Job Name:** SAS Superstructure

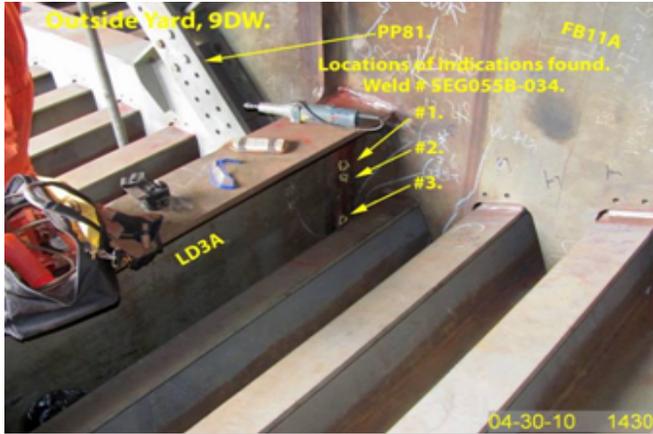
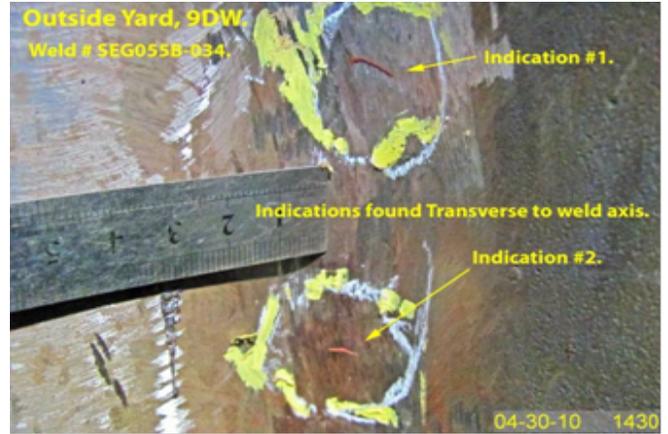
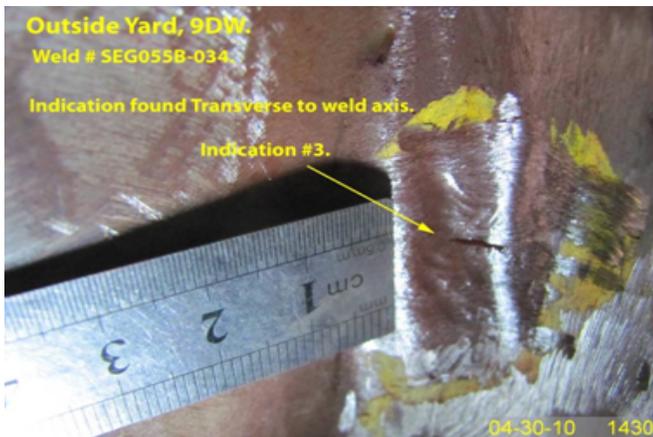
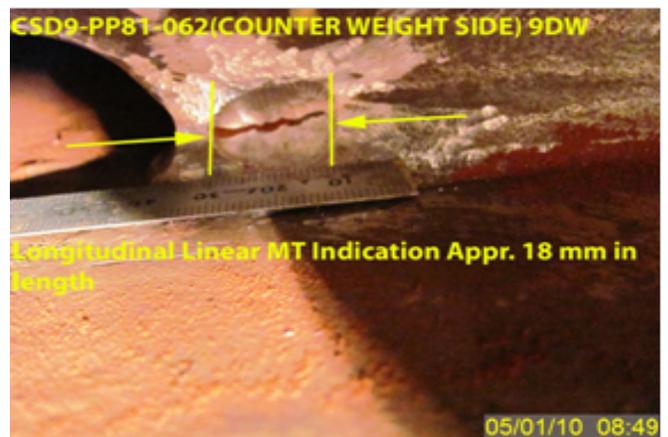
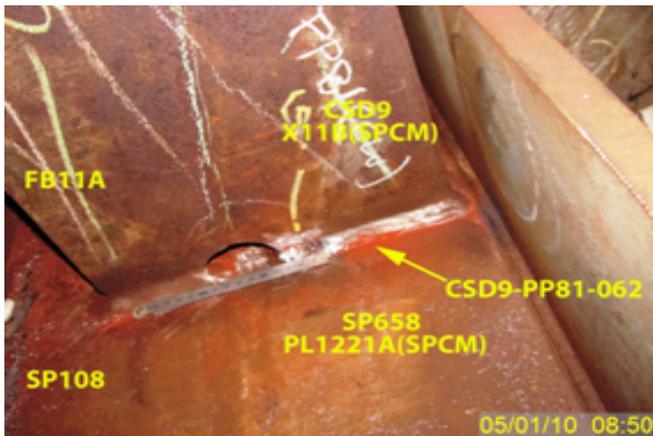
- Three transverse linear indications, one measuring approximately 9mm and two indications measuring approximately 5mm in length at Longitudinal Diaphragm (LD) LD3A to Floor beam (FB) FB11A.
- Weld is identified as SEG055B-034 and designated as a Fracture Critical Weld (FCW).
- The weld is a 14mm Complete Joint Penetration (CJP) T-joint joining LD 3A shear plate identified as X39B to FB web plate identified as X47C (Seismic Performance Critical Material SPCM).
- The indications are clearly marked on the material.

- One (1) Longitudinal linear indication measuring approximately 18mm in length.
- The Y location is 7mm from the cope hole.
- The indication is clearly marked on the material near the weld.
- The weld is identified as: CSD9-PP81-062.
- The weld is designated as Seismic Performance Critical Member (SPCM).
- The weld is located at PP81 (Counter Weight Side).
- The weld is a Fillet Weld T-joint joining the Corner Assembly Diaphragm identified as X11B (SPCM) to Side Plate identified as SP658 (SPCM).
- OBG segment 9DW is located west of Bay #14.

The Notice of Witness Inspection Number (NWIT) is 005616. The indication is located inside the area that has been previously tested and accepted by ZPMC Quality Control (QC) personnel. Per the contract documents ZPMC's QC personnel are required to perform 100% MT inspection of this weld.

**Reference Resolution:** ZPMC has repaired the welds in question and is providing NDT documentation to show that the welds are acceptable. Based on this ZPMC requests closure of this NCR.

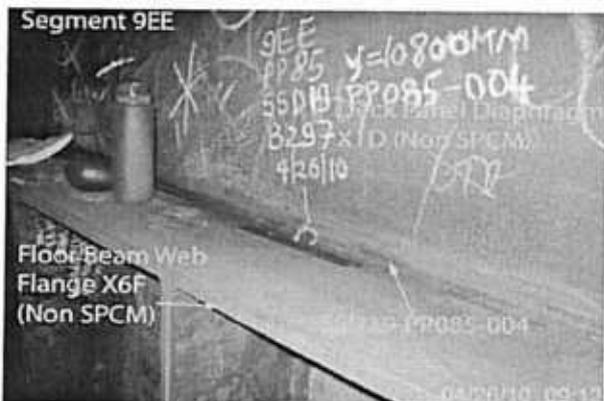
- One (1) transverse crack measuring approximately 10mm in length in the fillet weld joining the Deck Panel Diaphragm (X1D) to Floor Beam Web Flange (X6F) at panel point 85.
- The Y location is 10800mm from the termination of the weld on the crossbeam side.
- The indication is clearly marked near the weld.
- The weld is identified as: SSD19-PP085-004.
- OBG segment 9EE is located north of the blast shop.
- The Notice of Witness Inspection Number (NWIT) is 005583. The indication is located within the area that has been previously tested and accepted by ZPMC Quality Control (QC) personnel.
