Contract #: 04-0120F4Cty: SF/ALA Rte: 80 PM: 13.2/13.9File #: 69.25B**QUALITY ASSURANCE -- NON-CONFORMANCE REPORT****Location:** Changxing Island, Shanghai, P.R. China**Report No:** NCR-000726**Prime Contractor:** American Bridge/Fluor Enterprises, a JV**Date:** 01-May-2010**Submitting Contractor:** Zhenhua Port Machinery Company, Ltd (ZPMC), Changxing Island**NCR #:** ZPMC-0689**Type of problem:**

Reference Description: Excessive heat was utilized during heat straightening of the traveler rail bracket TR6A-052; QC allowed heat straightening to be performed without a temperature measuring device

Job Name: SAS Superstructure

Subject: NCR No. ZPMC-0689

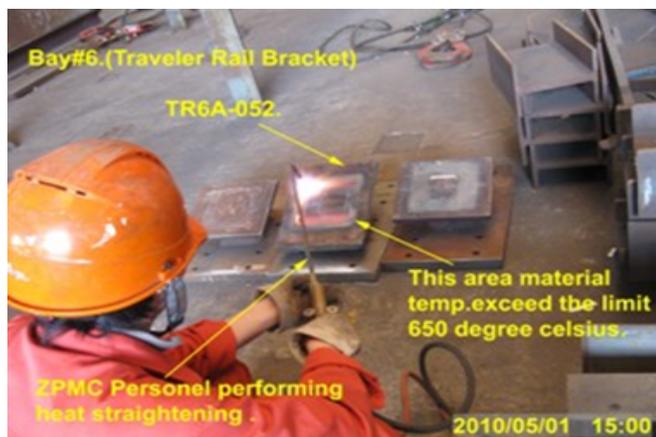
- ZPMC personnel perform heat straightening of traveler rail bracket base plate. The material was heated to a bright red color.
- Per ZPMC Heat Straightening Report identified as HSR1 (B)-8405, the maximum temperature is 650 °C.
- AWS D1.5 2002 defines the color of material heated to 650 °C as a "dull red color".
- A temperature indicating crayon, digital temperature measurement gauge, or other similar means of monitoring the temperature was not utilized by ZPMC QC and the actual maximum attained temperature was not measured.
- ZPMC QC personnel Shen Jian Gao was aware of the on-going heat straightening work performed without any temperature measuring device.
- The Traveler Rail Bracket is identified as TR6A-052.
- The base material thickness measured 30mm.

AWS 1.5 2002 section 3.7.3 “Members distorted by welding shall be straightened by mechanical means or by carefully supervised application of a limited amount of localized heat as approved by the Engineer. The temperature of the heated areas as measured by approved methods shall not exceed 600°C [1100°F] for quenched and tempered steel nor 650°C [1200°F] (a dull, red color) for other steels. The part to be heated for straightening shall be substantially free of stress and from external forces, except those stresses resulting from the mechanical straightening method used in conjunction with the application of heat.”

Please provide HSR and documentations that demonstrate the over-heated element is acceptable. Propose a resolution for the identified non-conformance to prevent future occurrences. A response for the resolution of this issue is expected within 7 days.

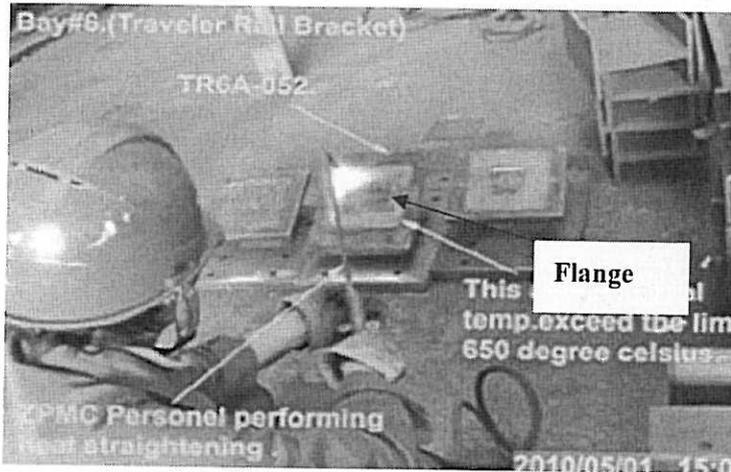
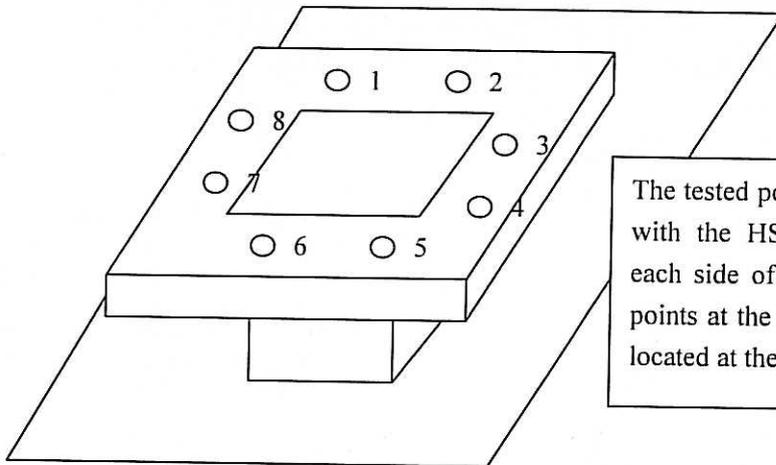
Hardness testing 10TR3-002

The tested points were located along with the HS trace. Two points at each side of the square. The tested points at the compared bracket were located at the similar locations.

Flange			
HS Area (TR6A-PP52)		No HS Area (TR6A-PP108)	
Location	Data	Location	Data
1	152	1	185
2	156	2	179
3	165	3	194
4	160	4	176
5	152	5	143
6	156	6	165
7	181	7	195
8	152	8	195

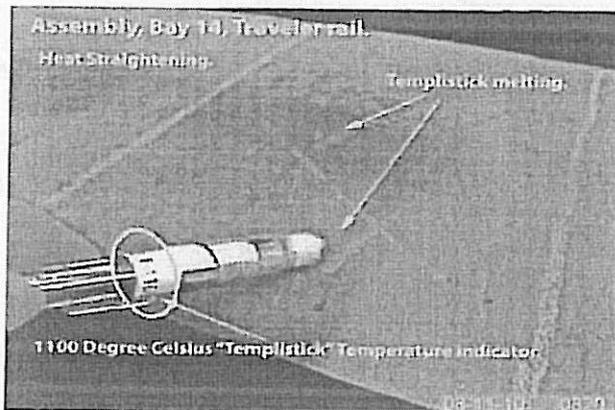
- Temperature of the heat straightened traveler rail was beyond the allowable 650 Degree Celsius in two locations.
- Per ZPMC heat straightening report (HSR) maximum temperature limit is 650 Degree Celsius.
- The 1100 Degree Celsius rating "templstick" was melted when check was made against the metal surface.
- "Y" location of the spots identified as 3000mm & 8000mm at the flange.
- The Traveler Rail is identified as 11TR2-007.

AWS 1.5 WORKMANSHIP, 3.7.3 "Members distorted by welding shall be straightened by mechanical means or by carefully supervised application of a limited amount of localized heat as approved by the Engineer. The temperature of the heated areas as measured by approved methods shall not exceed 600°C [1100°F] for quenched and tempered steel nor 650°C [1200°F] (a dull, red color) for other steels. The part to be heated for straightening shall be substantially free of stress and from external forces, except those stresses resulting from the mechanical straightening method used in conjunction with the application of heat."

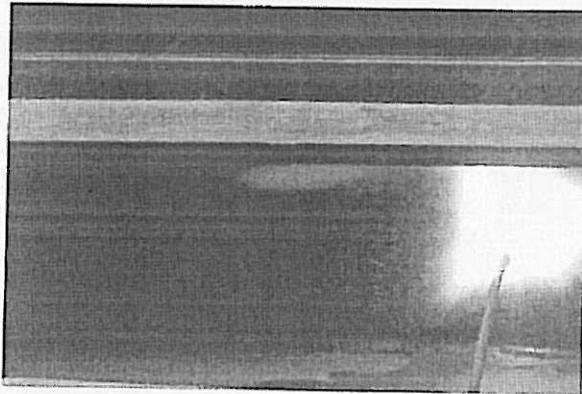
- Temperature of the heat straightened traveler rail was beyond the allowable 650 Degree Celsius.
- Metal color turns into "cherry red" after it was heat straightened.
- Per ZPMC heat straightening report (HSR) maximum temperature limit is 650 Degree Celsius.
- The 1100 Degree Celsius rating "templstick" was melted when check was made against the metal surface.
- "Y" location of the spot identified was 3890 mm and it is at the flange to web joint.
- The Traveler Rail is identified as 10TR3-022.

AWS 1.5 WORKMANSHIP, 3.7.3 "Members distorted by welding shall be straightened by mechanical means or by carefully supervised application of a limited amount of localized heat as approved by the Engineer. The temperature of the heated areas as measured by approved methods shall not exceed 600°C [1100°F] for quenched and tempered steel nor 650°C [1200°F] (a dull, red color) for other steels. The part to be heated for straightening shall be substantially free of stress and from external forces, except those stresses resulting from the mechanical straightening method used in conjunction with the application of heat."

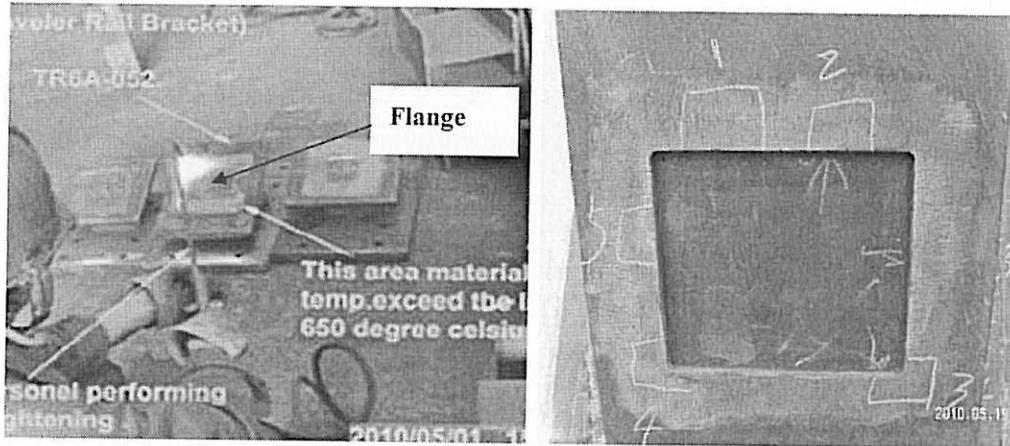
Hardness testing TR6A-052

Area \ Value	a	b	c	d	e	Average Value
1	177	187	184	199	232	190
2	194	186	177	207	177	186
3	188	195	202	196	190	194
4	186	193	208	192	204	196
5	186	201	188	192	181	189

TR6A-052 Flange Hardness Testing Result

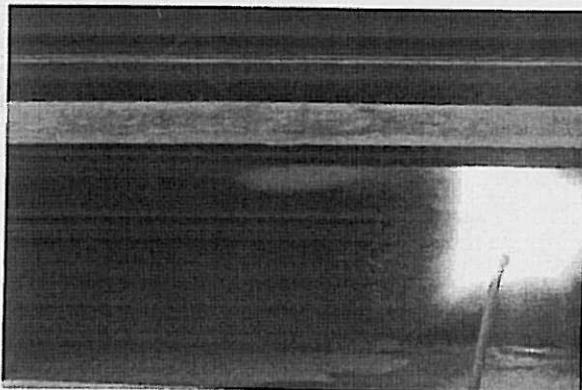
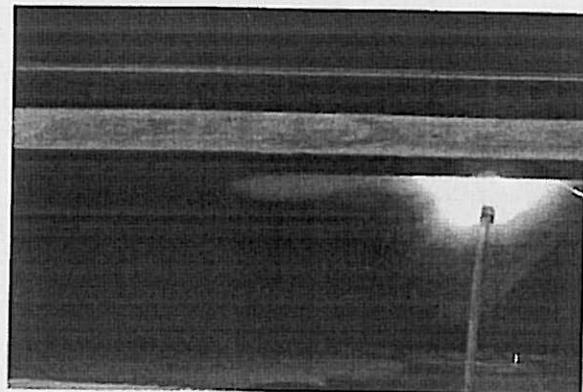
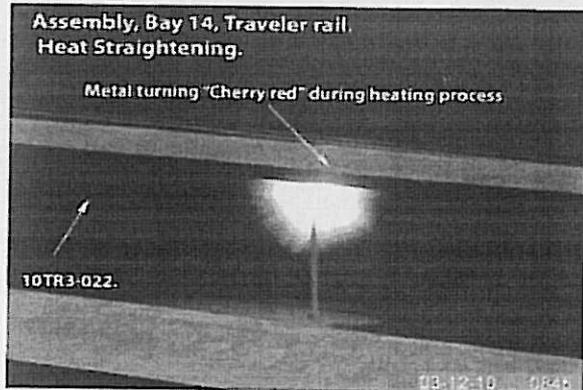
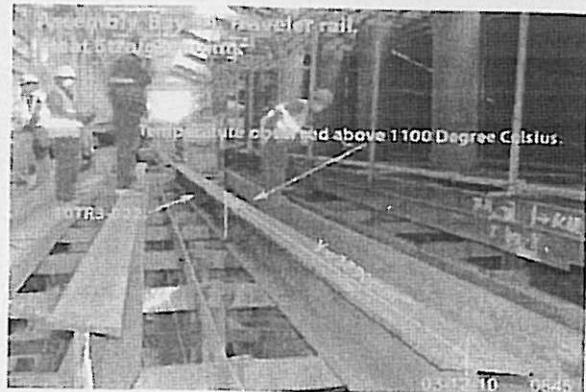
- Temperature of the heat straightened traveler rail was beyond the allowable 650 Degree Celsius.
- Metal color turns into "cherry red" after it was heat straightened.
- Per ZPMC heat straightening report (HSR) maximum temperature limit is 650 Degree Celsius.
- The 1100 Degree Celsius rating "templstick" was melted when check was made against the metal surface.
- "Y" location of the spot identified was 3890 mm and it is at the flange to web joint.
- The Traveler Rail is identified as 10TR3-022.

AWS 1.5 WORKMANSHIP, 3.7.3 "Members distorted by welding shall be straightened by mechanical means or by carefully supervised application of a limited amount of localized heat as approved by the Engineer. The temperature of the heated areas as measured by approved methods shall not exceed 600°C [1100°F] for quenched and tempered steel nor 650°C [1200°F] (a dull, red color) for other steels. The part to be heated for straightening shall be substantially free of stress and from external forces, except those stresses resulting from the mechanical straightening method used in conjunction with the application of heat."
