Contract #: 04-0120F4Cty: SF/ALA Rte: 80 PM: 13.2/13.9File #: 69.25B**QUALITY ASSURANCE -- NON-CONFORMANCE REPORT****Location:** Changxing Island, Shanghai, P.R. China**Report No:** NCR-000730**Prime Contractor:** American Bridge/Fluor Enterprises, a JV**Date:** 05-May-2010**Submitting Contractor:** Zhenhua Port Machinery Company, Ltd (ZPMC), Changxing Island**NCR #:** ZPMC-0693**Type of problem:**

Reference Description: Missed UT indication by QC on Lift 13W Floorbeam Weld**Description of Non-Conformance:**

Reference Description: Missed UT indication by QC on Lift 13W Floorbeam Weld

Report No: NCR-000730

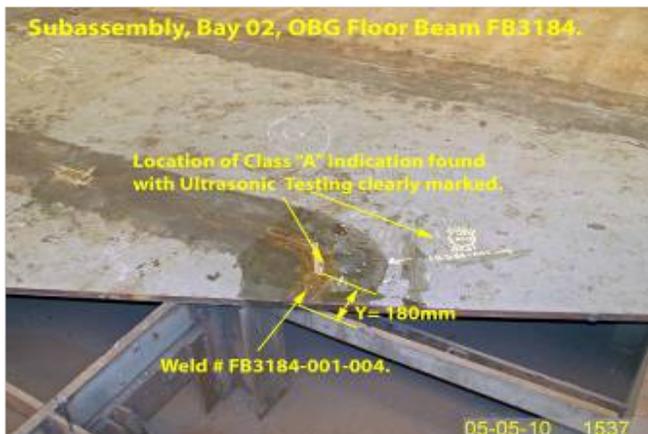
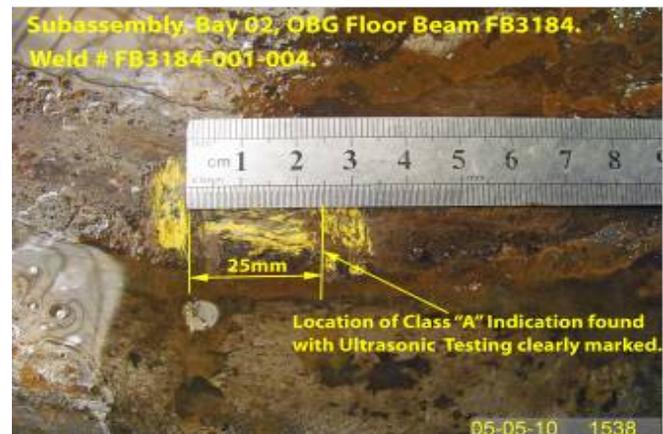
During the Quality Assurance (QA) Ultrasonic Testing (UT) verification of welds located on OBG Floor Beam (FB), this QA Inspector discovered the following issue:

- One (1) longitudinal "Class A" indication measuring approximately 25mm in length.
- The D rating was +6dB at a depth of 26.15mm and the thickness of the steel material is 35mm.
- The weld is identified as: FB3184-001-004, located at Panel Point 119-1500 (Lift 13W)
- The weld is a Complete Joint Penetration (CJP) butt weld joining FB plate X4397A to FB plate X7501A.
- The "Y" location of the indication is approximately 180mm from nearest end of the weld and is clearly marked on or near the weld.
- This material is designated as Seismic Critical Performance Members (SPCM).
- This FB member is located in Bay 02.

The Notice of Witness Inspection Number (NWIT) is 005665. The indication is located inside the area that has been previously tested and accepted by ZPMC Quality Control (QC) personnel. As per the contract documents, ZPMC's QC personnel are required to perform one hundred (100%) percent UT inspection of this weld.

AWS D1.5-02 Section 6; AWS D1.5-02 Section 6; Table 6.3 specifies a class “A” indication as having a rating of 8dbs and under for material thicknesses 20mm through 38mm.

Propose a resolution for the identified non-conformance with revised procedures to prevent future occurrences. A response for the resolution of this issue is expected within 7 days.

Reference Resolution: ZPMC has repaired the indications documented in the NCR and is providing NDT to show that the weld is acceptable. Based on this ZPMC requests closure of this NCR.

Repair indication and perform NDT required to verify weld quality.

Contractor has repaired the indication in this NCR and has provided documented NDT results to show that the weld is acceptable.

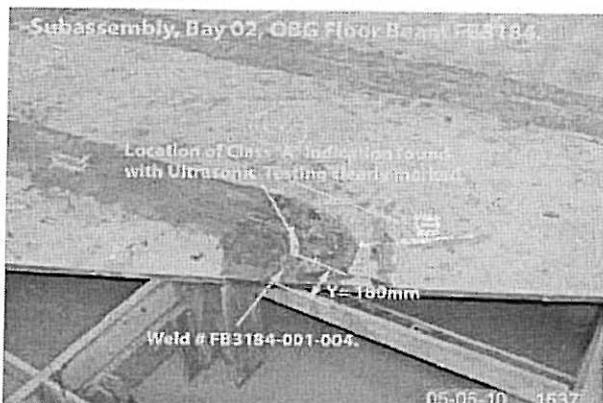
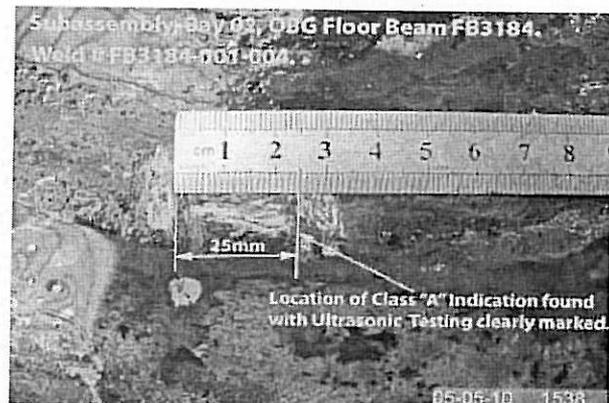
During the Quality Assurance (QA) Ultrasonic Testing (UT) verification of welds located on OBG Floor Beam (FB), this QA Inspector discovered the following issue:

- One (1) longitudinal "Class A" indication measuring approximately 25mm in length.
- The D rating was +6dB at a depth of 26.15mm and the thickness of the steel material is 35mm.
- The weld is identified as: FB3184-001-004, located at Panel Point 119-1500 (Lift 13W)
- The weld is a Complete Joint Penetration (CJP) butt weld joining FB plate X4397A to FB plate X7501A.
- The "Y" location of the indication is approximately 180mm from nearest end of the weld and is clearly marked on or near the weld.
- This material is designated as Seismic Critical Performance Members (SPCM).
- This FB member is located in Bay 02.

The Notice of Witness Inspection Number (NWIT) is 005665. The indication is located inside the area that has been previously tested and accepted by ZPMC Quality Control (QC) personnel. As per the contract documents, ZPMC's QC personnel are required to perform one hundred (100%) percent UT inspection of this weld.

AWS D1.5-02 Section 6; AWS D1.5-02 Section 6; Table 6.3 specifies a class “A” indication as having a rating of 8dbs and under for material thicknesses 20mm through 38mm.
