QUALITY ASSURANCE -- NON-CONFORMANCE REPORT

Report No: NCR-000732

Reference Description: Removal of Improperly Fit Members Without Notifying Engineer

Reference Description: Removal of Improperly Fit Members Without Notifying Engineer/ Tower/ West Lift 3

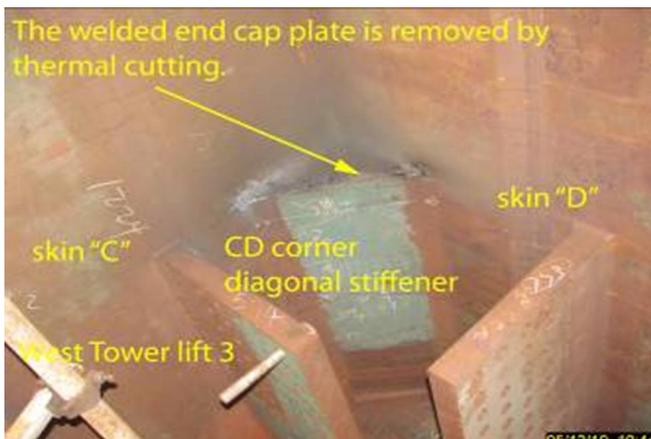
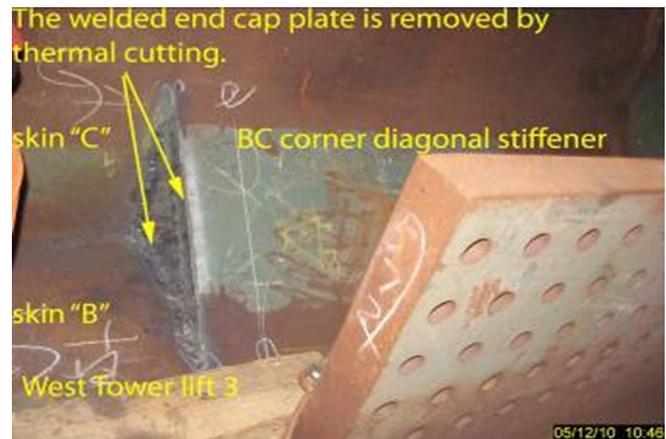
- The welded end cap plate of B/C and C/D corner diagonal stiffener of West Tower lift 3 (top) has been removed by thermal cutting without notifying the engineer.
- As per AWS D1.5, section 3.7.5; The Engineer shall be notified before improperly fitted and welded members are cut apart.
- The green tag has been previously issued for this member.
- The members are located in Bay 11.

AWS D1.5 (02) Section 3.7.4: "The Engineer shall be notified before improperly fitted and welded members are cut apart."

Special Provisions 8-3: "The Engineer shall be notified immediately in writing when welding problems, deficiencies, base metal repairs, or any other type of repairs not submitted in the WQCP are discovered and also the proposed repair procedures to correct them."

Propose a resolution for the identified non-conformance, documenting that the welds are in compliance with the contract requirements. Documentation provided for the Engineer's review of the acceptability of the weld repairs shall at a minimum include the procedure utilized and the NDT results.

In addition to the material/workmanship non-conformance, address the failure by Quality Control in proceeding with work without prior notification to the Engineer. Provide documentation of the steps/actions taken by Production and Quality Control to prevent future occurrences.

ZPMC provided the NDT reports confirming the re-welded areas are acceptable. The production team and QC personnel have been educated not to allow similar incidents to happen in future.

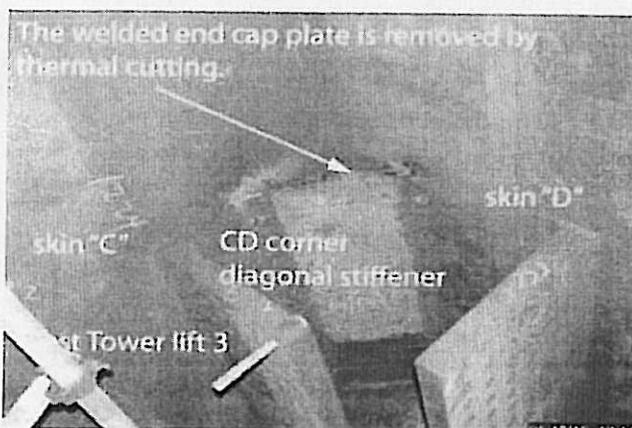
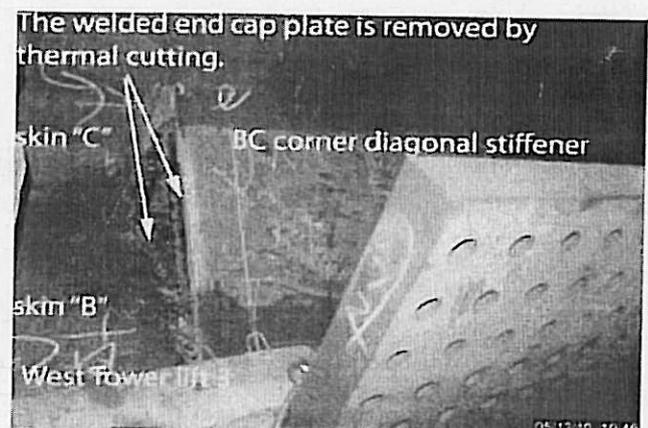
- The welded end cap plate of B/C and C/D corner diagonal stiffener of West Tower lift 3 (top) has been removed by thermal cutting without notifying the engineer.
- As per AWS D1.5, section 3.7.5; The Engineer shall be notified before improperly fitted and welded members are cut apart.
- The green tag has been previously issued for this member.
- The members are located in Bay 11.

AWS D1.5 (02) Section 3.7.4: "The Engineer shall be notified before improperly fitted and welded members are cut apart."

Special Provisions 8-3: "The Engineer shall be notified immediately in writing when welding problems, deficiencies, base metal repairs, or any other type of repairs not submitted in the WQCP are discovered and also the proposed repair procedures to correct them."
