Contract #: 04-0120F4Cty: SF/ALA Rte: 80 PM: 13.2/13.9File #: 69.25B**QUALITY ASSURANCE -- NON-CONFORMANCE REPORT****Location:** Changxing Island, Shanghai, P.R. China**Report No:** NCR-000733**Prime Contractor:** American Bridge/Fluor Enterprises, a JV**Date:** 14-May-2010**Submitting Contractor:** Zhenhua Port Machinery Company, Ltd (ZPMC), Changxing Island**NCR #:** ZPMC-0696**Type of problem:**

**Reference Description:** Critical Weld Repair Without Engineer's Approval, Welding to Incorrect WPS, Strut Angle ED1-SA4-143M-5

**Job Name:** SAS Superstructure  
**Document No:** 05.03.06-000691

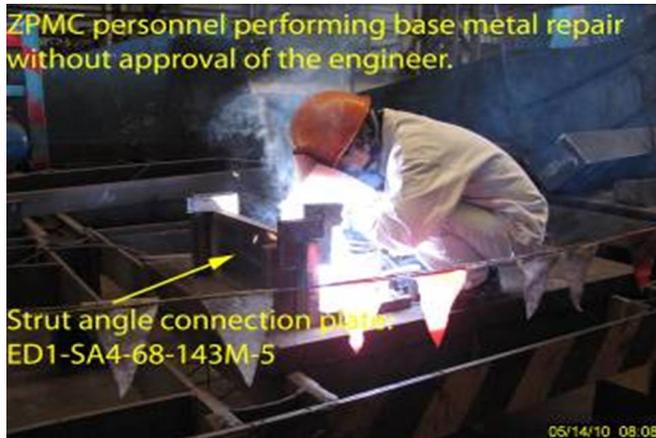
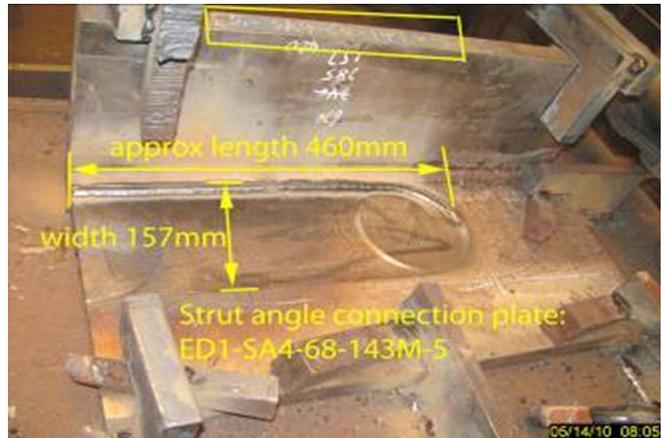
During random in-process verification of strut angle connection plate, Caltrans Quality Assurance (QA) discovered the following issues:

- ZPMC personnel were performing base metal repair by Shielded Metal Arc Welding (SMAW) process on the base metal of strut angle connection plate as per Welding Repair Report (WRR) T-WR3217, Rev. 0.
- Weld Repair Report (WRR) cites WPS-485-SMAW-1G(1F)-FCM-REPAIR as applicable.
- This repair welding has been performed as per WPS-485-SMAW-1G(1F)-REPAIR.
- This repair area is measured to be approximately 157mm in width, 460mm in length and 6mm in deep.
- This base metal repair has been performed without prior approval of the engineer.
- The welder is identified as 040655.
- The member is identified as ED1-SA4-68-143M-5.
- The material is identified as Seismic Performance Critical Member (SPCM).
- The member is located in Bay 11.

AWS D1.5 Section: 3.7.4: "Prior approval of the Engineer shall be obtained for repairs to base metal (other than those required by 3.2), or for a revised design to compensate for deficiencies."

Special Provisions 8-3: "The Engineer shall be notified immediately in writing when welding problems, deficiencies, base metal repairs, or any other type of repairs not submitted in the WQCP are discovered and also the proposed repair procedures to correct them."

Propose a resolution for the identified non-conformance, documenting that the repairs are in compliance with the contract requirements. Documentation provided for the Engineer's review of the acceptability of the weld repairs shall at a minimum include the procedure utilized and the NDT results.

**Reference Resolution:** ZPMC has removed the weld in question and re welded it using the correct WPS. The welds has been subsequently tested and accepted by the Department.
