Contract #: 04-0120F4Cty: SF/ALA Rte: 80 PM: 13.2/13.9File #: 69.25B**QUALITY ASSURANCE -- NON-CONFORMANCE REPORT****Location:** Changxing Island, Shanghai, P.R. China**Report No:** NCR-000734**Prime Contractor:** American Bridge/Fluor Enterprises, a JV**Date:** 16-May-2010**Submitting Contractor:** Zhenhua Port Machinery Company, Ltd (ZPMC), Changxing Island**NCR #:** ZPMC-0697**Type of problem:**

Reference Description: Missed MT Indication by QC in OBG Segment 10BE Corner Assembly**Description of Non-Conformance:**

Dear: Mr. Charles Kanapicki
Job Name: SAS Superstructure

Subject: NCR No. ZPMC-0697

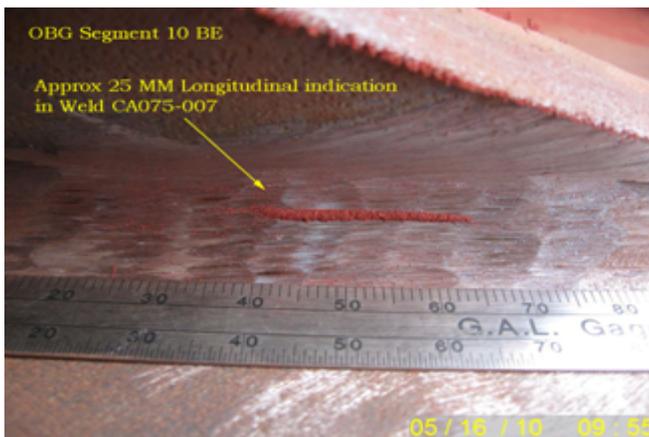
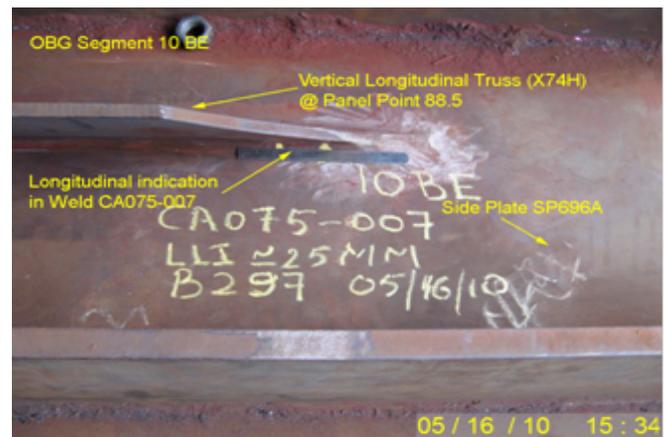
During the Quality Assurance (QA) Magnetic Particle Testing (MT) review of welds located on Segment 10BE, this QA Inspector discovered the following issue:

- One Longitudinal indication, approximately 25mm in length at Panel Point 88.5.
- The weld identified as CA075-007.
- The weld is a fillet weld joining Vertical Longitudinal Truss identified as X74H to Side Plate SP696A.
- The indication is marked clearly near the weld.
- OBG segment 10BE is located in outside yard, North of Blast Shop.
- The Notice of Witness Inspection (NWIT) Number is 005723. The indication is located inside the area previously tested and accepted by ZPMC personnel.

AWS D1.5 (02) Section 6.26.2 – “Welds that are subject to MT in addition to visual inspection shall have no cracks.”

ZPMC has repaired the missed indication and is providing the NDT after repair to show that the weld is acceptable. ZPMC has issued an internal NCR to inform all affected parties that this type of action is unacceptable. In addition, ABFJV has had discussions with the ZPMC QA Manager and he has agreed to increase CWI presence in all areas to prevent lapse in QC oversight in the future. Based on these actions and submitted documents, ZPMC requests closure of this NCR.

The preventative measures taken by the QCM is acceptable. The area has been repaired and NDT documents have been submitted. This NCR is considered closed.

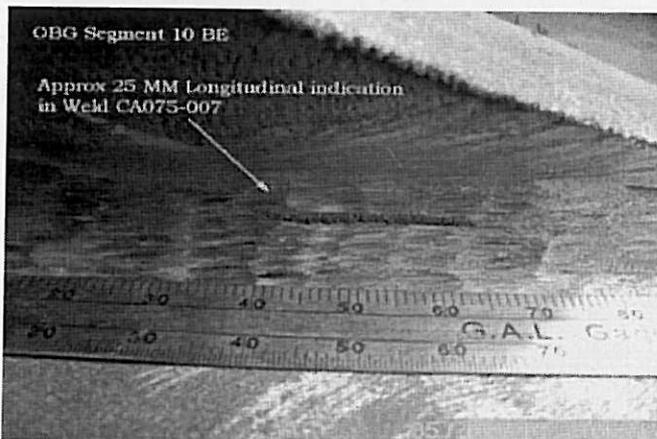
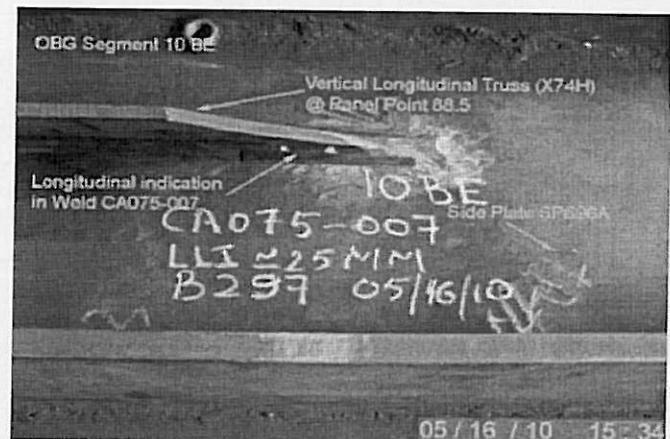
During the Quality Assurance (QA) Magnetic Particle Testing (MT) review of welds located on Segment 10BE, this QA Inspector discovered the following issue:

- One Longitudinal indication, approximately 25mm in length at Panel Point 88.5.
- The weld identified as CA075-007.
- The weld is a fillet weld joining Vertical Longitudinal Truss identified as X74H to Side Plate SP696A.
- The indication is marked clearly near the weld.
- OBG segment 10BE is located in outside yard, North of Blast Shop.
- The Notice of Witness Inspection (NWIT) Number is 005723. The indication is located inside the area previously tested and accepted by ZPMC personnel.

AWS D1.5 (02) Section 6.26.2 – “Welds that are subject to MT in addition to visual inspection shall have no cracks.”

Repair said indication and perform NDT required to verify weld quality.

Contractor supplied post repair NDT documentation verifying weld conforms with Contract weld quality requirements. An internal NCR was also issued by ZPMC in regards to this issue.
