Contract #: 04-0120F4Cty: SF/ALA Rte: 80 PM: 13.2/13.9File #: 69.25B**QUALITY ASSURANCE -- NON-CONFORMANCE REPORT****Location:** Changxing Island, Shanghai, P.R. China**Report No:** NCR-000736**Prime Contractor:** American Bridge/Fluor Enterprises, a JV**Date:** 18-May-2010**Submitting Contractor:** Zhenhua Port Machinery Company, Ltd (ZPMC), Changxing Island**NCR #:** ZPMC-0699**Type of problem:****Welding****Concrete****Other****Welding****Curing****Procedural****Bridge No:** 34-0006**Joint fit-up****Coating****Other****Component:** Crossbeam 14 Bottom Panel**Procedural****Procedural****Description:**

Reference Description: ZPMC performed Heat Straightening without prior Engineer's approval and without following the ZPMC internal HSR1 document

Job Name: SAS Superstructure

Report No: NCR-000736

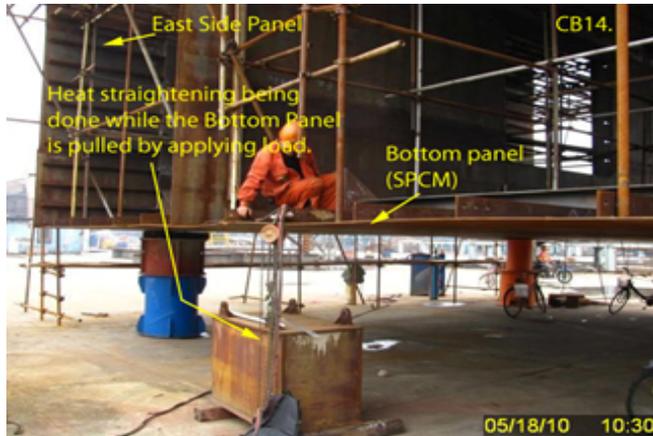
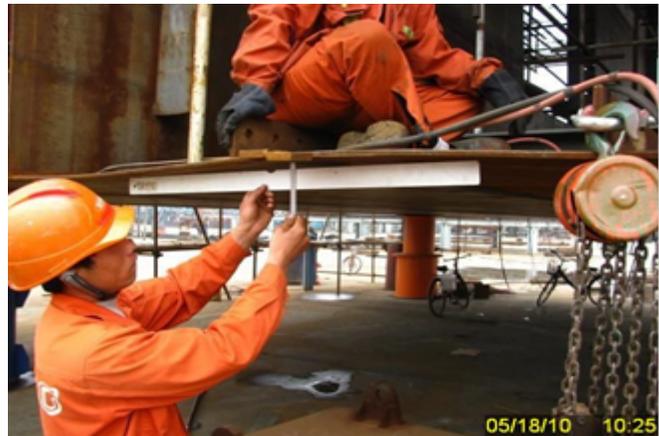
- ZPMC personnel performed heat straightening to the bottom panels BP203A and BP201A in Crossbeam 14.
- ZPMC personnel did not follow the heat straightening report presented by ZPMC Quality Control (QC) on site. According to ZPMC Heat Straightening Record (HSR) identified as HSR1 (B)-8472, the straightening would be performed using an oxygen/acetylene torch. ZPMC personnel were straightening the material using heat and a hand operated winch (come-along) attached to a weight placed on some timber on the ground. The amount of pull down force being applied is not known. Also, the use of the come-along and weight or any other mechanical force is not mentioned in the HSR.

- The out of flatness was measured to 16mm per 1000mm, which requires a HSR with prior Engineer's approval.
- The bottom panel of the crossbeam is identified as Seismic Performance Critical Member (SPCM).

- Bottom panel material thickness is 12mm.

Reference Resolution: ZPMC will provide a revised HASR to show the work that was performed. Also provide the NDT done after to show that affected welds are acceptable.

This proposed resolution is accepted, action pending. Please provide an HSR showing the work that was performed and NDT results for these welds upon completion of heat straightening.

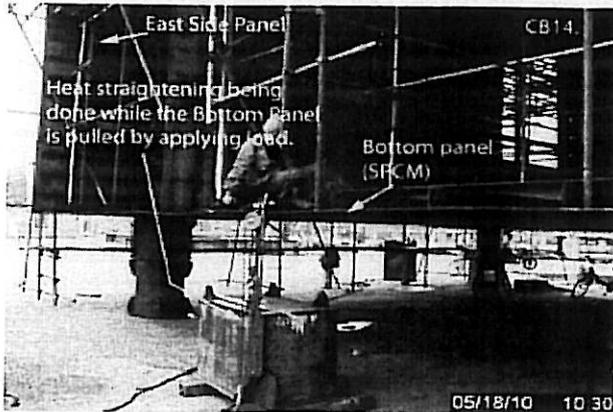
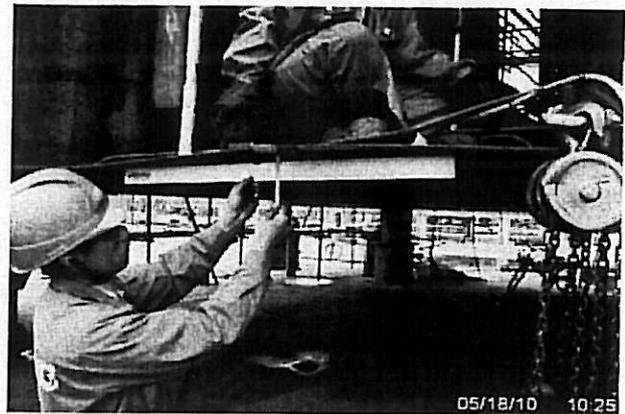
- ZPMC personnel performed heat straightening to the bottom panels BP203A and BP201A in Crossbeam 14.
- ZPMC personnel did not follow the heat straightening report presented by ZPMC Quality Control (QC) on site. According to ZPMC Heat Straightening Record (HSR) identified as HSR1 (B)-8472, the straightening would be performed using an oxygen/acetylene torch. ZPMC personnel were straightening the material using heat and a hand operated winch (come-along) attached to a weight placed on some timber on the ground. The amount of pull down force being applied is not known. Also, the use of the come-along and weight or any other mechanical force is not mentioned in the HSR.

- The out of flatness was measured to 16mm per 1000mm, which requires a HSR with prior Engineer's approval.
- The bottom panel of the crossbeam is identified as Seismic Performance Critical Member (SPCM).

- Bottom panel material thickness is 12mm.

Provide a corrected version of the HSR1 detailing the heat straightening that was performed in the field and perform NDT required to verify weld quality.

Contractor has made the appropriate changes to the HSR used on site detailing the work which was actually performed and has submitted subsequent NDT reports verifying the affected welds meet Contract weld quality requirements.

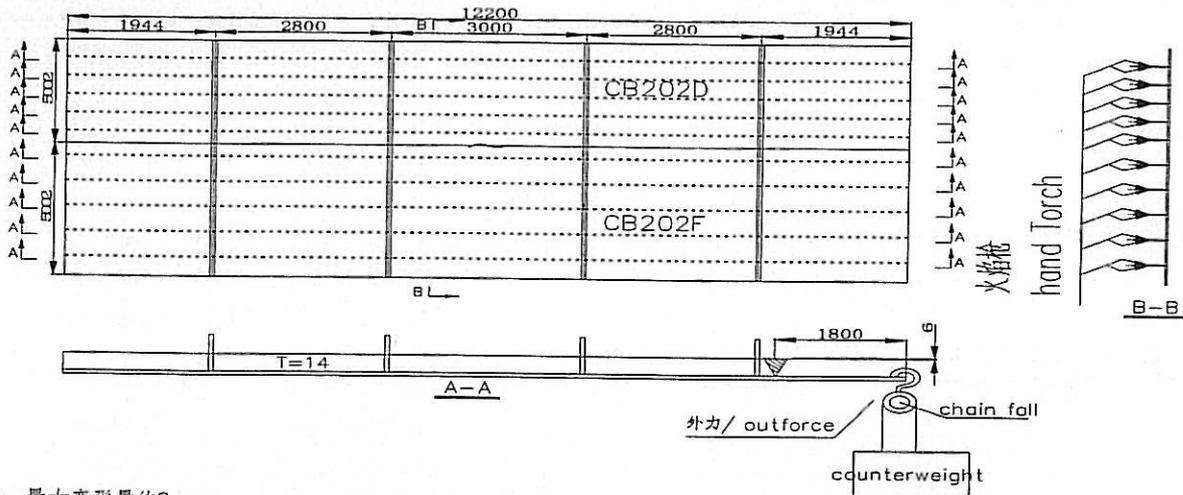
简图 Sketch

Cause原因 Welding distortion 焊接变形

Type of Defect缺陷类型 Welding distortion 焊接变形

注: 最大变形量约6mm.

NOTE: the max deformation is about 6mm.

缺陷去除方法(Defect Removal Method): Flame Straightening by oxygen acetylene 运用氧乙炔进行校火

后续NDE(Post-Removal NDE): After finishing heat straightening, the weld of the heat area shall perform NDT according to the approved shop drawing 校火后, 根据图纸要求对热影响区域进行NDT检测。

纠正措施(Corrective Action(s)): Control current, voltage and weld speed according to relevant WPS. If necessary anti-deformation or hold down device can be added. 依据相应的WPS的要求控制电流, 电压和焊接速度。如有必要, 可使用反变形设施进行校正。
