Contract #: 04-0120F4Cty: SF/ALA Rte: 80 PM: 13.2/13.9File #: 69.25B**QUALITY ASSURANCE -- NON-CONFORMANCE REPORT****Location:** Changxing Island, Shanghai, P.R. China**Report No:** NCR-000739**Prime Contractor:** American Bridge/Fluor Enterprises, a JV**Date:** 23-May-2010**Submitting Contractor:** Zhenhua Port Machinery Company, Ltd (ZPMC), Changxing Island**NCR #:** ZPMC-0702**Type of problem:****Welding****Concrete****Other****Welding****Curing****Procedural****Bridge No:** 34-0006**Joint fit-up****Coating****Other****Component:** Angle Plates on Shear Plate**Procedural****Procedural****Description:****Reference Description:** There are Two Angle Plates Damaged and Distorted on the Shear Plate WD1- A25**Description of Non-Conformance:**

Job Name: SAS Superstructure
Document No: 05.03.06-000699

Reference Description: Angle Plates Damaged and Distorted / Tower / Shear Plate WD1- A25

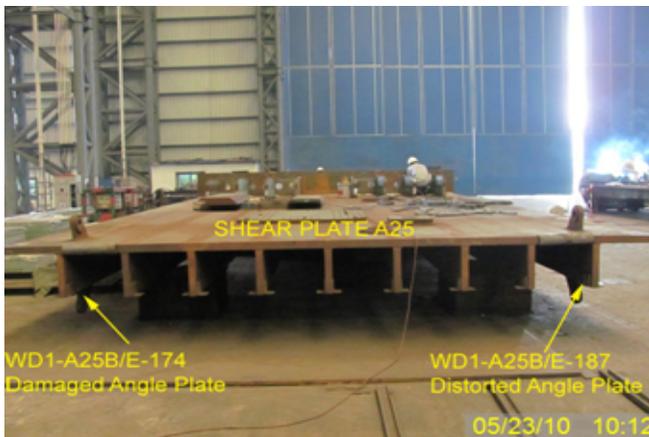
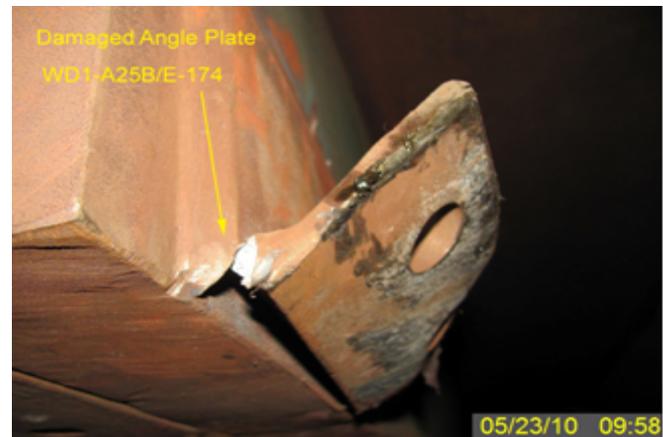
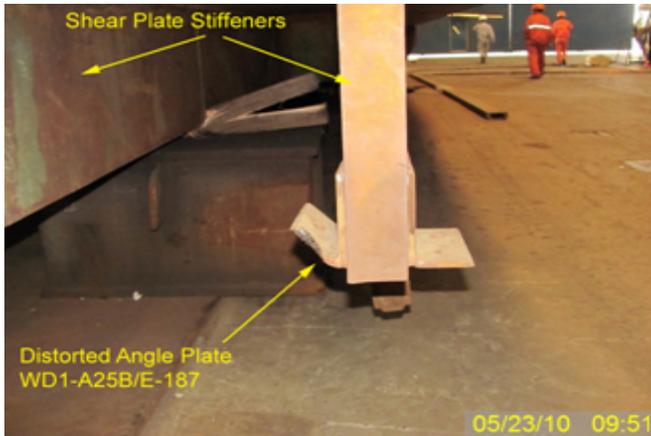
During random visual inspection in Bay 11, Quality Assurance Inspector discovered the following issue:

- Two (2) angle plates in the top elevation of Shear Plate were damaged and distorted.
- The welds are identified as WD1-A25B/E-174,187; fillet weld.
- Tower Lift 1 Shear Plate WD1-A25.
- The member is located in Bay#11.
- These angle plates were previously VT and MT tested.
- The Notice of Witness Inspection Number (NWIT) is 005762.

“In handling and shipping of the steel work, every care shall be taken to avoid bending, scraping or overstressing the pieces. All pieces bent or otherwise injured will be rejected.”

In accordance with Section 55-1.04 of the Standard Specifications, Shear Plate WD1-A25 is rejected due to damaged/ distorted angle plates as referenced in this transmittal.

Please submit a repair plan for the Engineer's approval prior to any remedial work begins.
