Contract #: 04-0120F4Cty: SF/ALA Rte: 80 PM: 13.2/13.9File #: 69.25B**QUALITY ASSURANCE -- NON-CONFORMANCE REPORT****Location:** Changxing Island, Shanghai, P.R. China**Report No:** NCR-000740**Prime Contractor:** American Bridge/Fluor Enterprises, a JV**Date:** 23-May-2010**Submitting Contractor:** Zhenhua Port Machinery Company, Ltd (ZPMC), Changxing Island**NCR #:** ZPMC-0703**Type of problem:**

Reference Description: Unknown Material being tacked onto a CB10 Side Panel not conforming to the AWS D1.5 Section 12 Requirement

Dear: Mr. Charles Kanapicki
Job Name: SAS Superstructure

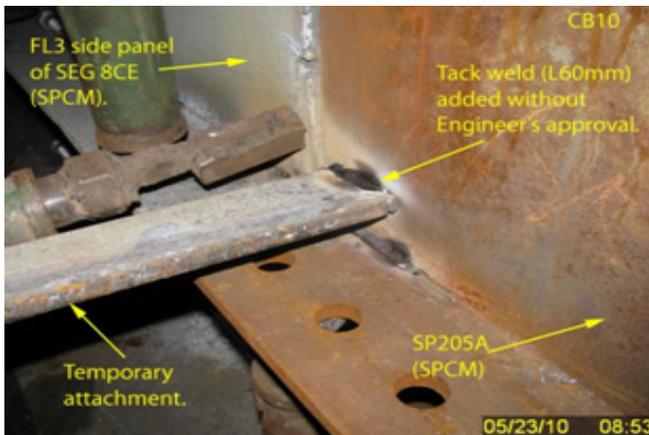
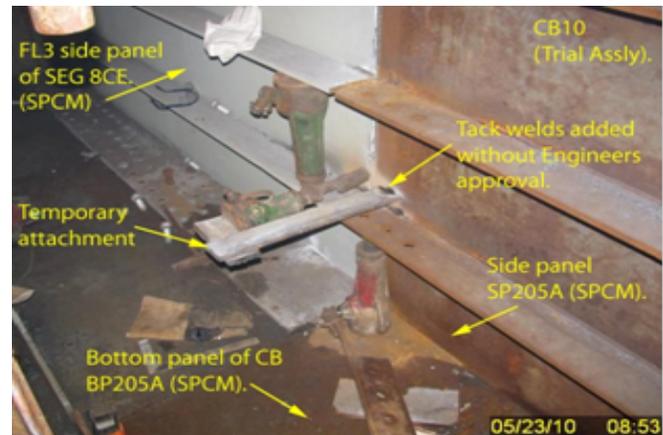
- During fit-up of Cross Beam CB10 side panel to FL3 panel of OBG segment 8CE, ZPMC personnel had temporarily tack welded a steel plate at the south end of side panel (SP205A) of CB10.
- Side Panel – SP205A is identified on the approved shop drawings as Seismic Performance Critical Member (SPCM).
- The size and length of the tack weld do not meet the requirements of AWS D1.5 2002, Table 12.2.
- The approved Shop drawing does not specify any weld in this area.
- No fabrication procedure was available with QC.
- The material composition of the temporary steel plate is not known.
- Cross Beam 10 is located in the Trial Assembly.

AWS D1.5-2002 Section 12.13.1.1 Location: All tack welds used in assembly shall be located within the joint unless otherwise approved by the Engineer.

AWS D1.5-2002 Table 12.2: Specifies tack welds outside the joint shall be a minimum of 75mm in length and refers to footnote 3 which specifies. "Tack welds outside the joint shall require the Engineer's approval".

The areas where unidentified material was tacked welded shall be ground out such that any impurities introduced are removed. MT should then be performed and the base metal repaired per approved methods. Additionally, a description of the measures being taken to ensure that similar non-conformances do not occur in the future.

ZPMC acknowledged this problem and has written an internal NCR. The area where unidentified material was tacked welded have been ground out and fixed. ZPMC is providing the NDT record what shows the acceptance of this area after repair. Based on this, please consider closure of this NCR.

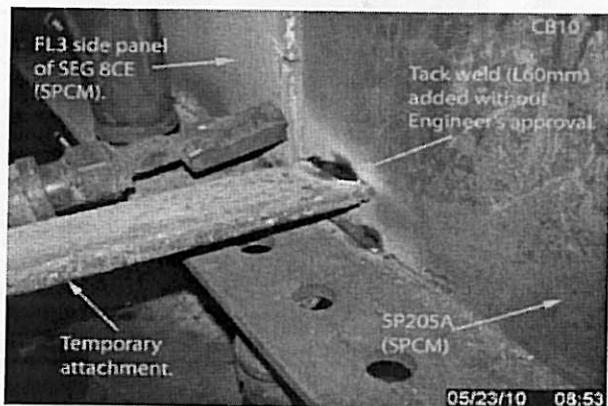
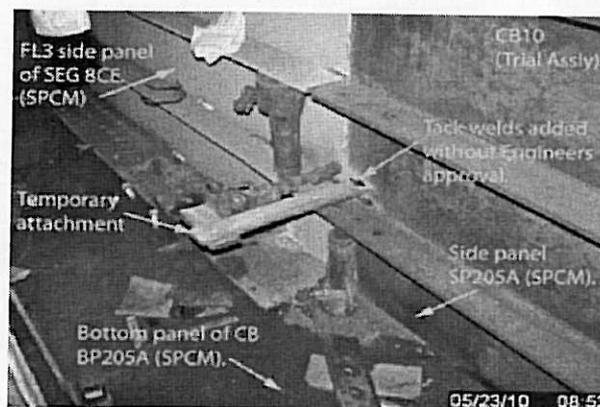
- During fit-up of Cross Beam CB10 side panel to FL3 panel of OBG segment 8CE, ZPMC personnel had temporarily tack welded a steel plate at the south end of side panel (SP205A) of CB10.
- Side Panel – SP205A is identified on the approved shop drawings as Seismic Performance Critical Member (SPCM).
- The size and length of the tack weld do not meet the requirements of AWS D1.5 2002, Table 12.2.
- The approved Shop drawing does not specify any weld in this area.
- No fabrication procedure was available with QC.
- The material composition of the temporary steel plate is not known.
- Cross Beam 10 is located in the Trial Assembly.

AWS D1.5-2002 Section 12.13.1.1 Location: All tack welds used in assembly shall be located within the joint unless otherwise approved by the Engineer.

AWS D1.5-2002 Table 12.2: Specifies tack welds outside the joint shall be a minimum of 75mm in length and refers to footnote 3 which specifies. "Tack welds outside the joint shall require the Engineer's approval".

Remove temporary welds, repair base metal, and perform NDT required to verify weld quality.

Contractor submitted post repair NDT documentation verifying base metal has been repaired and repair welds meet Contract weld quality requirements.
