Contract #: 04-0120F4
 Cty: SF/ALA Rte: 80 PM: 13.2/13.9
 File #: 69.25B

QUALITY ASSURANCE -- NON-CONFORMANCE REPORT

Report No: NCR-000741

Reference Description: Missed MT Indication by QC in OBG Segment 10AW Side Panel

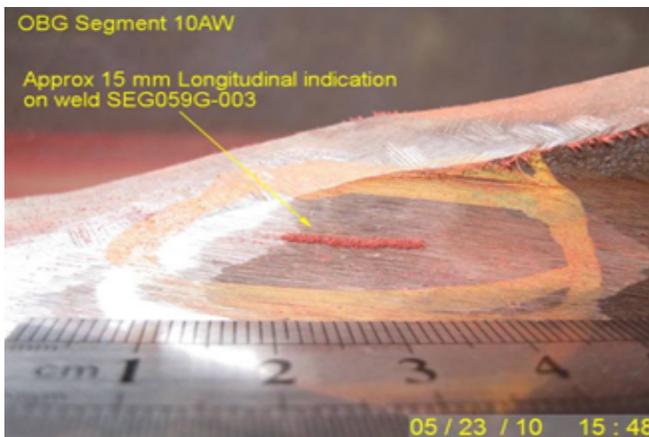
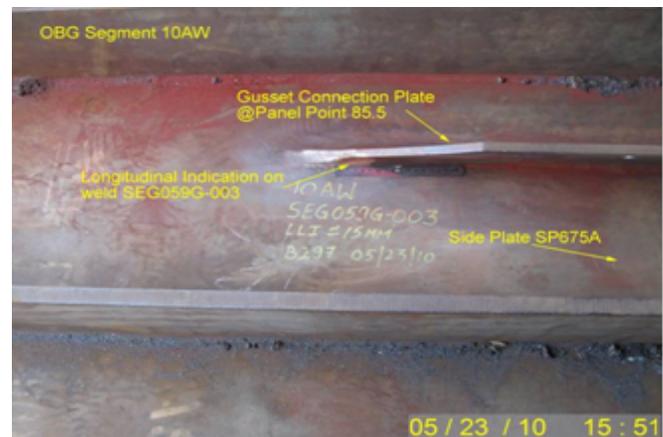
During the Quality Assurance (QA) Magnetic Particle Testing (MT) review of welds located on Segment 10AW, this QA Inspector discovered the following issue:

- One Longitudinal indication approximately 15 mm in length in the CJP weld joining the gusset connection plate identified as X74G to Side Plate 675A at panel point 85.5.
- The weld is identified as SEG059G-003.
- The weld is a designated on the contract drawings as a Seismic Performance Critical Member (SPCM).
- The indication is marked clearly near the weld.
- OBG segment 10AW is located in the segment repair yard north of Fabrication Bay 19.
- The Notice of Witness Inspection (NWIT) Number is 005771. The indication was found inside of the area previously tested and accepted by ZPMC QC personnel. According to the contract documents ZPMC's required percentage of testing is 100% of this weld.

AWS D1.5 (02) Section 6.26.2 – “Welds that are subject to MT in addition to visual inspection shall have no cracks.

Repair said indication and perform NDT required to verify weld quality.

Contractor supplied post repair NDT documentation verifying weld conforms with Contract weld quality requirements. An internal NCR was also issued by ZPMC in regards to this issue.

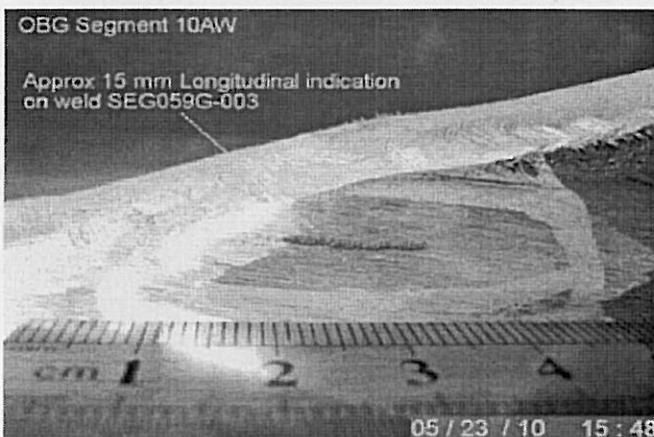
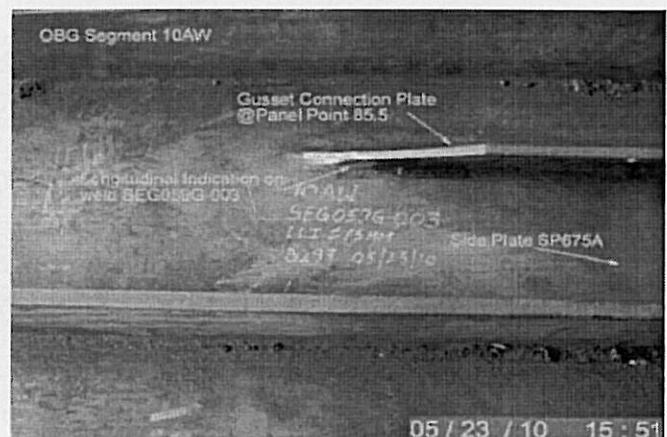
During the Quality Assurance (QA) Magnetic Particle Testing (MT) review of welds located on Segment 10AW, this QA Inspector discovered the following issue:

- One Longitudinal indication approximately 15 mm in length in the CJP weld joining the gusset connection plate identified as X74G to Side Plate 675A at panel point 85.5.
- The weld is identified as SEG059G-003.
- The weld is a designated on the contract drawings as a Seismic Performance Critical Member (SPCM).
- The indication is marked clearly near the weld.
- OBG segment 10AW is located in the segment repair yard north of Fabrication Bay 19.
- The Notice of Witness Inspection (NWIT) Number is 005771. The indication was found inside of the area previously tested and accepted by ZPMC QC personnel. According to the contract documents ZPMC's required percentage of testing is 100% of this weld.

AWS D1.5 (02) Section 6.26.2 – “Welds that are subject to MT in addition to visual inspection shall have no cracks.
