QUALITY ASSURANCE -- NON-CONFORMANCE REPORT

Report No: NCR-000742

Component: ED1-A27 Angle Plates on Shear Plate

Reference Description: There are two Angle Plates damaged and distorted

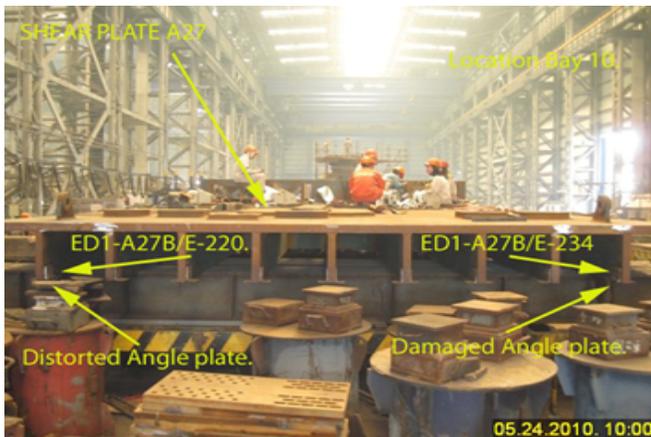
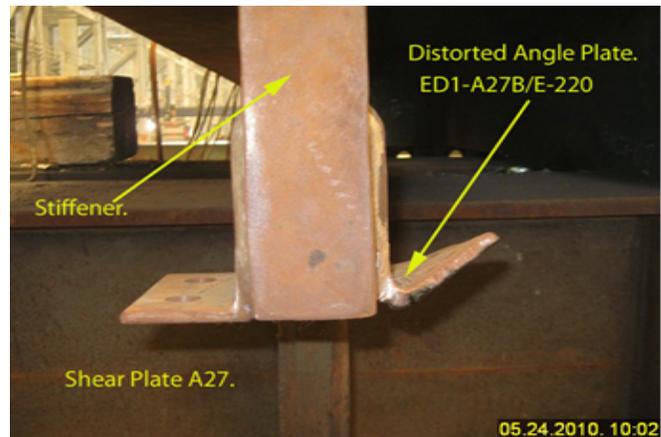
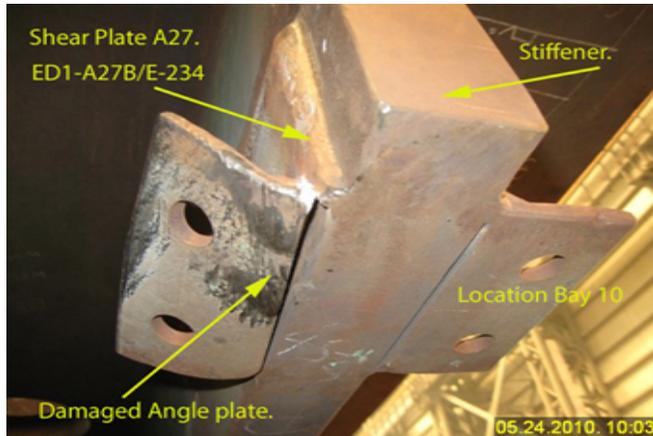
- Two (2) angle plates in the top elevation of Shear Plate were damaged and distorted.
- The welds are identified as ED1-A27B/E-234, 220; fillet weld.
- Tower Lift 1 Shear Plate ED1-A27.
- The member is located in Bay#10.
- These angle plates were previously VT and MT tested.
- The Notice of Witness Inspection Number (NWIT) is 005737.

“In handling and shipping of the steel work, every care shall be taken to avoid bending, scraping or overstressing the pieces. All pieces bent or otherwise injured will be rejected.”

In accordance with Section 55-1.04 of the Standard Specifications, Shear Plate ED1-A27 is rejected due to damaged/ distorted angle plates as referenced in this transmittal.

ZPMC removed the distorted angles, and replaced the new angles with NDT reports provided.
