Contract #: 04-0120F4  
 Cty: SF/ALA Rte: 80 PM: 13.2/13.9  
 File #: 69.25B

## QUALITY ASSURANCE -- NON-CONFORMANCE REPORT

**Report No:** NCR-000743

**Reference Description:** Unknown Material being tacked onto a Lift 13 Floorbeam. Performed work is not conforming to the requirements in AWS D1.5 Section 12.

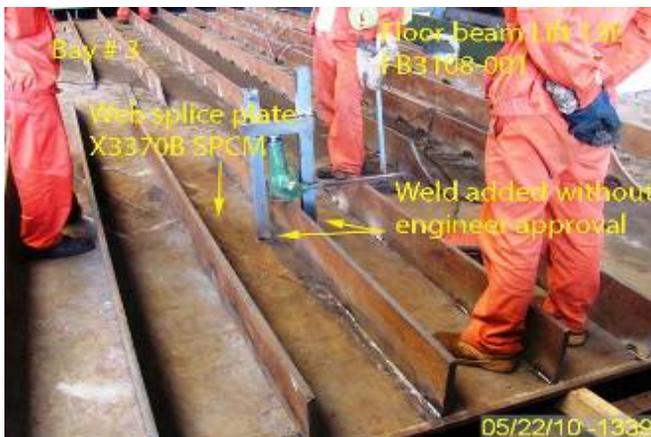
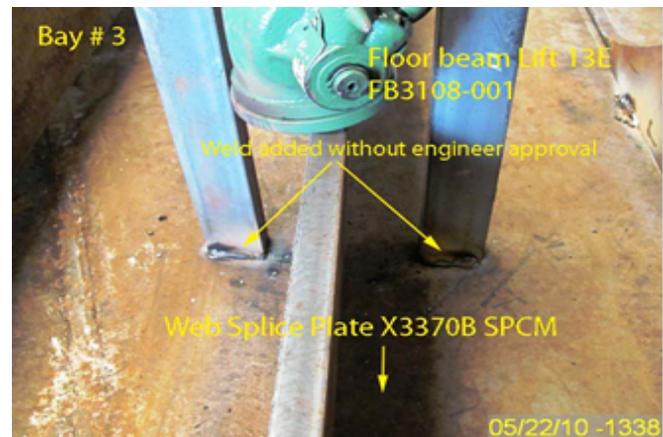
During the Quality Assurance (QA) random visual inspection of Orthotropic Box Girder (OBG) Floor beam Lift 13E, this QA Inspector discovered the following issues:

- ZPMC has temporarily tack welded steel plate to a Seismic Performance Critical Member (SPCM).
- The approved shop drawings do not specify any welds in these areas.
- The size and length of the tack welds do not meet the requirements of AWS D1.5 2002, table 12.2.
- The member is a Floor beam identified as: FB3108-001.
- The location of the temporary tack welds are Floor beam web splice plate X3370B.
- The Floor beam web splice plate is designated on the approved shop drawings as SPCM.
- The material composition of the added steel plate being welded to the Floor beam is not known.
- OBG Floor beam FB3108-001 is located in the Bay 3.

AWS D1.5-2002 Section 3.3.8 Temporary welds: "Temporary welds shall be subject to the same WPS requirements as final welds." "Temporary welds at other locations shall be shown on the shop drawings."

AWS D1.5-2002 Table 12.2: Specifies tack welds outside the joint shall be a minimum of 75mm in length and refers to footnote 3 which specifies. "Tack welds outside the joint shall require the Engineer's approval."

The areas where unidentified material was tacked welded shall be ground out such that any impurities introduced are removed. MT should then be performed and the base metal repaired per approved methods. Additionally, a description of the measures being taken to ensure that similar non-conformances do not occur in the future.

ZPMC has removed the tack welds by grinding and has instructed the work crew that, before the temporary attachments are applied, they must be part of a drawing as stated in the AWS code. ZPMC is generating a procedure for specific parts that will require temporary attachments. ZPMC has removed the temporary welds and MT the relative locations. ZPMC requests closure of this NCR.

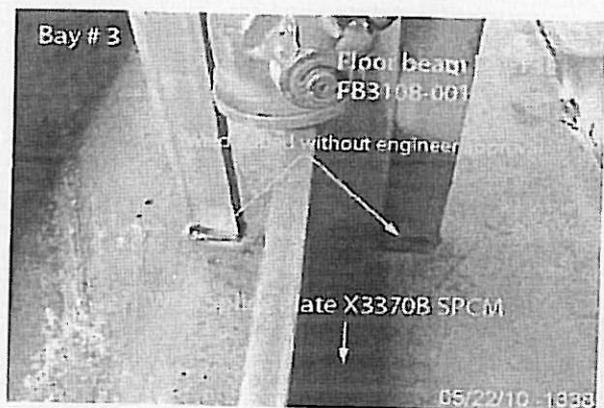
During the Quality Assurance (QA) random visual inspection of Orthotropic Box Girder (OBG) Floor beam Lift 13E, this QA Inspector discovered the following issues:

- ZPMC has temporarily tack welded steel plate to a Seismic Performance Critical Member (SPCM).
- The approved shop drawings do not specify any welds in these areas.
- The size and length of the tack welds do not meet the requirements of AWS D1.5 2002, table 12.2.
- The member is a Floor beam identified as: FB3108-001.
- The location of the temporary tack welds are Floor beam web splice plate X3370B.
- The Floor beam web splice plate is designated on the approved shop drawings as SPCM.
- The material composition of the added steel plate being welded to the Floor beam is not known.
- OBG Floor beam FB3108-001 is located in the Bay 3.

AWS D1.5-2002 Section 3.3.8 Temporary welds: "Temporary welds shall be subject to the same WPS requirements as final welds." "Temporary welds at other locations shall be shown on the shop drawings."

AWS D1.5-2002 Table 12.2: Specifies tack welds outside the joint shall be a minimum of 75mm in length and refers to footnote 3 which specifies. "Tack welds outside the joint shall require the Engineer's approval."

Remove welds, grind base metal under tacks, perform base metal repairs and NDT required to verify weld quality.

Contractor submitted post repair NDT documentation verifying base metal has been repaired and repair welds meet Contract weld quality requirements. ZPMC has also issued a temporary attachment procedure to Production to eliminate recurrence of this problem.
