Contract #: 04-0120F4Cty: SF/ALA Rte: 80 PM: 13.2/13.9File #: 69.25B**QUALITY ASSURANCE -- NON-CONFORMANCE REPORT****Location:** Changxing Island, Shanghai, P.R. China**Report No:** NCR-000744**Prime Contractor:** American Bridge/Fluor Enterprises, a JV**Date:** 26-May-2010**Submitting Contractor:** Zhenhua Port Machinery Company, Ltd (ZPMC), Changxing Island**NCR #:** ZPMC-0707**Type of problem:**

**Reference Description:** Work performed without an approved WPS on Bikepath Assembly BK004A-008, 010, 011

**Dear:** Mr. Charles Kanapicki  
**Job Name:** SAS Superstructure

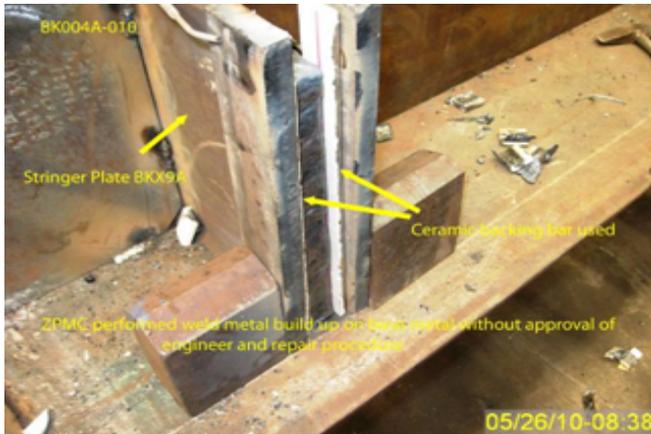
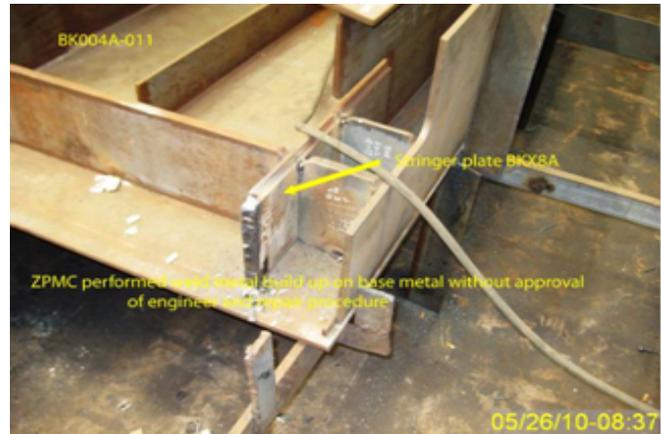
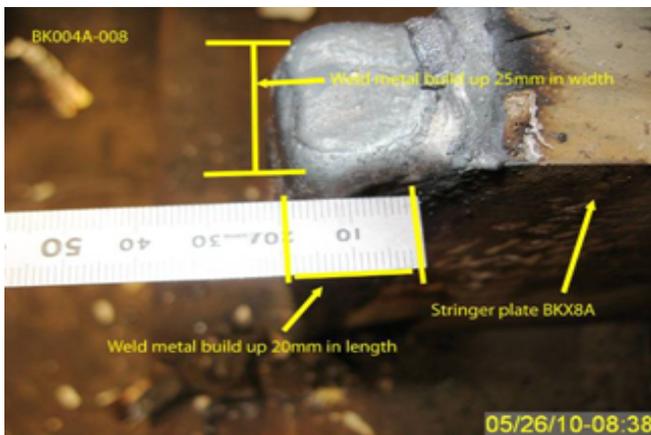
- Weld Build up (Buttering) performed without following an approved WPS.
- The buttering was performed by sandwiching the end of the material between two ceramic backing bars, one on each side of the plate and filling the square groove created by the backing bars with weld metal in the vertical position.

- The amount of buttering was approximately 20mm deep, 25mm wide, and over the full height of the edge.
- The members affected are identified as stringer plates BKX10A and BK8A on bike path assembly BK004A-008.

- Stringer plates BKX9A and BKX8A on bike path assembly BK004A-010.
- Stringer plates BKX10A and BKX8C on bike path assembly BK004A-011.
- ZPMC Quality Control (QC) provided Caltrans QA with Weld Repair Report (WRR) B-WR13162 for review.

- The WRR did not describe the use of the two ceramic backing bars, and the details of the use of steel backing and joint preparation.
- The WPS mentioned in the WRR were not utilized.

- A critical weld repair (CWR) is required and subsequent to the repair, ZPMC wrote up a CWR requesting for review and approval.

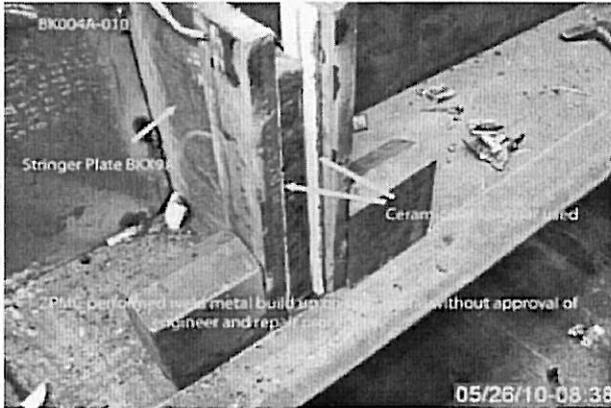
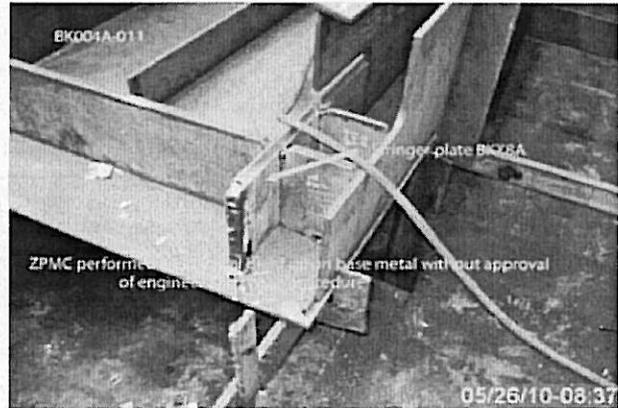
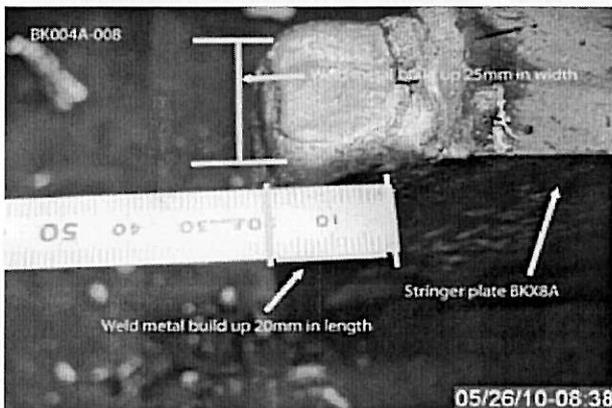
- Weld Build up (Buttering) performed without following an approved WPS.
  - The buttering was performed by sandwiching the end of the material between two ceramic backing bars, one on each side of the plate and filling the square groove created by the backing bars with weld metal in the vertical position.

- The amount of buttering was approximately 20mm deep, 25mm wide, and over the full height of the edge.
  - The members affected are identified as stringer plates BKX10A and BK8A on bike path assembly BK004A-008.

- Stringer plates BKX9A and BKX8A on bike path assembly BK004A-010.
  - Stringer plates BKX10A and BKX8C on bike path assembly BK004A-011.
  - ZPMC Quality Control (QC) provided Caltrans QA with Weld Repair Report (WRR) B-WR13162 for review.

- The WRR did not describe the use of the two ceramic backing bars, and the details of the use of steel backing and joint preparation.
  - The WPS mentioned in the WRR were not utilized.

- A critical weld repair (CWR) is required and subsequent to the repair, ZPMC wrote up a CWR requesting for review and approval.
- The OBG Bike paths are located inside the Fabrication Bay 19.

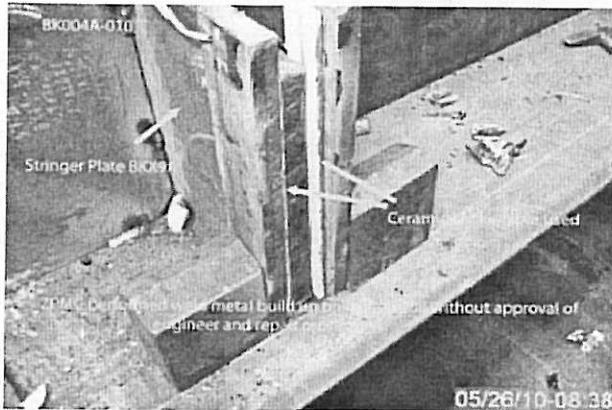
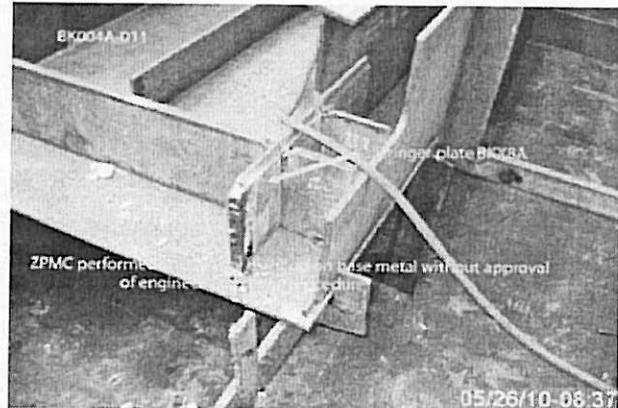
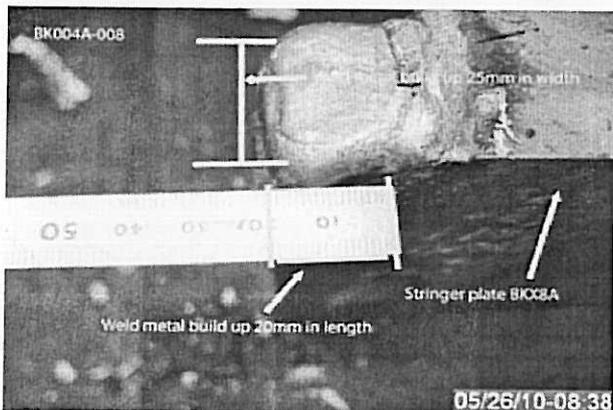
- Stringer plates BKX9A and BKX8A on bike path assembly BK004A-010.
  - Stringer plates BKX10A and BKX8C on bike path assembly BK004A-011.
  - ZPMC Quality Control (QC) provided Caltrans QA with Weld Repair Report (WRR) B-WR13162 for review.

- A critical weld repair (CWR) is required and subsequent to the repair, ZPMC wrote up a CWR requesting for review and approval.
- The OBG Bike paths are located inside the Fabrication Bay 19.
