Contract #: 04-0120F4Cty: SF/ALA Rte: 80 PM: 13.2/13.9File #: 69.25B**QUALITY ASSURANCE -- NON-CONFORMANCE REPORT****Location:** Changxing Island, Shanghai, P.R. China**Report No:** NCR-000746**Prime Contractor:** American Bridge/Fluor Enterprises, a JV**Date:** 27-May-2010**Submitting Contractor:** Zhenhua Port Machinery Company, Ltd (ZPMC), Changxing Island**NCR #:** ZPMC-0709**Type of problem:**

Reference Description: Missed UT indication by QC on OBG Segment 10CE Upper Floorbeam Flange (PP94)

Subject: NCR No. ZPMC-0709

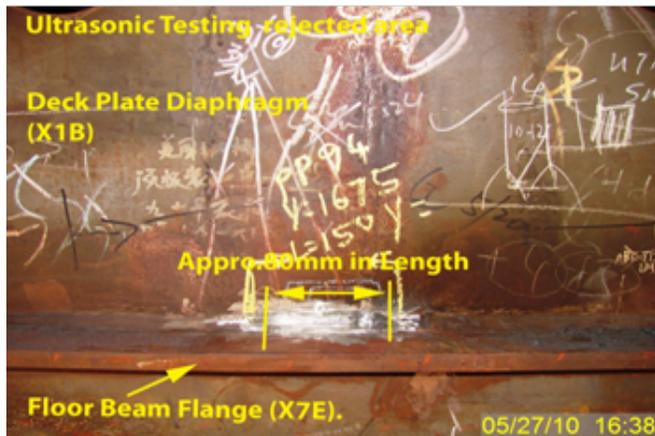
- One (1) longitudinal linear indication measuring approximately 80mm in length.
 - The indication dB rating is a +4.
 - Material thickness is 14mm.
 - The depth of the indication is approximately 10mm.

- The weld is identified as SSD-PP94-001/002 at Crossbeam side, Panel Point (PP) 94.
 - According to the approved shop drawing and due to excessive root gap ZPMC has changed the joint to a Complete Joint Penetration (CJP) "T" joint.

- This joint joins the Deck Plate Diaphragm (X1B) to Floor Beam Flange (X7E).
 - The weld is designated as Non-Seismic Performance Critical Material (Non SPCM).

- The indication is clearly marked on or near the weld.
 - The Y distance for this indication is 1675 mm from the Corner Assembly diaphragm at the Crossbeam side.

- Segment 10CE is located outside of the Paint shop.
- The Notice of Witness Inspection (NWIT) No. is 005832. The indication is located in an area previously tested and accepted by ZPMC Quality Control (QC) personnel. As per the contract documents, ZPMC's QC personnel are required to perform hundred (100%) percent UT inspection of this weld.

AWS D1.5-02 Section 6; Table 6.3 specifies a class “A” indication as having a rating of 10dBs and under for material thicknesses 8mm through 20mm.

Reference Resolution: ZPMC will provide NDT to show these welds are acceptable after the repairs are complete. Based on this proposal ZPMC requests that this NCR be approved, with actions pending.

This proposed resolution is accepted, action pending. Please provide NDT results for these welds upon completion of the repairs.

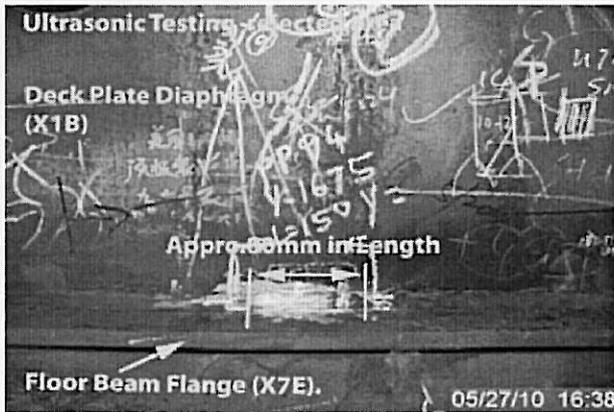
-One (1) longitudinal linear indication measuring approximately 80mm in length.

-The indication dB rating is a +4.

-Material thickness is 14mm.

-The depth of the indication is approximately 10mm.

-The weld is identified as SSD-PP94-001/002 at Crossbeam side, Panel Point (PP) 94.

-According to the approved shop drawing and due to excessive root gap ZPMC has changed the joint to a Complete Joint Penetration (CJP) "T" joint.

-This joint joins the Deck Plate Diaphragm (X1B) to Floor Beam Flange (X7E).

-The indication is clearly marked on or near the weld.

-The Y distance for this indication is 1675 mm from the Corner Assembly diaphragm at the Crossbeam side.

The Notice of Witness Inspection (NWIT) No. is 005832. The indication is located in an area previously tested and accepted by ZPMC Quality Control (QC) personnel. As per the contract documents, ZPMC's QC personnel are required to perform hundred (100%) percent UT inspection of this weld.

AWS D1.5-02 Section 6; Table 6.3 specifies a class "A" indication as having a rating of 10dBs and under for material thicknesses 8mm through 20mm.

Repair said indication and perform NDT required to verify weld quality.

Contractor supplied post repair NDT documentation verifying weld is in conformance with Contract weld quality requirements. Contractor has also taken action directly with NDT Technicians to avoid similar issues in the future.

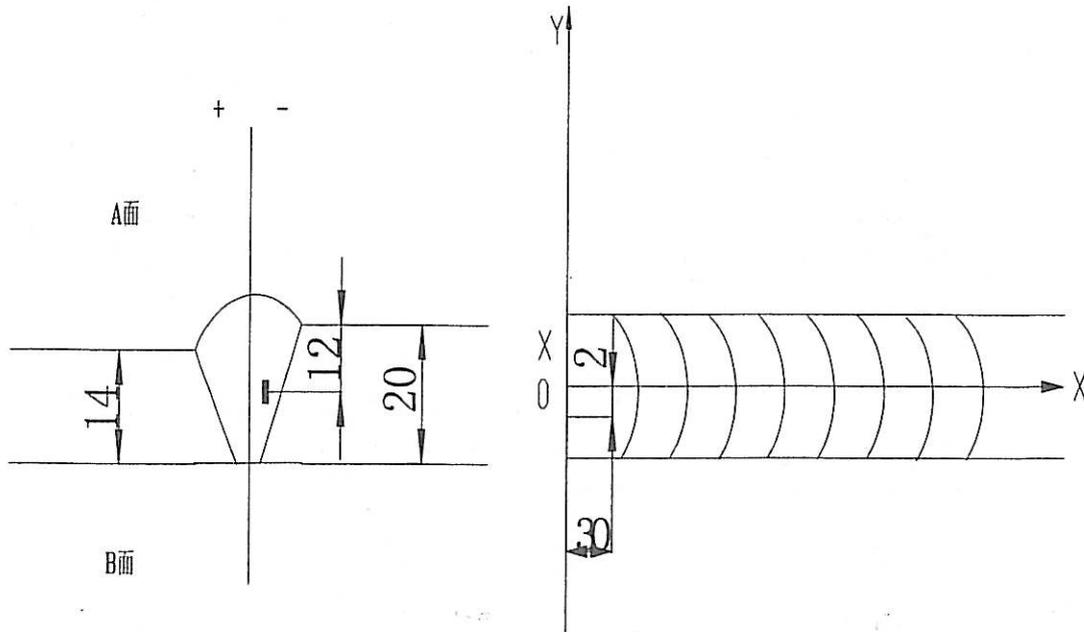
WELD NUMBER: SSD18-PP94-303

Rejected indication found by ultrasonic inspection is less than the maximum allowance aggregate length.

1. Did not clear the weld pass completely in time.

1. Gouge or grind from nearer side from metal edge ($D \leq 0.65T$, "D" is depth of defects, "T" is thickness of metal) to remove all defects;

2. Follow repair WPS for joint preparation, preheat, and weld deposit;

3. Verify with VT no defects remain in the weld joint prior to welding;

4. Grind the repaired area flush with base metal or the adjacent weld;

5. Check the welds according to the working drawings.

1. Improve monitoring of welding and interpass cleaning.
