QUALITY ASSURANCE -- NON-CONFORMANCE REPORT

Location: Changxing Island, Shanghai, P.R. China **Report No:** NCR-000747
Prime Contractor: American Bridge/Fluor Enterprises, a JV **Date:** 27-May-2010
Submitting Contractor: Zhenhua Port Machinery Company, Ltd (ZPMC), Changxing Island **NCR #:** ZPMC-0710

Reference Description: West Shaft: The Bearing Stiffeners overlap on the anchor bolt holes at External Skin D.

SAN FRANCISCO OAKLAND BAY BRIDGE
 EAST SPAN SEISMIC SAFETY PROJECT
 SELF-ANCHORED SUSPENSION BRIDGE
 (SUPERSTRUCTURE & TOWER)

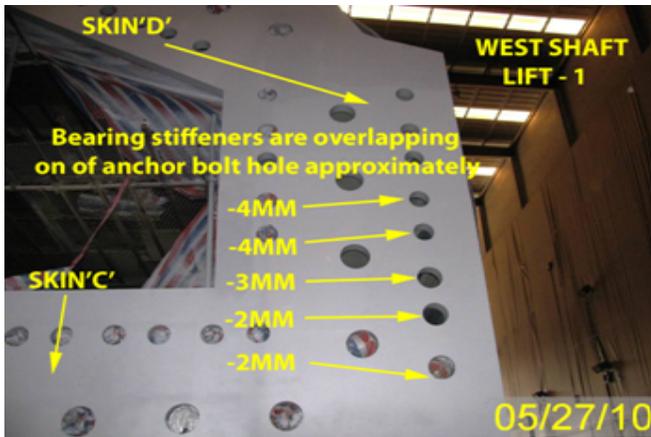
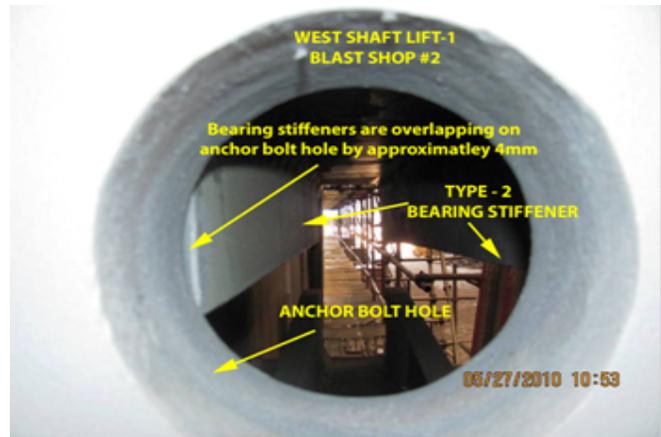
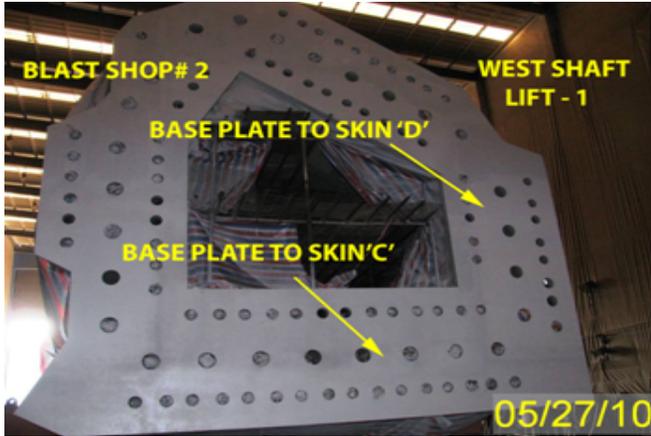
During the Quality Assurance Inspection of Anchor Bolt Hole to Bearing stiffener distance measurement at West shaft Skin D External side, this Quality Assurance Inspector discovered the following issue:

- Type 2 Bearing stiffeners are overlapping on top of anchor bolt hole.
- Type 2 Bearing stiffeners to Anchor bolt hole distances at five (5) different locations found approximately -2 mm, -2mm, -3mm, -4mm, -4mm.
- The Anchor bolt holes found inappropriate readings are consecutive from Skin 'D' side. (For readings see above)
- This bearing stiffener is found in Skin D of External West Shaft Lift 1.
- The location is Skin D, near CD Corner.

Despite the conflicts that were noted in the NCR, the bolt holes were designed to be oversized to account for any potential issues during installation. Attached is the contract drawing showing that the holes are oversized and the conflicts of 4mm, 3mm, and 2mm is not an issue because of the large oversized holes. Based on this ZPMC requests closure of this NCR.

Although the bearing stiffeners were not built to contract tolerances, there is enough flexibility in the design to account for the potential conflict during installation of the anchor rods. This NCR is conderised accepted with action pending and will be closed once final installation of the anchor rods has been achieved in Oakland without conflict.

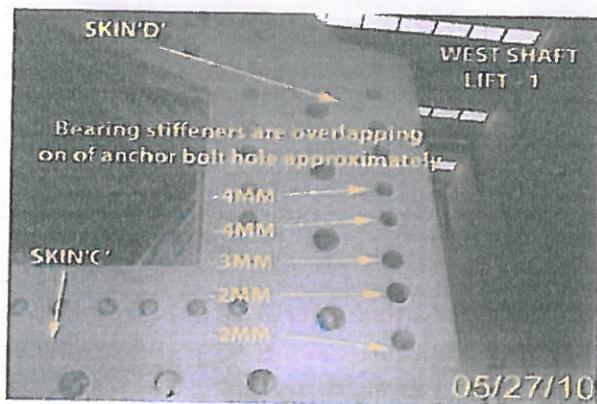
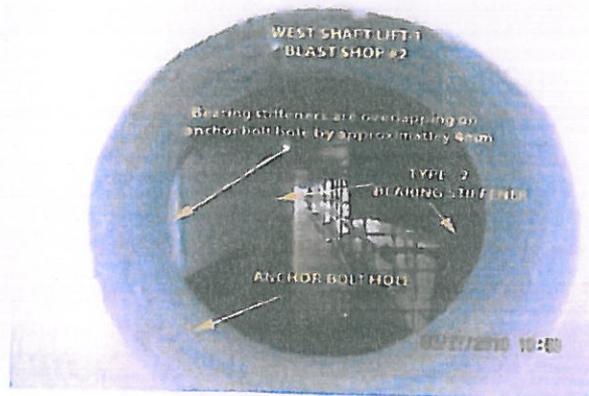
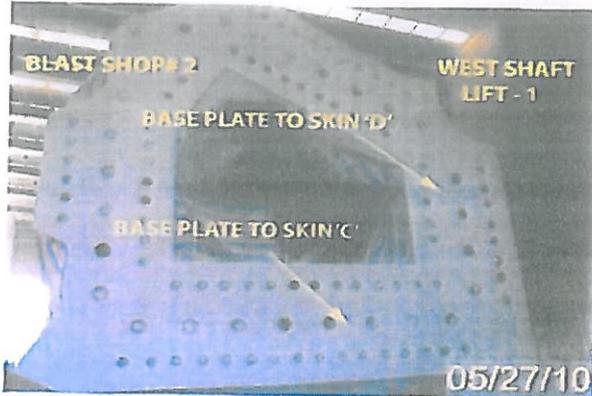
During the Quality Assurance Inspection of Anchor Bolt Hole to Bearing stiffener distance measurement at West shaft Skin D External side, this Quality Assurance Inspector discovered the following issue:

- Type 2 Bearing stiffeners are overlapping on top of anchor bolt hole.
- Type 2 Bearing stiffeners to Anchor bolt hole distances at five (5) different locations found approximately -2 mm, -2mm, -3mm, -4mm, -4mm.
- The Anchor bolt holes found inappropriate readings are consecutive from Skin 'D' side. (For readings see above)
- This bearing stiffener is found in Skin D of External West Shaft Lift 1.
- The location is Skin D, near CD Corner.

Construction/Design confirmed the mis-alignment appear to have no impact on the erection as designed. No retrofit works was necessary. Erection of the base plate was completed successfully in Oakland.

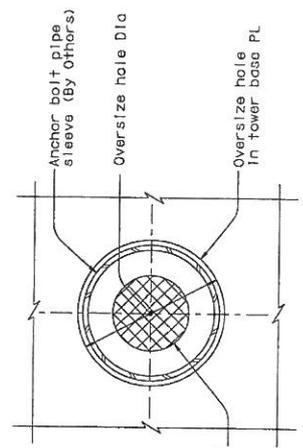
ANCHOR BOLT HOLE PLAN VIEW
 1:2.5

Anchor Bolt Dia	75	100
Oversize hole Dia	145	170
