QUALITY ASSURANCE -- NON-CONFORMANCE REPORT

Report No: NCR-000748

Component: Bike path assembly BK004A-004

Reference Description: Improper welding process was utilized in repair of Bike path assembly BK004A-004

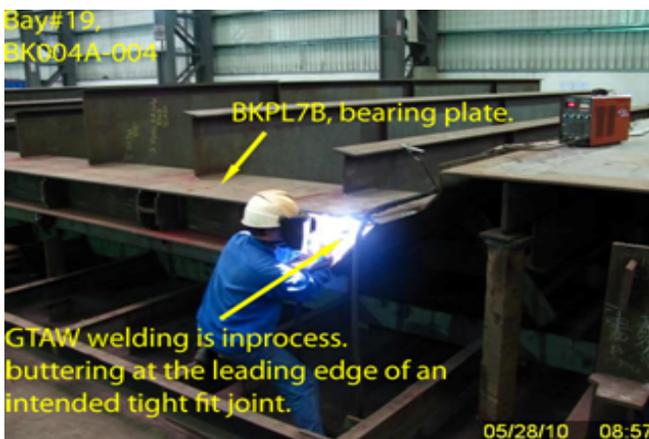
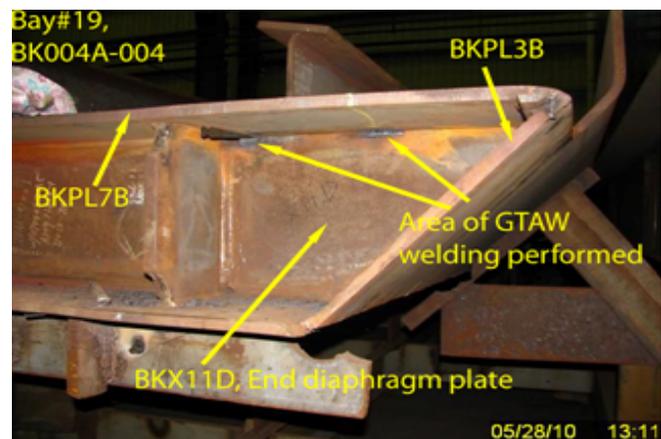
During random in-process visual inspection of bike path assembly BK004A-004, this Quality Assurance (QA) Inspector discovered the following issue:

- Weld buttering being performed at the leading edge of an intended tight fit joint, between the end diaphragm plate (BKX11D) and the bearing plate (BKPL7B) with an unapproved welding process.
- The welding process being utilized during the repair was Gas Tungsten Arc Welding (GTAW).
- The welder is identified as ZP09-1381.
- The ZPMC QC Mr. Zhou Cheng was unable to identify the consumables used at the time of welding.
- Bike Path: BK004A-004 is located in Bay 19.

AWS D1.5-2002 Section 1.3.5: "Other welding processes not described in this code may be used if approved by the Engineer."

AWS D1.5-2002 Section 3.2.3.7: "All repair welding shall conform to the requirements of an approved WPS".

AWS D1.5-2002 Section 3.5.1.10: "Where tight fit of intermediate stiffeners is specified, it shall be defined as allowing a gap of up to 2mm between stiffener & flange.

The unsatisfied welds have been removed. A WRR has been written in order to fix this area. ZPMC QC will enhance the welding control during welding. The non-conformance in NCR has been cleared. Please consider to close this NCR.

Remove said welds and replace utilizing an approved welding process.

Welds were removed within the workshift and have since been replaced with the appropriate welding process.

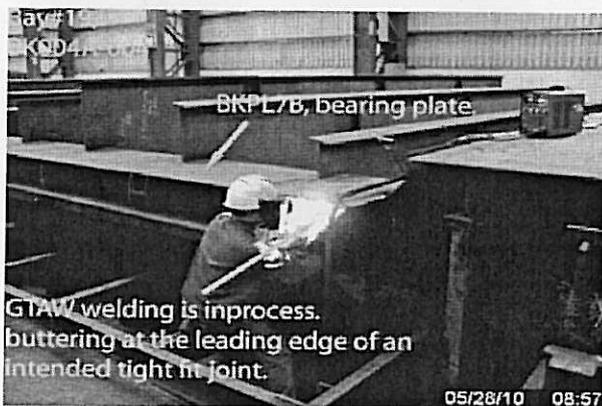
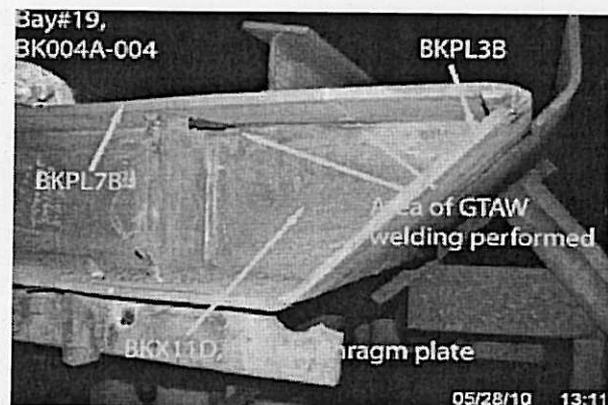
During random in-process visual inspection of bike path assembly BK004A-004, this Quality Assurance (QA) Inspector discovered the following issue:

- Weld buttering being performed at the leading edge of an intended tight fit joint, between the end diaphragm plate (BKX11D) and the bearing plate (BKPL7B) with an unapproved welding process.
- The welding process being utilized during the repair was Gas Tungsten Arc Welding (GTAW).
- The welder is identified as ZP09-1381.
- The ZPMC QC Mr. Zhou Cheng was unable to identify the consumables used at the time of welding.
- Bike Path: BK004A-004 is located in Bay 19.

AWS D1.5-2002 Section 1.3.5: "Other welding processes not described in this code may be used if approved by the Engineer."

AWS D1.5-2002 Section 3.2.3.7: "All repair welding shall conform to the requirements of an approved WPS".

AWS D1.5-2002 Section 3.5.1.10: "Where tight fit of intermediate stiffeners is specified, it shall be defined as allowing a gap of up to 2mm between stiffener & flange.
