Contract #: 04-0120F4  
 Cty: SF/ALA Rte: 80 PM: 13.2/13.9  
 File #: 69.25B

**QUALITY ASSURANCE -- NON-CONFORMANCE REPORT**

**Location:** Changxing Island, Shanghai, P.R. China **Report No:** NCR-000749  
**Prime Contractor:** American Bridge/Fluor Enterprises, a JV **Date:** 28-May-2010  
**Submitting Contractor:** Zhenhua Port Machinery Company, Ltd (ZPMC), Changxing Island **NCR #:** ZPMC-0712

**Reference Description:** Missed MT transverse indications by QC on Segment 10CE U-Rib Deck Panel to Diaphragm Weld at PP93

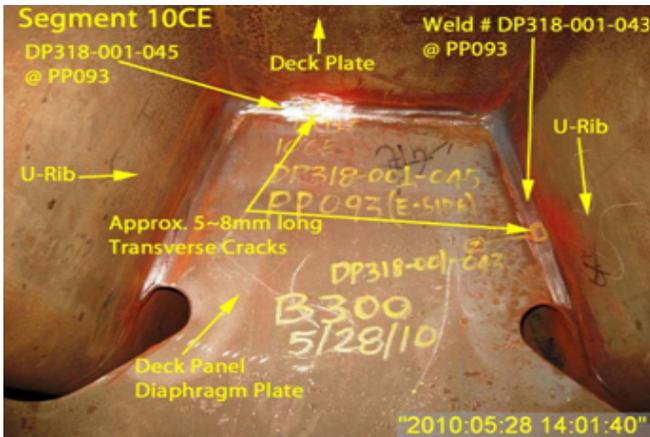
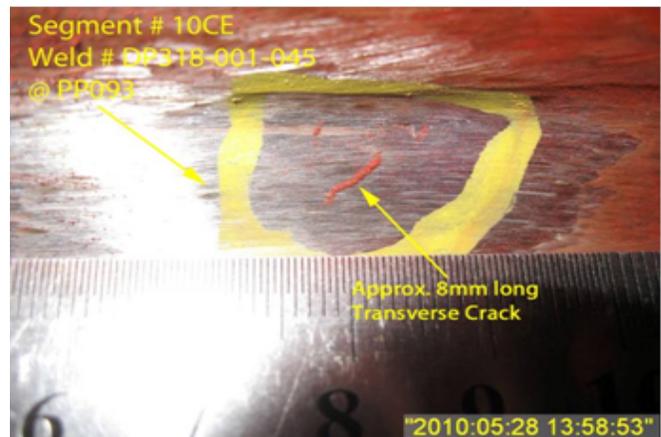
During the Quality Assurance (QA) Magnetic Particle Testing (MT) review of welds located on Segment 10CE, this QA Inspector discovered the following issues:

- Two (2) Transverse linear cracks measuring approximately 5~8 mm in length.
- The welds are identified as DP318-001-045 & DP318-001-043 at PP93.
- The welds are Fillet Weld T-joints, joining the Deck Plate (DP318) to Deck Panel Diaphragm plate & Deck Plate (DP318) to the U-Rib.
- OBG segment 10CE is located at the front side of OBG Paint shop.

The Notice of Witness Inspection Number (NWIT) is 005832. The indication is located inside the area that has been previously tested and accepted by ZPMC Quality Control (QC) personnel. ZPMC's QC personnel perform one hundred (100%) percent MT inspection of this weld.

AWS D1.5 (02) Section 6.26.2 – “Welds that are subject to MT in addition to visual inspection shall have no cracks.

**Reference Resolution:** ZPMC has repaired the indications and is providing the NDT after to show it is acceptable. Based on that ZPMC requests closure of this NCR.

ZPMC has repaired the indications and is providing the NDT after to show it is acceptable. Based on that ZPMC requests closure of this NCR. Also note that weld IDs identified in the NCR were incorrect. The correct weld IDs have been noted in the NDT reports.

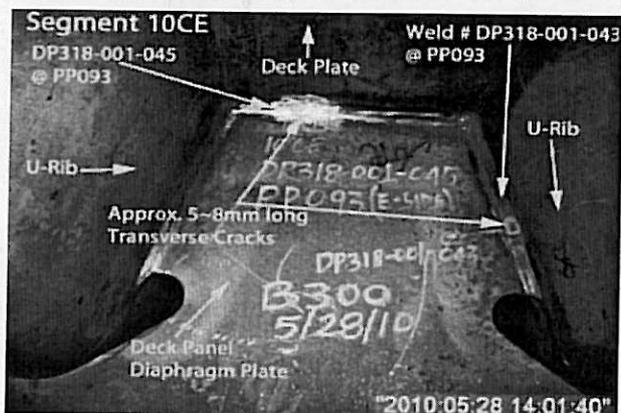
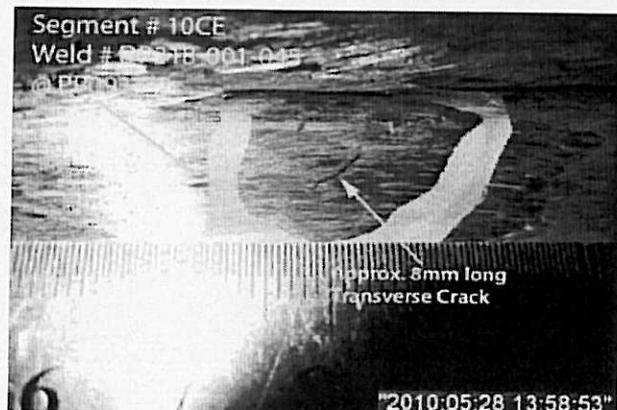
During the Quality Assurance (QA) Magnetic Particle Testing (MT) review of welds located on Segment 10CE, this QA Inspector discovered the following issues:

-Two (2) Transverse linear cracks measuring approximately 5~8 mm in length.

-The welds are identified as DP318-001-045 & DP318-001-043 at PP93.

-The welds are Fillet Weld T-joints, joining the Deck Plate (DP318) to Deck Panel Diaphragm plate & Deck Plate (DP318) to the U-Rib.

The Notice of Witness Inspection Number (NWIT) is 005832. The indication is located inside the area that has been previously tested and accepted by ZPMC Quality Control (QC) personnel. ZPMC's QC personnel perform one hundred (100%) percent MT inspection of this weld.

**Reference Resolution:** ZPMC has performed the required repair and has attached the MT report as objective evidence to verify the repair is acceptable.

ZPMC has confirmed this indication is relevant as found by CT inspector. ZPMC has performed the required repair and has attached the MT report as objective evidence to verify the repair is acceptable. The ABF QCM and ZPMC QCM have discussed these types of NCR's and have verbally informed all NDT technicians to be more thorough in performing NDT. ZPMC requests closure of this NCR.

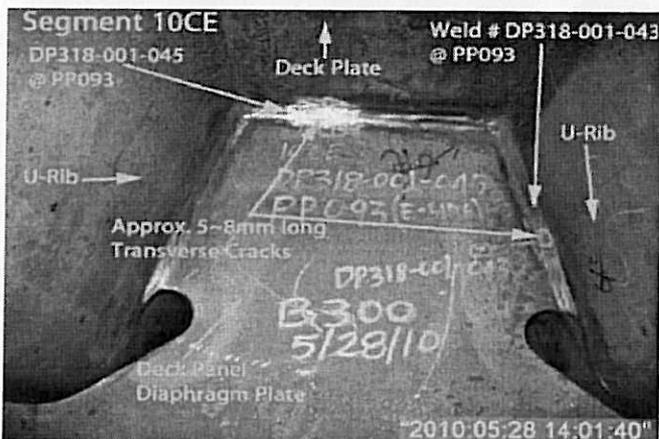
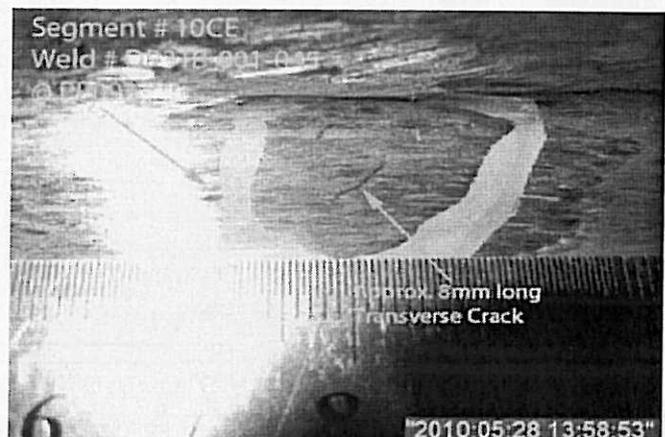
During the Quality Assurance (QA) Magnetic Particle Testing (MT) review of welds located on Segment 10CE, this QA Inspector discovered the following issues:

- Two (2) Transverse linear cracks measuring approximately 5~8 mm in length.
- The welds are identified as DP318-001-045 & DP318-001-043 at PP93.
- The welds are Fillet Weld T-joints, joining the Deck Plate (DP318) to Deck Panel Diaphragm plate & Deck Plate (DP318) to the U-Rib.
- OBG segment 10CE is located at the front side of OBG Paint shop.

The Notice of Witness Inspection Number (NWIT) is 005832. The indication is located inside the area that has been previously tested and accepted by ZPMC Quality Control (QC) personnel. ZPMC's QC personnel perform one hundred (100%) percent MT inspection of this weld.

Repair said indications and perform NDT required to verify weld quality.

Contractor supplied post repair NDT documentation verifying weld conforms with Contract weld quality requirements. ABF has met with ZPMC QC to discuss means to preventing this problem.
