Contract #: 04-0120F4Cty: SF/ALA Rte: 80 PM: 13.2/13.9File #: 69.25B**QUALITY ASSURANCE -- NON-CONFORMANCE REPORT****Location:** Changxing Island, Shanghai, P.R. China**Report No:** NCR-000750**Prime Contractor:** American Bridge/Fluor Enterprises, a JV**Date:** 28-May-2010**Submitting Contractor:** Zhenhua Port Machinery Company, Ltd (ZPMC), Changxing Island**NCR #:** ZPMC-0713**Type of problem:**

**Reference Description:** Excessive heat was utilized during heat straightening of the traveler rail 20TR2-013**Description of Non-Conformance:**

# QUALITY ASSURANCE -- NON-CONFORMANCE REPORT

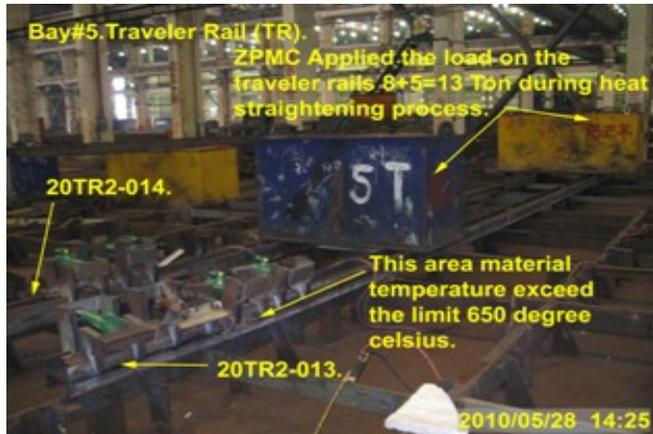
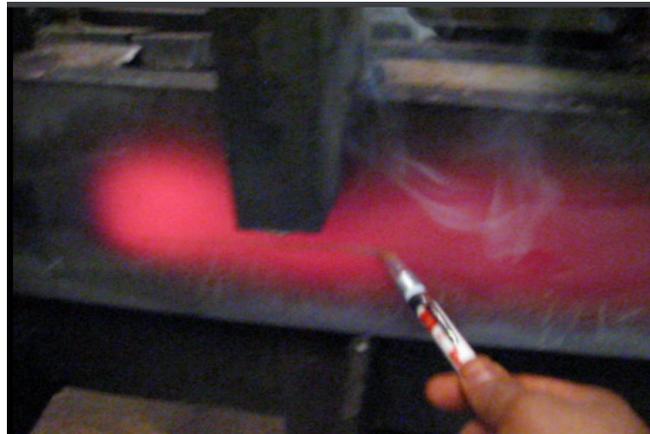
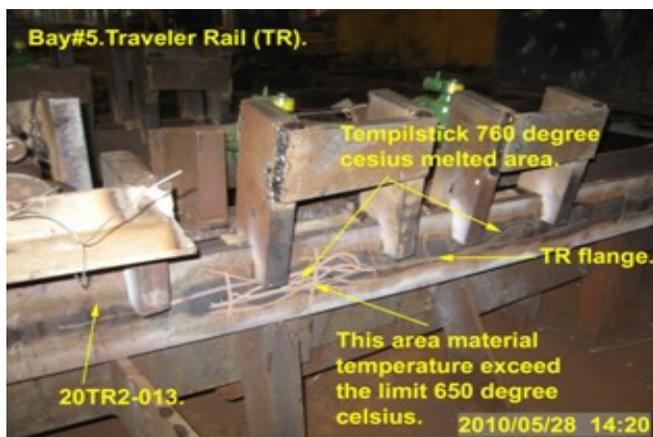
- ZPMC personnel performed heat straightening of the traveler rail flange base plate. The material was heated to a bright red condition and the temperature is above 650°C.

- Per ZPMC Heat Straightening Report identified as HSR1 (B)-8350, the maximum allowable temperature is 650°C.
- The AWS D1.5 Section 3.7.3 states that the heated steel shall not exceed 650°C, which gives a dull red color.

- This QA Inspector observed the 760°C Tempilstik was melted when struck against the red base metal.
- A temperature indicating crayon, digital temperature measurement gauge, or other similar means of monitoring the temperature was not utilized by ZPMC QC and the actual maximum attained temperature was not measured.

- The Traveler rail is identified as 20TR2-013.
- The affected area was measured at Y location 800mm when measured from nearest leading edge, having a total area 150 x 1200mm.

- Additionally, this QA Inspector observed ZPMC apply a 13 Tons load on the Traveler rail.
- ZPMC HSR1 Report doesn't specify the exact weight or weight range to be applied on the TR during heat straightening process.

Please provide HSR and documentations that demonstrate the over-heated element is acceptable. Propose a resolution for the identified non-conformance with revised procedures to prevent future occurrences. A response for the resolution of this issue is expected within 7 days.

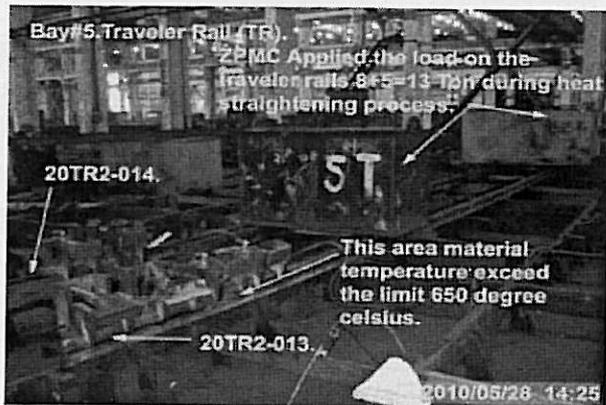
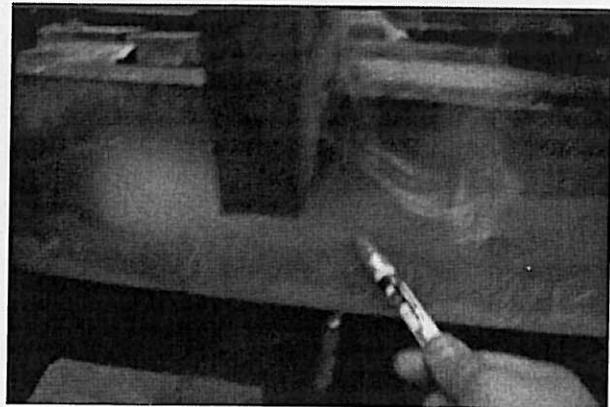
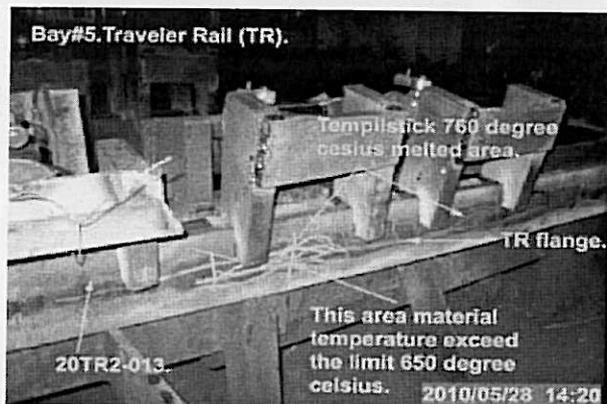
- ZPMC personnel performed heat straightening of the traveler rail flange base plate. The material was heated to a bright red condition and the temperature is above 650°C.

- This QA Inspector observed the 760°C Tempilstik was melted when struck against the red base metal.
- A temperature indicating crayon, digital temperature measurement gauge, or other similar means of monitoring the temperature was not utilized by ZPMC QC and the actual maximum attained temperature was not measured.

- Additionally, this QA Inspector observed ZPMC apply a 13 Tons load on the Traveler rail.
- ZPMC HSR1 Report doesn't specify the exact weight or weight range to be applied on the TR during heat straightening process.

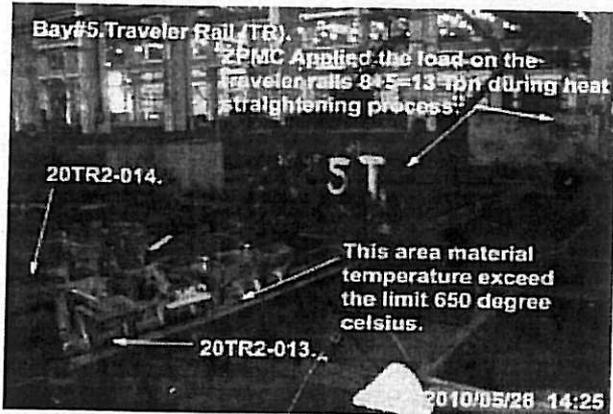
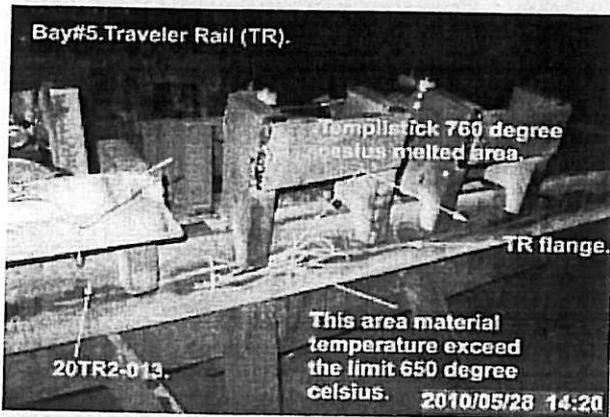
- ZPMC personnel performed heat straightening of the traveler rail flange base plate. The material was heated to a bright red condition and the temperature is above 650°C.

- This QA Inspector observed the 760°C Tempilstik was melted when struck against the red base metal.
- A temperature indicating crayon, digital temperature measurement gauge, or other similar means of monitoring the temperature was not utilized by ZPMC QC and the actual maximum attained temperature was not measured.

- Additionally, this QA Inspector observed ZPMC apply a 13 Tons load on the Traveler rail.
- ZPMC HSR1 Report doesn't specify the exact weight or weight range to be applied on the TR during heat straightening process.

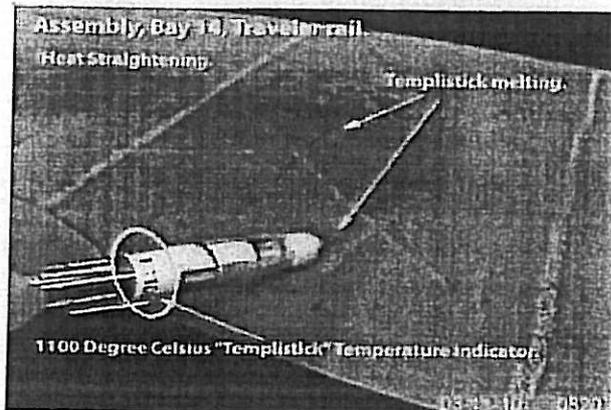
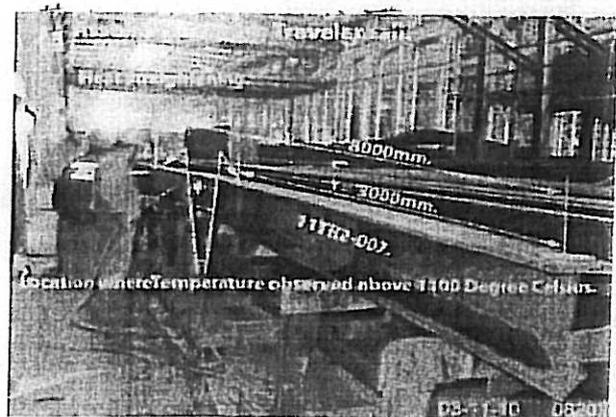
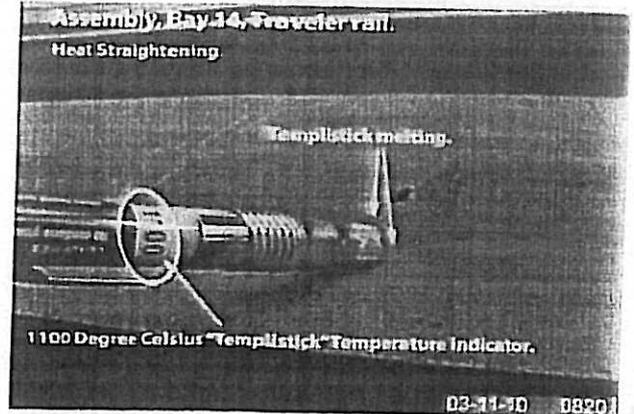
- Temperature of the heat straightened traveler rail was beyond the allowable 650 Degree Celsius in two locations.
- Per ZPMC heat straightening report (HSR) maximum temperature limit is 650 Degree Celsius.
- The 1100 Degree Celsius rating "templstick" was melted when check was made against the metal surface.
- "Y" location of the spots identified as 3000mm & 8000mm at the flange.
- The Traveler Rail is identified as 11TR2-007.

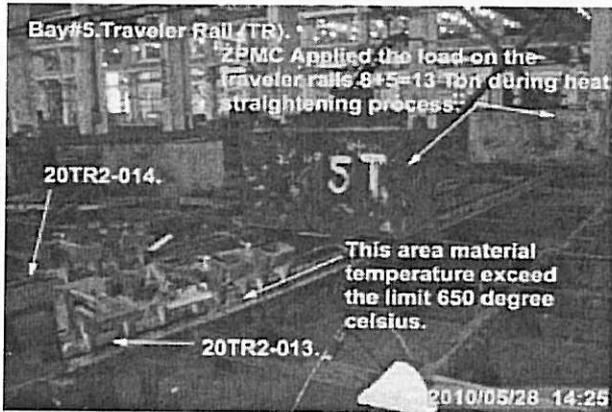
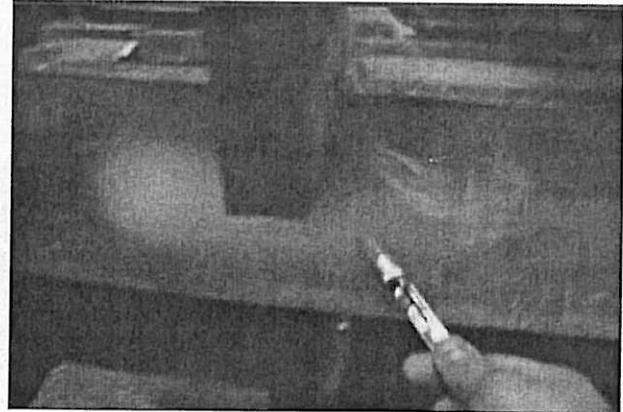
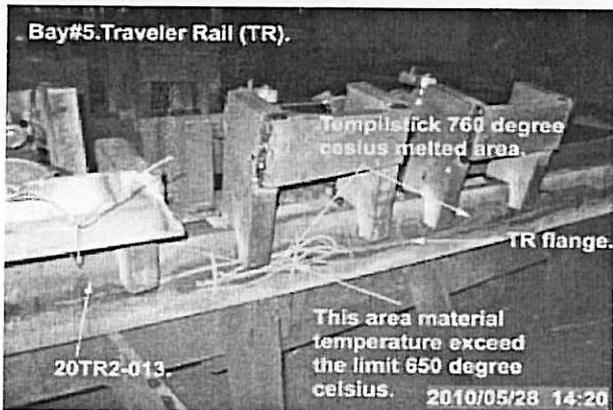
- ZPMC personnel performed heat straightening of the traveler rail flange base plate. The material was heated to a bright red condition and the temperature is above 650°C.

- This QA Inspector observed the 760°C Tempilstik was melted when struck against the red base metal.
- A temperature indicating crayon, digital temperature measurement gauge, or other similar means of monitoring the temperature was not utilized by ZPMC QC and the actual maximum attained temperature was not measured.

- Additionally, this QA Inspector observed ZPMC apply a 13 Tons load on the Traveler rail.
- ZPMC HSR1 Report doesn't specify the exact weight or weight range to be applied on the TR during heat straightening process.
