**DEPARTMENT OF TRANSPORTATION**

# QUALITY ASSURANCE -- NON-CONFORMANCE REPORT

**Subject:** NCR No. ZPMC-0715

**Component:** Suspender Brackets for OBG Lift 7

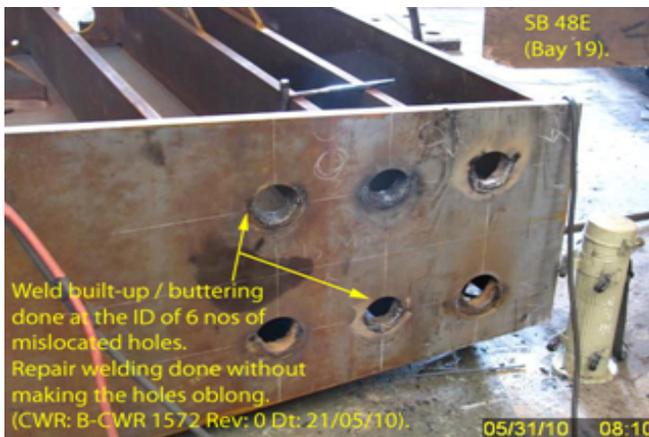
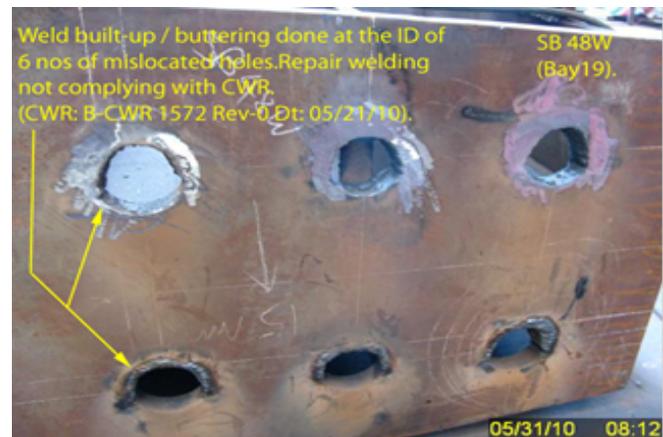
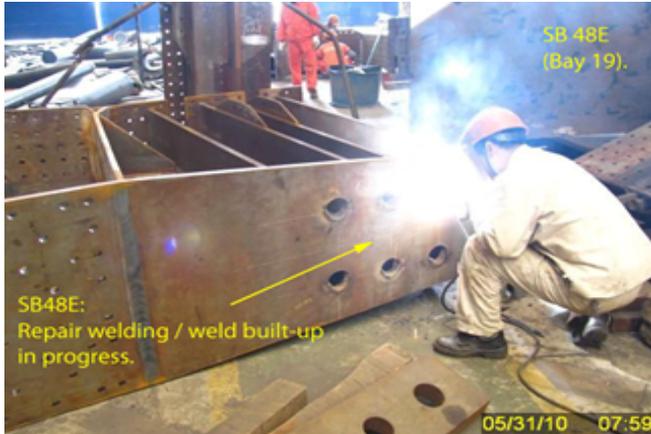
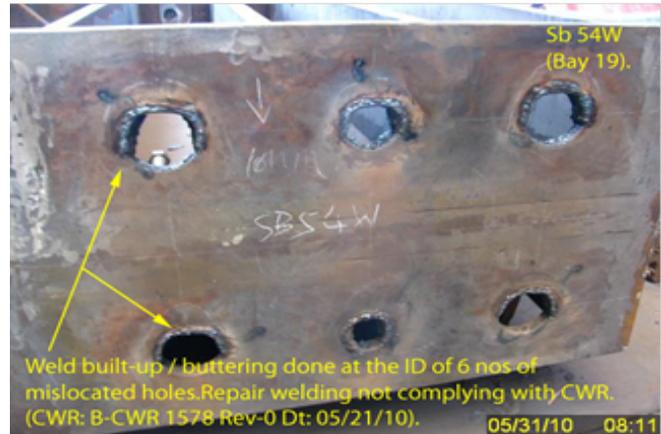
-ZPMC welding personnel performing base metal restoration of the mis-located suspender rod holes on suspender bracket identified as SB48E.

-The repairs did not comply with the approved Critical Welding Report (CWR): B-CWR1572 and B-CWR1578.

-ZPMC welder was buttering (build up with weld) the cross-sectional surface along the full circumference of the mis-drilled holes.

-This manner of repair appears to have been performed on all 6 suspender rod holes on the following suspender brackets: SB48E (Segment 7AE), SB48W (Segment 7AW), and SB54W (Segment 7CW).

**Reference Resolution:** ZPMC will build up the base metal and rebore the holes, after ZPMC will perform 100% UT and MT of the area to show that weld is sound.

The original buttering that was noted in the NCR was performed without Engineer's approval. A CWR was submitted after the fact and the disposition of this CWR stated that the repair would be performed in accordance with Submittal #200. However, the work as it was actually performed was not in accordance with this. The buttered weld material added needs to be removed and replaced in accordance with Submittal #200R3. It is not necessary to completely fill the holes but edges need to be beveled and NDT performed prior to redrilling the holes.

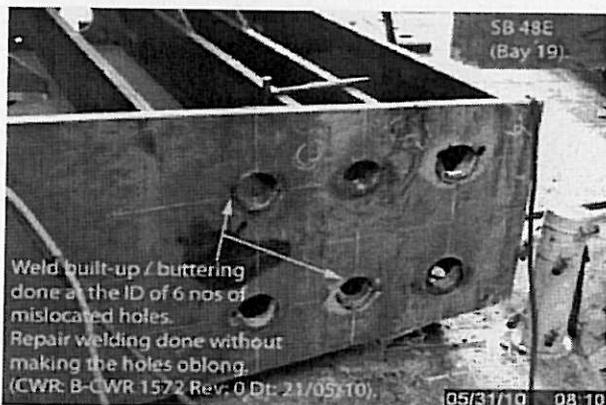
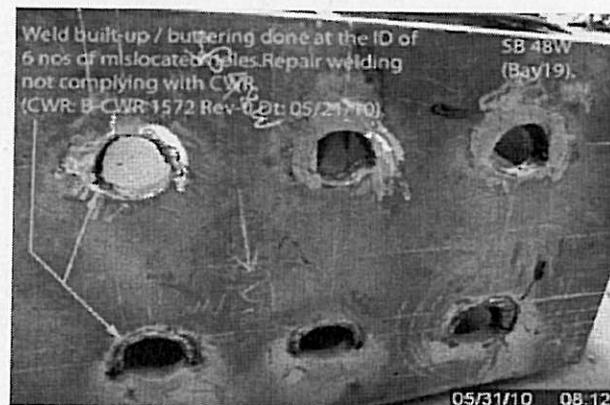
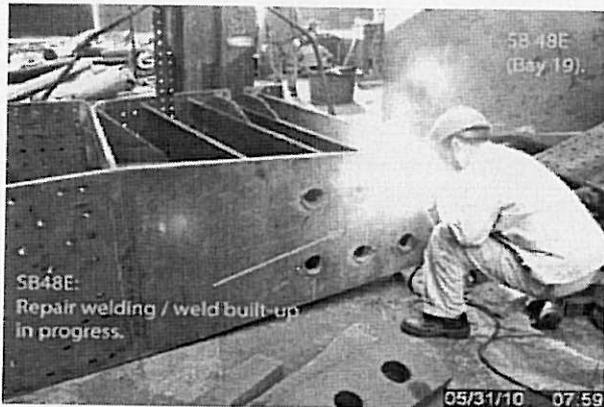
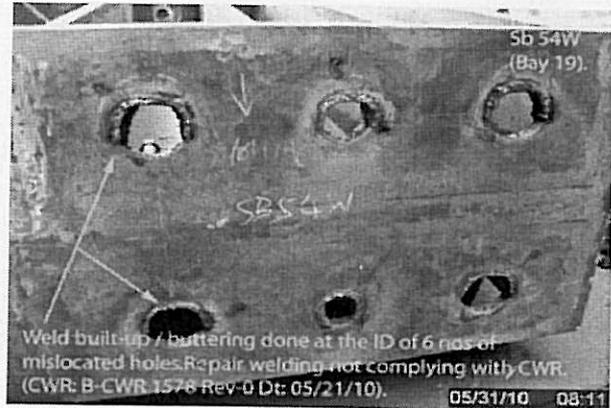
-ZPMC welding personnel performing base metal restoration of the mis-located suspender rod holes on suspender bracket identified as SB48E.

-The repairs did not comply with the approved Critical Welding Report (CWR): B-CWR1572 and B-CWR1578.

-ZPMC welder was buttering (build up with weld) the cross-sectional surface along the full circumference of the mis-drilled holes.

-This manner of repair appears to have been performed on all 6 suspender rod holes on the following suspender brackets: SB48E (Segment 7AE), SB48W (Segment 7AW), and SB54W (Segment 7CW).

This NCR pertains to a welding issue not a fit up issue. The repair was not performed in conformance with the approved CWRs. Corrective actions and preventive measures are required to close this NCR.

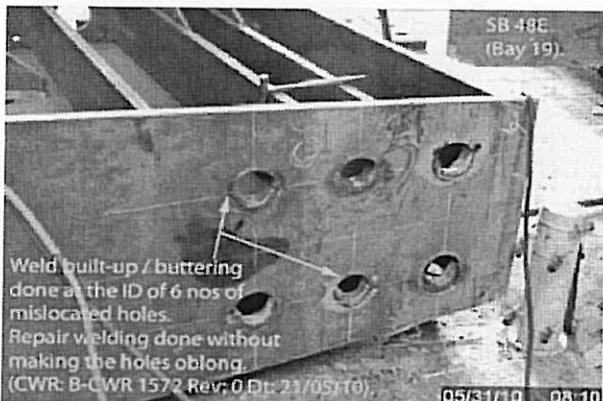
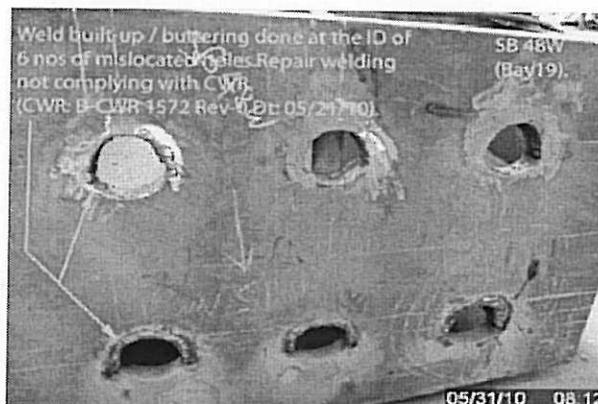
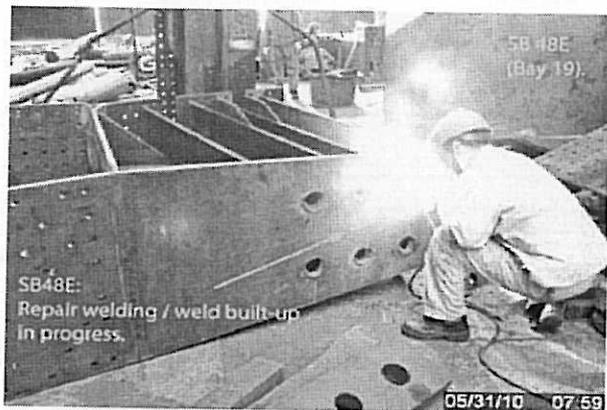
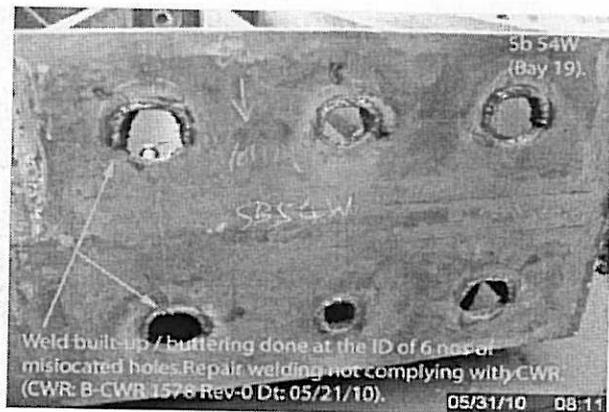
-ZPMC welding personnel performing base metal restoration of the mis-located suspender rod holes on suspender bracket identified as SB48E.

-The repairs did not comply with the approved Critical Welding Report (CWR): B-CWR1572 and B-CWR1578.

-ZPMC welder was buttering (build up with weld) the cross-sectional surface along the full circumference of the mis-drilled holes.

-This manner of repair appears to have been performed on all 6 suspender rod holes on the following suspender brackets: SB48E (Segment 7AE), SB48W (Segment 7AW), and SB54W (Segment 7CW).

**Reference Resolution:** ZPMC is submitting the NDT records to show that the welds are acceptable. Based on this, ZPMC requests closure of this NCR.

The proposed resolution is acceptable. This NCR is considered closed.
