Contract #: 04-0120F4Cty: SF/ALA Rte: 80 PM: 13.2/13.9File #: 69.25B**QUALITY ASSURANCE -- NON-CONFORMANCE REPORT****Location:** Changxing Island, Shanghai, P.R. China**Report No:** NCR-000754**Prime Contractor:** American Bridge/Fluor Enterprises, a JV**Date:** 02-Jun-2010**Submitting Contractor:** Zhenhua Port Machinery Company, Ltd (ZPMC), Changxing Island**NCR #:** ZPMC-0717**Type of problem:**

Reference Description: QA found 3 MT Indications after the contractor's had tested and accepted the welds for Segment 10CW Corner Assembly Diaphragm to Edge Plate Stiffener

Job Name: SAS Superstructure

Subject: NCR No. ZPMC-0717

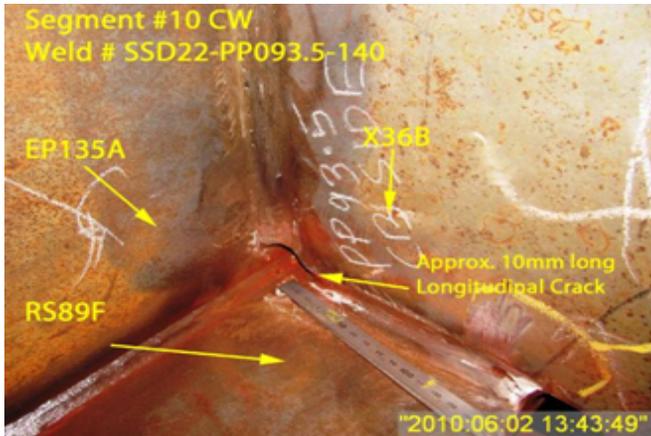
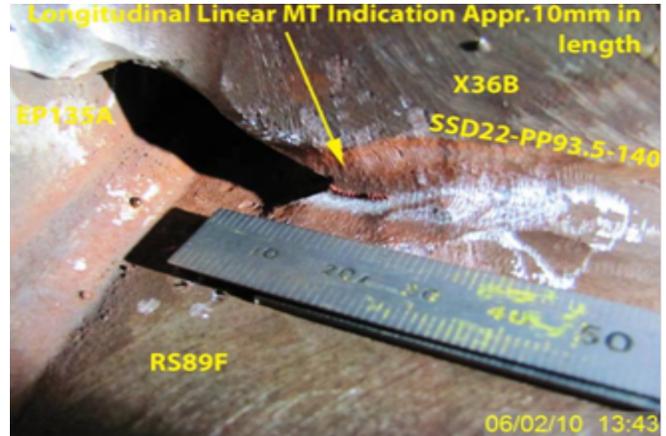
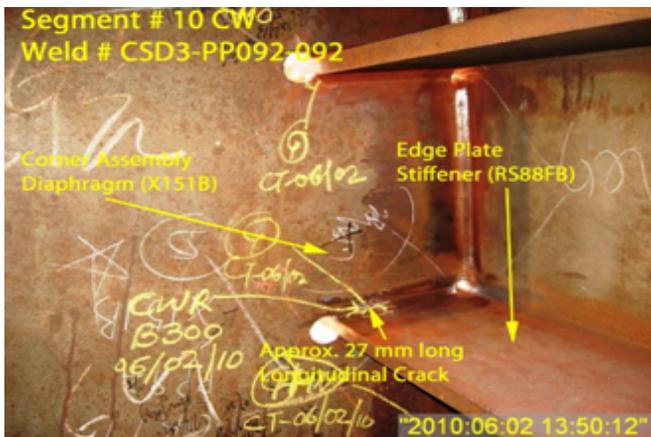
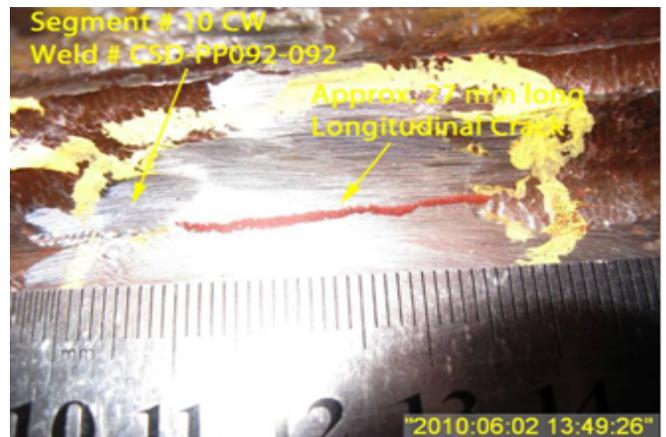
During the Quality Assurance (QA) Magnetic Particle Testing (MT) review of welds located on Segment 10CW, QA Inspectors discovered Three (3) Longitudinal Linear indications on the following welds:

- Weld #CSD3-PP092-092: One Longitudinal linear indication measuring approximately 27 mm in length.
- This weld is a Fillet Weld joining the Corner Assembly Diaphragm identified as X151B (SPCM) to Edge Plate Stiffener identified as RS88FB.
- The weld is designated as Seismic Performance Critical Material (SPCM).

- Weld #SSD22-PP093.5-140: One Longitudinal linear indication measuring approximately 12 mm in length.
- This weld is a Fillet Weld joining the Corner Assembly Diaphragm identified as X36B to Edge Plate Stiffener identified as RS89F.

- Weld #SSD22-PP093.5-144: One Longitudinal linear indication measuring approximately 9 mm in length.
- This weld is a Fillet Weld joining the Corner Assembly Diaphragm identified as X36B to Edge Plate Stiffener identified as RS89F.

- All indications are clearly marked on the material near the weld.
- OBG segment 10CW is located outside west of Bay#16.

The Notice of Witness Inspection Number (NWIT) is 005839. The indications are located within the area that has been previously tested and accepted by ZPMC Quality Control (QC) personnel.

Reference Resolution: ZPMC has repaired the indications and is providing NDT to show that the weld is acceptable. ZPMC has written and internal NCR.

ZPMC acknowledges the three indications were missed and is providing the NDT records show these indications have been removed, repaired and are now acceptable. Please be noticed the correct welds' ID are in attached NDT report. Based on this, please consider closure of this NCR.

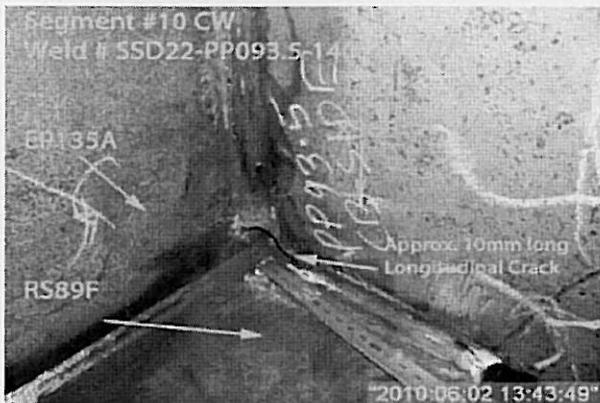
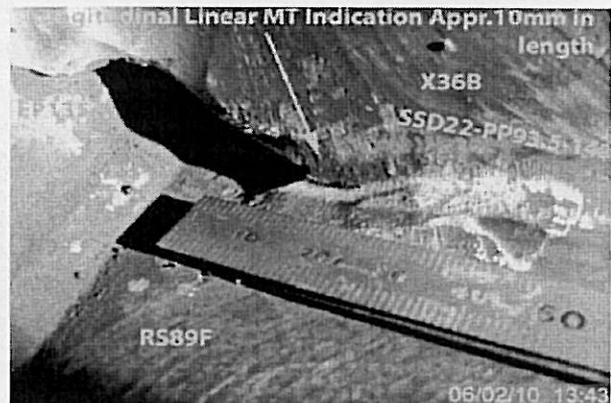
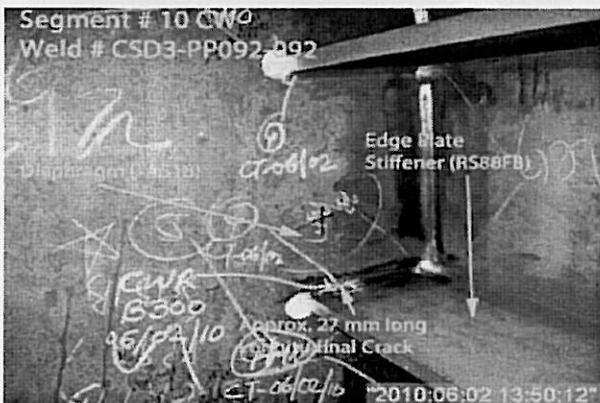
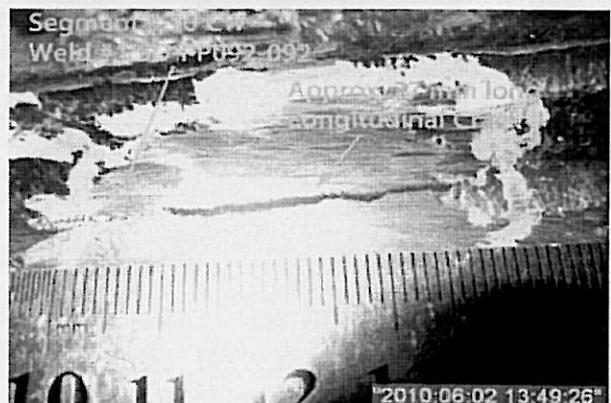
During the Quality Assurance (QA) Magnetic Particle Testing (MT) review of welds located on Segment 10CW, QA Inspectors discovered Three (3) Longitudinal Linear indications on the following welds:

-Weld #CSD3-PP092-092: One Longitudinal linear indication measuring approximately 27 mm in length.

-This weld is a Fillet Weld joining the Corner Assembly Diaphragm identified as X151B (SPCM) to Edge Plate Stiffener identified as RS88FB.

-Weld #SSD22-PP093.5-140: One Longitudinal linear indication measuring approximately 12 mm in length.

-Weld #SSD22-PP093.5-144: One Longitudinal linear indication measuring approximately 9 mm in length.

-All indications are clearly marked on the material near the weld.

Repair said indication and perform NDT required to verify weld quality.
