Contract #: 04-0120F4
 Cty: SF/ALA Rte: 80 PM: 13.2/13.9
 File #: 69.25B

QUALITY ASSURANCE -- NON-CONFORMANCE REPORT

Location: Changxing Island, Shanghai, P.R. China **Report No:** NCR-000758
Prime Contractor: American Bridge/Fluor Enterprises, a JV **Date:** 09-Jun-2010
Submitting Contractor: Zhenhua Port Machinery Company, Ltd (ZPMC), Changxing Island **NCR #:** ZPMC-0720

Reference Description: QC Missed (1) Transverse Indication found on weld number: FB3106-001-040 by QA

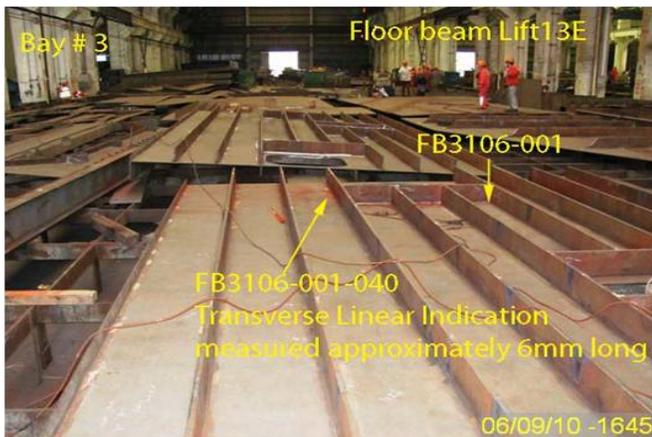
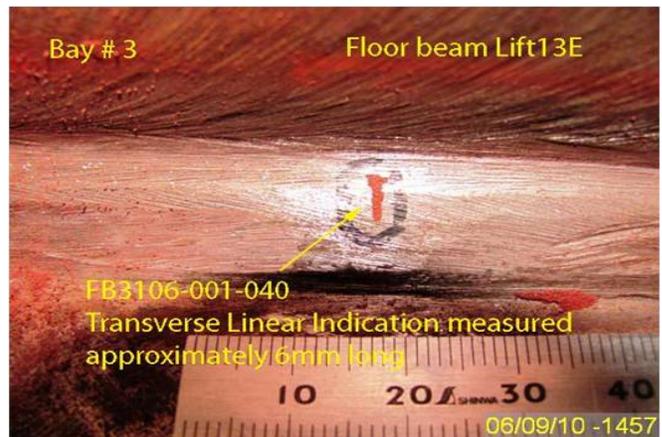
During the Quality Assurance (QA) Magnetic Particle Testing (MT) review of weld located on Floorbeam Sub Assembly FB3106A for 13AE, QA discovered the following issue:

- One (1) Transverse indication measuring approximately 6mm in length.
- The weld is a fillet T-joint joining the Stiffener to the floor beam web.
- The weld is identified as FB3106-001-040.
- The indication is clearly marked on the material near the weld.
- OBG Floor beam FB3106-001 is located in bay 3.

The Notice of Witness Inspection Number (NWIT) is 005939. The indication is located within an area that has been previously tested and accepted by ZPMC Quality Control (QC) personnel.

AWS D1.5 (02) Section 6.26.2 – "Welds that are subject to MT in addition to visual inspection shall have no cracks."

Reference Resolution: ZPMC has repaired the indication and is providing NDT to show that the weld is acceptable. . ZPMC has written and internal NCR.

Contractor supplied post repair NDT documentation verifying weld conforms with Contract weld quality requirements. An internal NCR was also issued by ZPMC in regards to this issue.

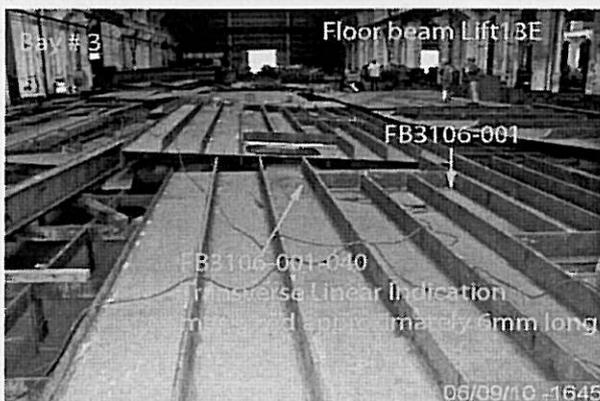
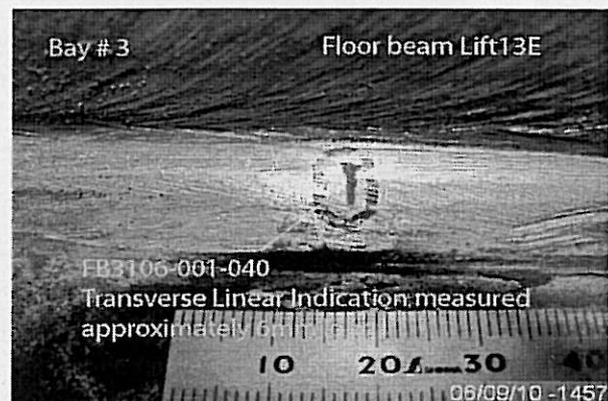
During the Quality Assurance (QA) Magnetic Particle Testing (MT) review of weld located on Floorbeam Sub Assembly FB3106A for 13AE, QA discovered the following issue:

- One (1) Transverse indication measuring approximately 6mm in length.
- The weld is a fillet T-joint joining the Stiffener to the floor beam web.
- The weld is identified as FB3106-001-040.
- The indication is clearly marked on the material near the weld.
- OBG Floor beam FB3106-001 is located in bay 3.

The Notice of Witness Inspection Number (NWIT) is 005939. The indication is located within an area that has been previously tested and accepted by ZPMC Quality Control (QC) personnel.

AWS D1.5 (02) Section 6.26.2 – "Welds that are subject to MT in addition to visual inspection shall have no cracks."

Repair said indication and perform NDT required to verify weld quality.
