Contract #: 04-0120F4Cty: SF/ALA Rte: 80 PM: 13.2/13.9File #: 69.25B**QUALITY ASSURANCE -- NON-CONFORMANCE REPORT****Location:** Changxing Island, Shanghai, P.R. China**Report No:** NCR-000761**Prime Contractor:** American Bridge/Fluor Enterprises, a JV**Date:** 10-Jun-2010**Submitting Contractor:** Zhenhua Port Machinery Company, Ltd (ZPMC), Changxing Island**NCR #:** ZPMC-0723**Type of problem:**

**Reference Description:** Repair Procedure not following WPS**Description of Non-Conformance:**

**Reference Description:** Repair Procedure not following WPS/Tower/ Base Shear Plate A25

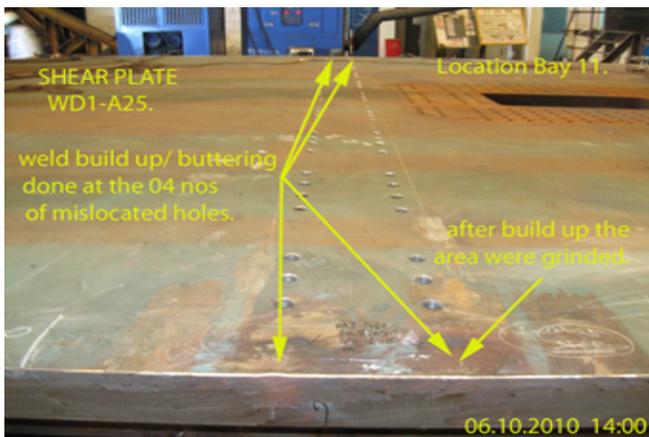
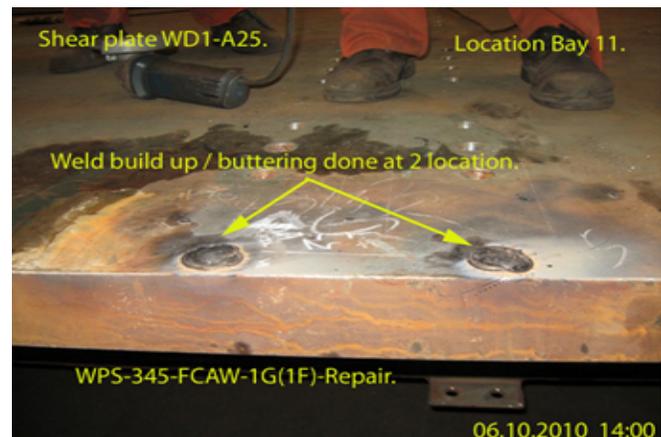
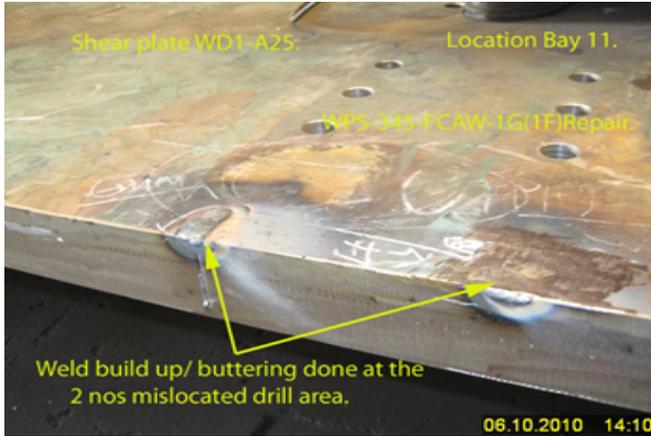
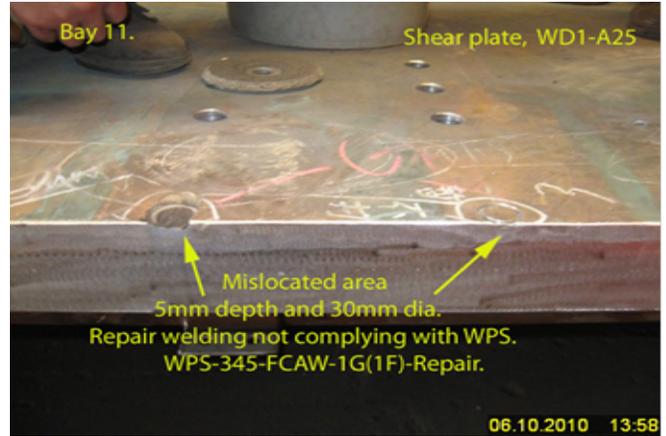
- During random visual inspection in Bay 11, this Quality Assurance Inspector discovered the following issues:
- ZPMC personnel performing Flux Core Arc Welding for base metal repair on mislocated holes on the surface of shear plate WD1-A25.
- ZPMC Quality Control (QC) presented WPS-345-FCAW-1G (1F)-Repair as applicable to repair.
- The repair welding completed without elongating the holes drill area as required by applicable WPS.
- This repair welding performed in the similar manner on four (4) holes of shear plate WD1-A25.
- Shear plate identified as WD1-A25.
- The members are located in Bay #11.

For further information, please see the attached pictures below.

**Reference Resolution:** ZPMC has repaired the base metal in accordance with the attached WPS and is providing the MT and UT to show that it is acceptable.

The material in question is actually TTP and not TM/SRM. ZPMC has repaired the base metal in accordance with the attached WPS and is providing the MT and UT to show that it is acceptable. Based on this ZPMC requests closure of this NCR.

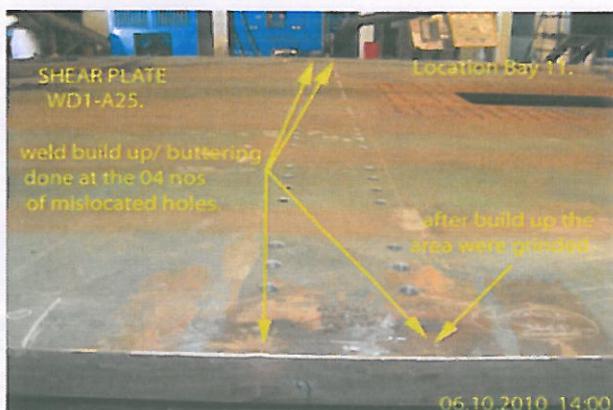
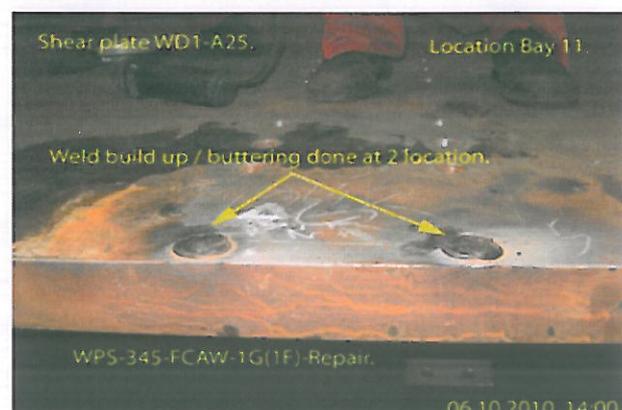
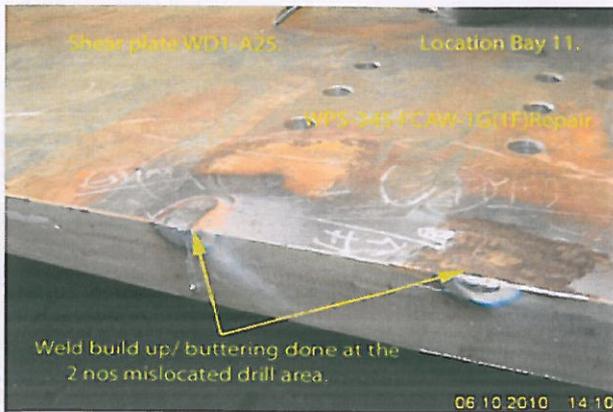
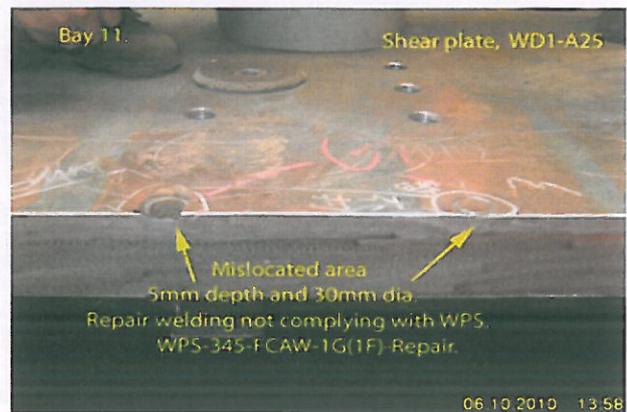
- ZPMC personnel performing Flux Core Arc Welding for base metal repair on mislocated holes on the surface of shear plate WD1-A25.

- The repair welding completed without elongating the holes drill area as required by applicable WPS.

- This repair welding performed in the similar manner on four (4) holes of shear plate WD1-A25.

For further information, please see the attached pictures below.

Repair Base Metal per approved WPS and perform MT and UT of required areas.

ZPMC has repaired the base metal, and received with the approved WPS. NDT documentation included 100% MT and UT. Verifying repaired welds are now in conformance with contract requirements. In addition, QCM held a meeting with ZPMC's QA Department to review this type of incident to prevent future occurrences.

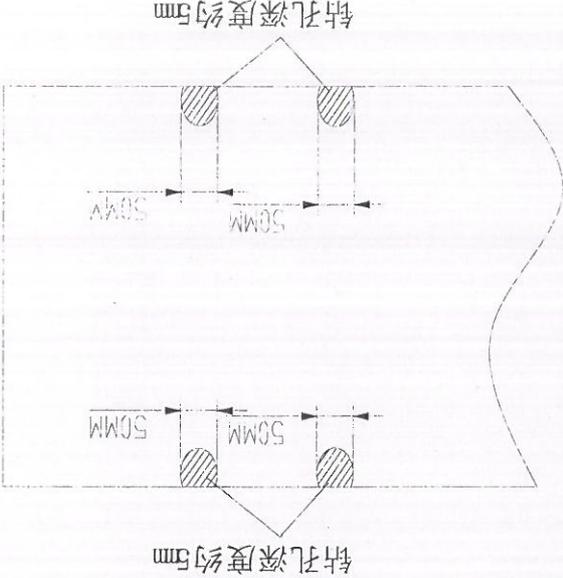
探伤位置图	Scheme showing the test part

注: 阴影部分为探伤区域
