Contract #: 04-0120F4
 Cty: SF/ALA Rte: 80 PM: 13.2/13.9
 File #: 69.25B

QUALITY ASSURANCE -- NON-CONFORMANCE REPORT

Report No: NCR-000762

Component: West Shaft 3 Skin C and D

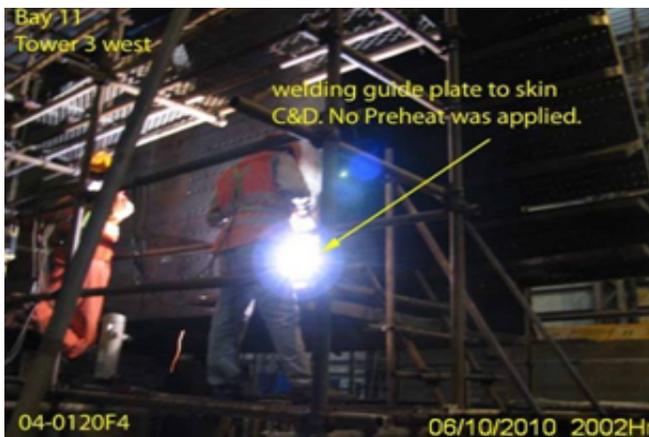
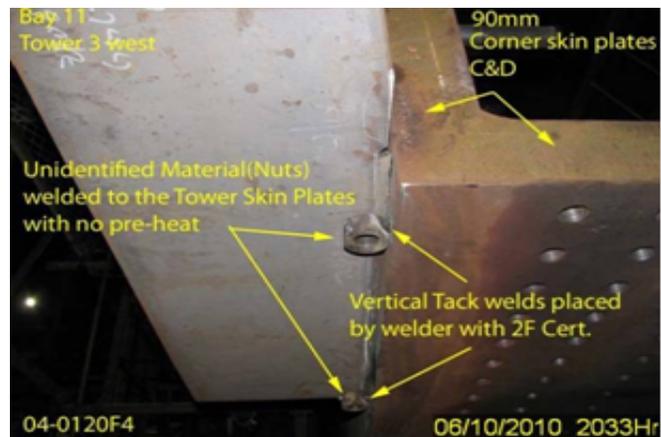
- ZPMC welding personnel performing tack welding without preheating.
- Tack welds were placed at the corner intersection of skin plates C & D.
- ZPMC Welding personnel identified as #048647 performed tack welding in the vertical position, which the welder was not qualified in.
- ZPMC has used unidentified material(nuts) for temporary attachments to the skin plates at corner C and D on tower 3 west.
- This QA inspector notified ZPMC CWI identified as Mr. Xu Lefeng and QC inspector identified as Mr. Zhao Mao Mao of this issue. Mr. Man Kan Hon of ABF was also present along with ZPMC QA Zhang Jiauli.

For further information, please see attach pictures below.

Minimum Pre heat for material over 60mm is 110 degrees C

A Tack welder shall be qualified by one fillet weld break specimen made in each position in which tack welds are to be made.

ZPMC has removed the unidentified material from the tower and has performed NDT of the material to show that the that base metal is acceptable. ZPMC QA and the production team leader have discussed this non conformance with the welder and reinforced the requirements of welding unidentified attachments onto the tower, to prevent future occurrences. ZPMC requests closure of this NCR.

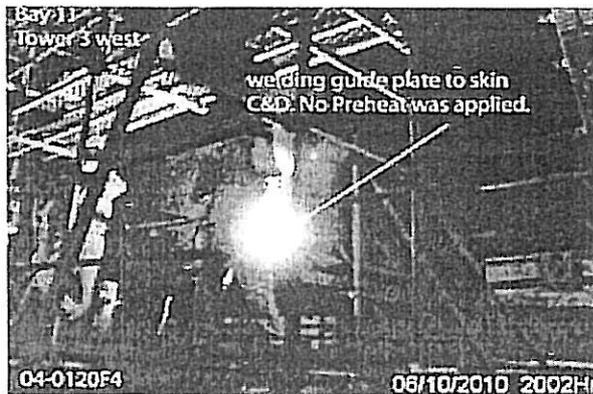
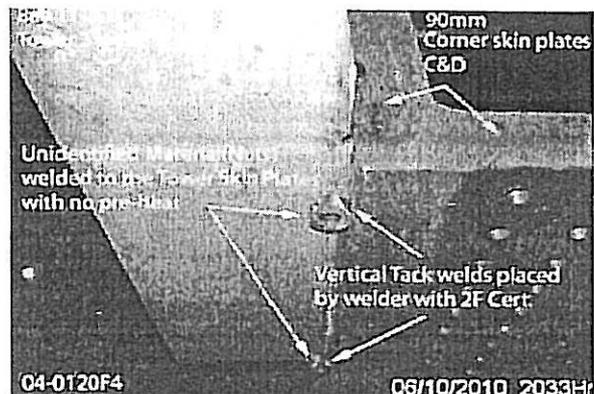
- ZPMC welding personnel performing tack welding without preheating.
- Tack welds were placed at the corner intersection of skin plates C & D.
- ZPMC Welding personnel identified as #048647 performed tack welding in the vertical position, which the welder was not qualified in.
- ZPMC has used unidentified material(nuts) for temporary attachments to the skin plates at corner C and D on tower 3 west.
- This QA inspector notified ZPMC CWI identified as Mr. Xu Lefeng and QC inspector identified as Mr. Zhao Mao Mao of this issue. Mr. Man Kan Hon of ABF was also present along with ZPMC QA Zhang Jiaili.

For further information, please see attach pictures below.

Minimum Pre heat for material over 60mm is 110 degrees C

A Tack welder shall be qualified by one fillet weld break specimen made in each position in which tack welds are to be made.

Contractor removed the unidentified attachment material, and performed the NDT on the base metal. NDT report showed the base metal is acceptable. ZPMC's QA with the Production Team leader discussed with the welder involved to reinforce the requirements and consequence of welding unidentified attachments on the tower.

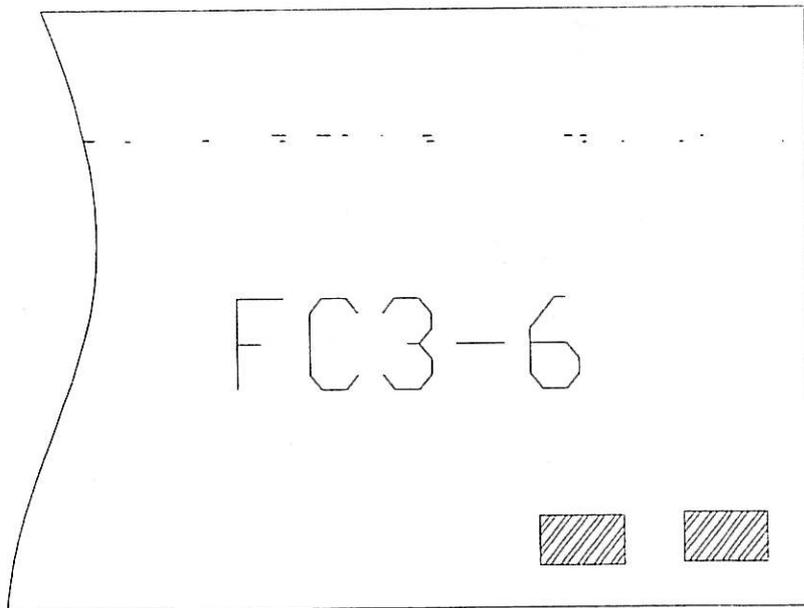
Scheme showing the test part

产品名称 Project Name		美国海湾大桥		探伤类别 NDT type	MT100%	数量 Quantity	1	
序号 No.	零部件图号 Drawing No.	零部件名称	件号 Item No.	数量 Quantity	板厚/尺寸 Thickness/Dime	炉批号 Batch No.	材料 Material	结论 Result
1	FC3-6	第三吊C面板	FC3-6	2	90*10*100	7300147N	A709M-345T2-Z	✓

注:阴影部分为探伤区域
