Contract #: 04-0120F4Cty: SF/ALA Rte: 80 PM: 13.2/13.9File #: 69.25B**QUALITY ASSURANCE -- NON-CONFORMANCE REPORT****Location:** Changxing Island, Shanghai, P.R. China**Report No:** NCR-000763**Prime Contractor:** American Bridge/Fluor Enterprises, a JV**Date:** 12-Jun-2010**Submitting Contractor:** Zhenhua Port Machinery Company, Ltd (ZPMC), Changxing Island**NCR #:** ZPMC-0725**Type of problem:**

Reference Description: Missed Indication on Diagonal Plate at North Shaft Lift 4**Description of Non-Conformance:**

Job Name: SAS Superstructure
Document No: 05.03.06-000720

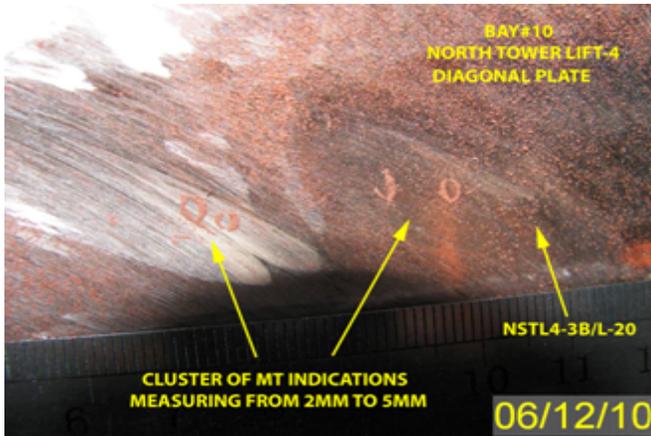
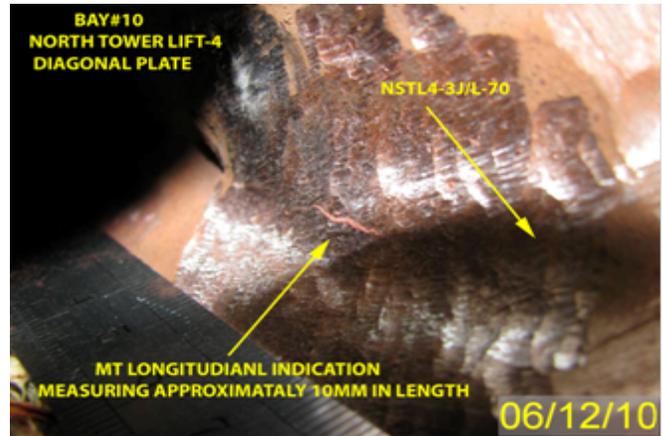
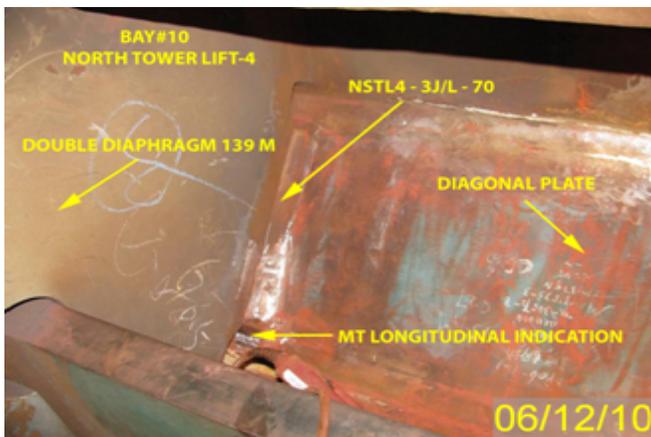
During Magnetic Particle Testing (MT) review of welds on Diagonal Plate, CD corner – North Tower Lift-4, this Quality Assurance Inspector discovered the following issues:

- Cluster of Transverse linear indications measuring approximately 2mm to 5mm in length.
- The member is identified as Diagonal Plate.
- The weld is identified as NSTL4 – 3B/L – 20.
- The weld is a Partial Joint Penetration (PJP) T-joint joining the Diagonal plate to Skin “C”.
- One (1) Longitudinal indication measuring approximately 10mm in length.
- The member is identified as Diagonal Plate.
- The weld is identified as NSTL4 – 3J/L – 70.
- The weld is a Partial Joint Penetration (PJP) T-joint joining the Diagonal plate to 139M Double diaphragm.
- The member is Non-Seismic Performance critical Member (SPCM).
- The member is located in TOWER Bay 10.

The Notice of Witness Inspection Number (NWIT) is 005962. The indication is located inside the area that has been previously tested and accepted by ZPMC Quality Control (QC) personnel. As per the contract documents,

ZPMC’s QC personnel are required to perform 100% MT inspection of these welds.

AWS D1.5 (02) Section 6.26.2 – “Welds that are subject to MT in addition to visual inspection shall have no cracks.

Reference Resolution: ZPMC has grinded the area to remove the indications and is submitting NDT after grinding to show that the indications have been removed.

Contractor repaired the defects noted by grinding. NDT documentation with acceptable results was provided for the Department. Contractor discussed the cause of the problem and ways of improvement with personnel to prevent future occurrences.
