QUALITY ASSURANCE -- NON-CONFORMANCE REPORT

Report No: NCR-000765

NCR #: ZPMC-0727

Reference Description: ZPMC performed weld removal of two SPCM welds without prior Engineer's approval or an approved CWR.

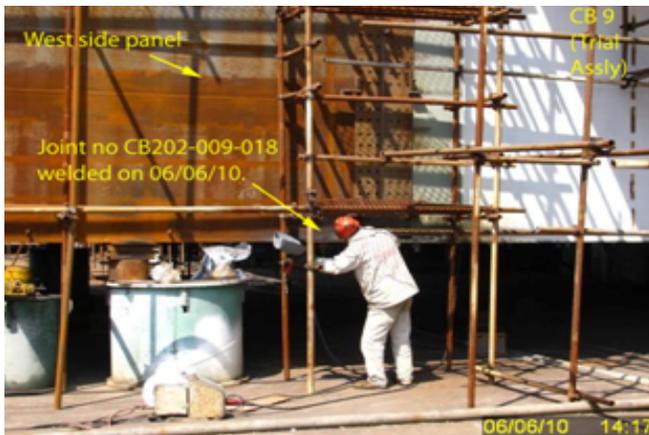
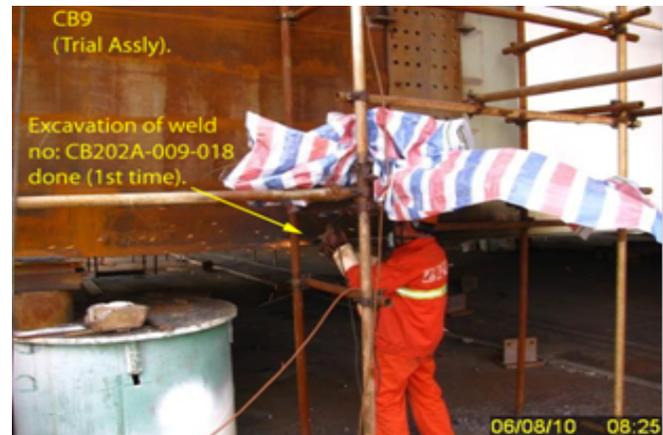
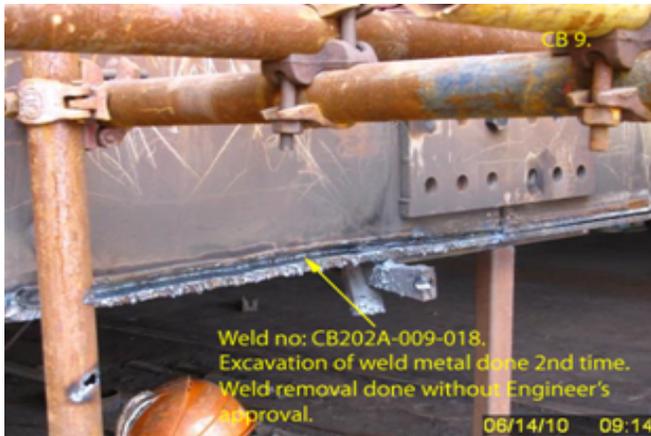
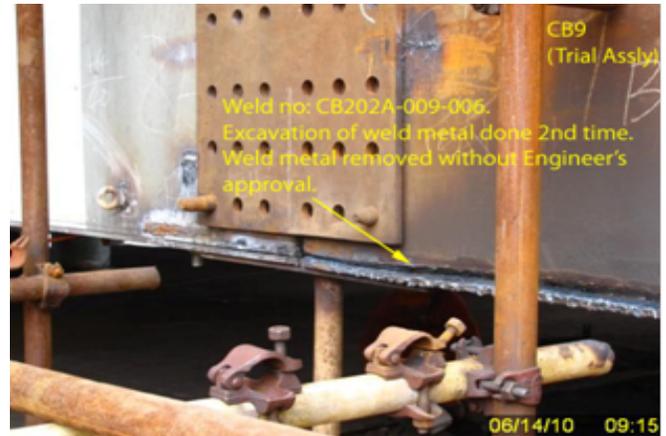
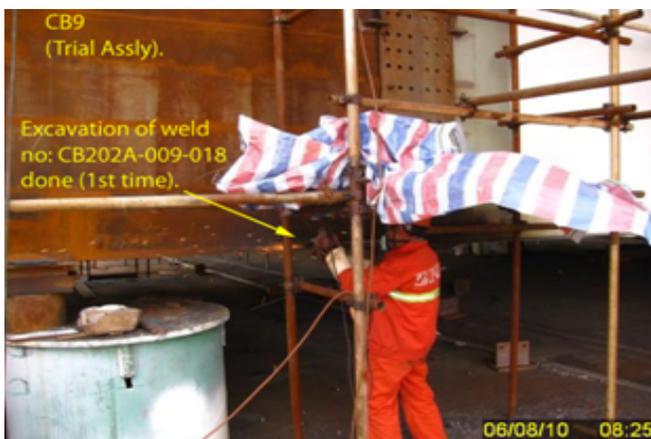
- On June 14, 2010, ZPMC performed the 2nd time removal of two Seismic Performance Critical Material (SPCM) weld joints identified as CB202A-009-018 & 006 without prior Engineer's approval or an approved Critical Weld Repair (CWR) Report.
- The welds are Complete Joint Penetration (CJP) joining the SPCM bottom panels to the SPCM side panels in CB9.
- The affected panels are identified as bottom panels BP205A and BP204A, side panels SP202A and SP205A. These members are identified as SPCM.
- Excavation length on these two welds was approximately 1 meter on each weld.
- Cross Beam 9 (CB9) is located in the Trial Assembly.

-Section 12.17: Repair welding shall be defined as any welding, including removal of weld or base metal in preparation for welding, necessary to correct unacceptable discontinuities in materials or workmanship.

-Section 12.17.3: Critical Weld Repairs. Except as provided in 12.17.2, all welded repairs shall be considered critical. They include, but are not limited to the following:

(5) Corrections requiring weld removal and rewelding except as provided in 12.17.2(4).

(6) All welding to correct errors in fabrication such as improper cutting, punching, drilling, machining, assembly, etc.

-Section 12.17.4: Approval. All critical repairs to base metal and welds shall be approved by the Engineer prior to beginning the repair and shall be documented giving details of the type of discontinuity and extent of repair.

Propose a resolution for the identified non-conformance with revised procedures to prevent future occurrences. A response for the resolution of this issue is expected within 7 days.

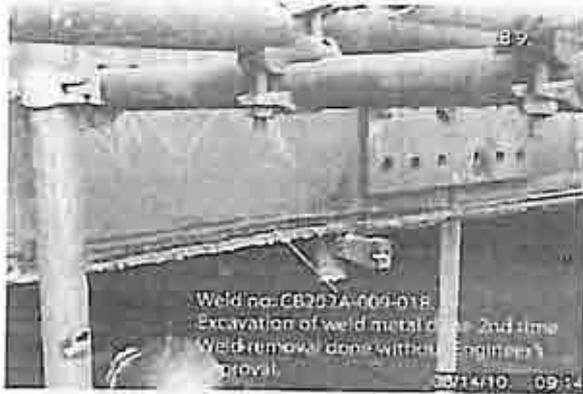
-On June 14, 2010, ZPMC performed the 2nd time removal of two Seismic Performance Critical Material (SPCM) weld joints identified as CB202A-009-018 & 006 without prior Engineer's approval or an approved Critical Weld Repair (CWR) Report.

-The welds are Complete Joint Penetration (CJP) joining the SPCM bottom panels to the SPCM side panels in CB9.

-The affected panels are identified as bottom panels BP205A and BP204A, side panels SP202A and SP205A. These members are identified as SPCM.

-Excavation length on these two welds was approximately 1 meter on each weld.

-Section 12.17: Repair welding shall be defined as any welding, including removal of weld or base metal in preparation for welding, necessary to correct unacceptable discontinuities in materials or workmanship.

-Section 12.17.3: Critical Weld Repairs. Except as provided in 12.17.2, all welded repairs shall be considered critical. They include, but are not limited to the following:

- (5) Corrections requiring weld removal and rewelding except as provided in 12.17.2(4).
- (6) All welding to correct errors in fabrication such as improper cutting, punching, drilling, machining, assembly, etc.

-Section 12.17.4: Approval. All critical repairs to base metal and welds shall be approved by the Engineer prior to beginning the repair and shall be documented giving details of the type of discontinuity and extent of repair.

The Contractor has submitted the appropriate form for changing weld joint type along with the required CWR and applicable NDT documentation verifying weld meets Contract weld quality requirements.

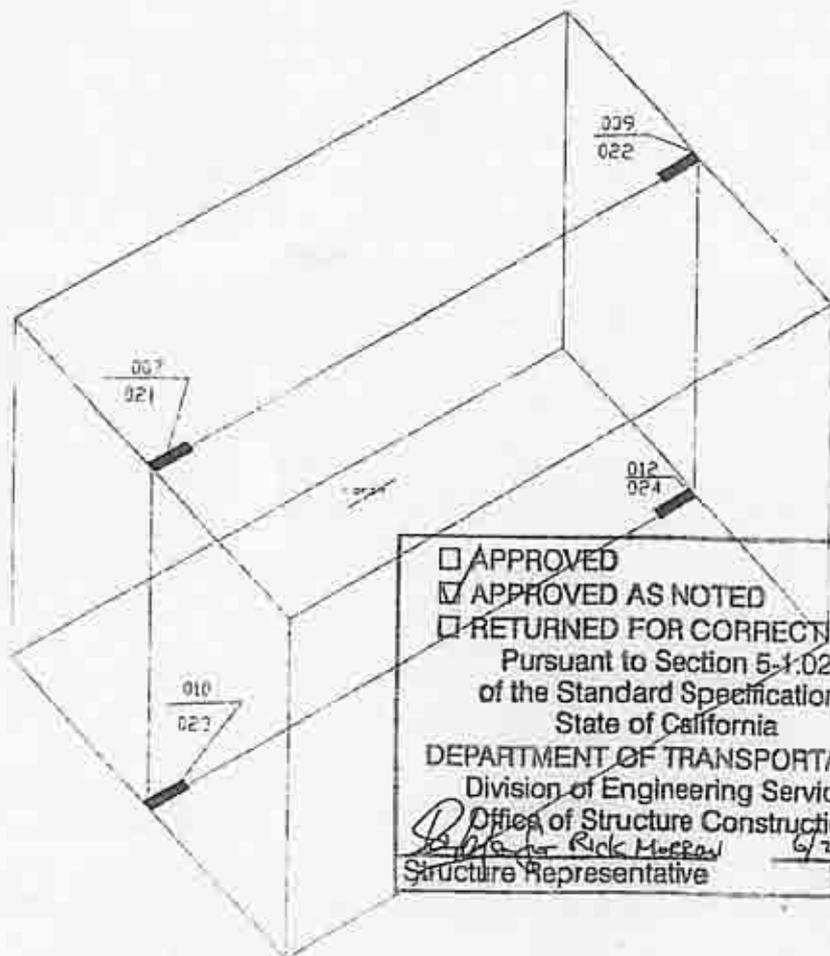
焊缝返修位置示意图

CB9中隔板土角焊缝错误碳刨，角焊缝需改为CJP焊缝 具体为CB202A-009-007/021,009/022,010/023,012/024分别改为CB202A-009-007,009,010,012。
 For CB9 corner weld gouging error, filler shall be changed to CJP weld, the welds (CB202A-009-007/021,009/022,010/023,012/024) revised to CB202A-009-007,009,010,012

Worker didn't review weld ID carefully before gouging caused error

1. QC和CWI在整个修补过程中都应在场并指导以确保返修按照处理意见以及AWS D1.5要求进行;
 2. 准备一个正确的接头形式;
 3. 在返修前对返修区域作100%VT检查以确认无缺陷存在;
 4. 如果发现有缺陷,通过打磨的方法去除所有缺陷以确认缺陷完全被消除,并重复第三步以确认缺陷完全被消除;
 5. 根据批准的焊接返修工艺规程(WPS)进行预热及焊接;
 6. 焊后将焊接区域打磨至与母材光滑平齐;
 7. 对返修区域作NDT检查(UT,MT和VT);
-
1. QC and CWI should be present to witness the repair, direct and supervise all repair operations during this repair to ensure the repair is per the disposition requirements, and the AWS D1.5 code requirements.
 2. Prepare the joint according to the approved WPS.
 3. Perform 100%VT of the repair area to ensure no defects exist.
 4. Remove all defects by grinding to ensure all defects are completely removed if defects exist, and repeat "step 3" to assure complete removal of all defects if necessary.
 5. Preheat and weld according to the approved WPS.
 6. Grind the weld flush after welding.
 7. Perform relevant NDT (UT, MT and VT) to the repair area.

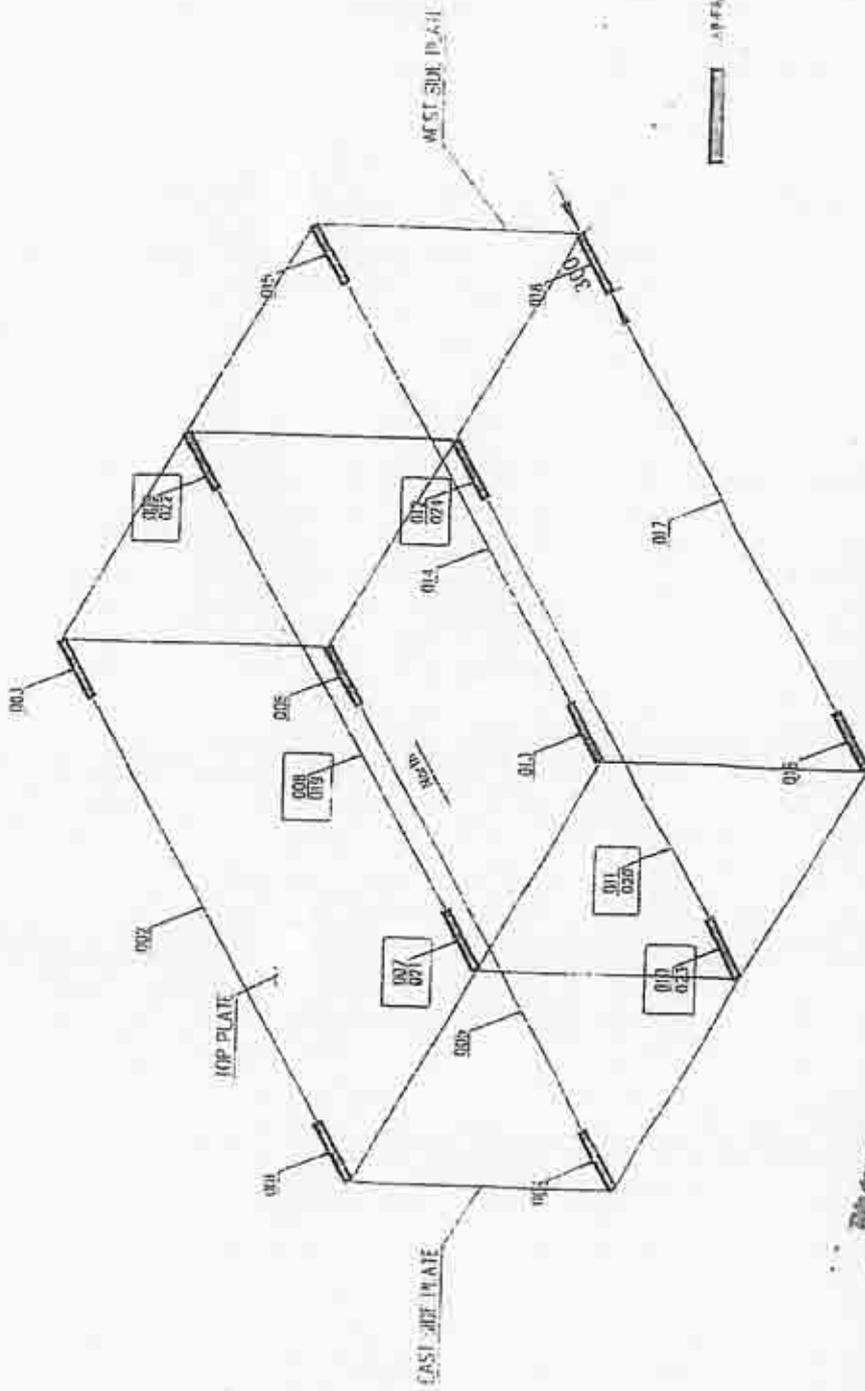
CROSSBEAM ASSEMBLY DIAGRAM

Weld ID#: LP200A-B209 107/021, 509/022, 010/023, 012/024

Engineer's Approval: Yes/No Reviewed by: ET Date: 2010.6.15 Time: 16:00
 Comments: CWR is required.
