Contract #: 04-0120F4Cty: SF/ALA Rte: 80 PM: 13.2/13.9File #: 69.25B**QUALITY ASSURANCE -- NON-CONFORMANCE REPORT****Location:** Changxing Island, Shanghai, P.R. China**Report No:** NCR-000766**Prime Contractor:** American Bridge/Fluor Enterprises, a JV**Date:** 14-Jun-2010**Submitting Contractor:** Zhenhua Port Machinery Company, Ltd (ZPMC), Changxing Island**NCR #:** ZPMC-0728**Type of problem:**

**Reference Description:** QA found an UT Indication after the contractor's had tested and accepted a weld for an Edge Plate to Stiffener weld in Segment 8CE

# QUALITY ASSURANCE -- NON-CONFORMANCE REPORT

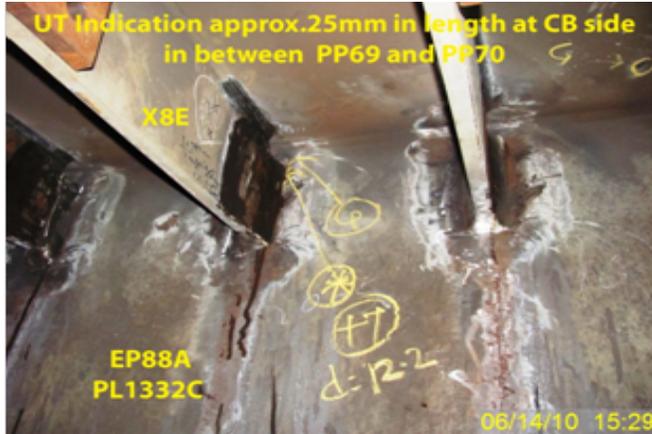
During the Quality Assurance (QA) Ultrasonic Testing (UT) review of welds located on Orthotropic Box Girder (OBG) segment 8CE, this QA Inspector discovered the following issues:

- One (1) longitudinal linear indication measuring approximately 25mm in length in the Complete Joint Penetration (CJP) "T" joint, joining Edge Plate EP88A (SPCM) to the under deck stiffener X8E.

- The indication D rating is +7.
- Material thickness is 25mm.
- The depth of the indication is approximately 13mm.
- The weld is identified as SEG048J-110 and is between panel point 69 and 70.

- The weld is designated as Seismic Performance Critical Material (SPCM).
- The indication is clearly marked near the weld.
- The Y distance for this indication was measured to be 5mm from the cope hole at the deck.

- Segment 8CE is located at Trial Assembly Yard.
- The Notice of Witness Inspection (NWIT) No. is 005977. The indication is located Within an area previously tested and accepted by ZPMC Quality Control (QC) personnel. As per the contract documents, ZPMC's QC personnel are required to perform hundred (100%) percent UT inspection of this weld.

AWS D1.5-02 Section 6; Table 6.3 specifies a class “A” indication as having a rating of 8db and under for material thicknesses 21mm through 38mm.

**Reference Resolution:** ZPMC has removed and repaired the indication and is providing NDT documentation to show the weld is acceptable.

ZPMC has removed and repaired the indication and is providing NDT documentation to show the weld is acceptable. ABFJV has discussed this letter of response with and ZPMC will adhere to the relevant inspection criteria when performing NDT and not add 2dB to the inspection criteria. To prevent future missed indications ZPMC will verify any indications which are on the border of being rejectable. Based on this documentation, ZPMC requests closure of this NCR.
