Contract #: 04-0120F4Cty: SF/ALA Rte: 80 PM: 13.2/13.9File #: 69.25B**QUALITY ASSURANCE -- NON-CONFORMANCE REPORT****Location:** Changxing Island, Shanghai, P.R. China**Report No:** NCR-000767**Prime Contractor:** American Bridge/Fluor Enterprises, a JV**Date:** 15-Jun-2010**Submitting Contractor:** Zhenhua Port Machinery Company, Ltd (ZPMC), Changxing Island**NCR #:** ZPMC-0729**Type of problem:**

Reference Description: QC absence of 1 hour inside OBG Segments 8AE, 8AW, and Crossbeam 9**Description of Non-Conformance:**

Dear: Mr. Charles Kanapicki
Job Name: SAS Superstructure

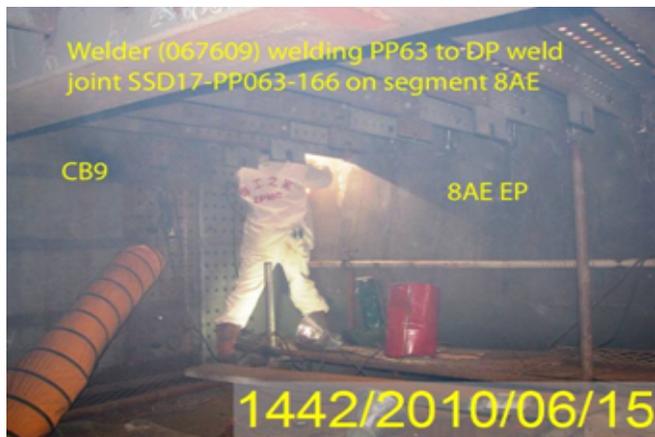
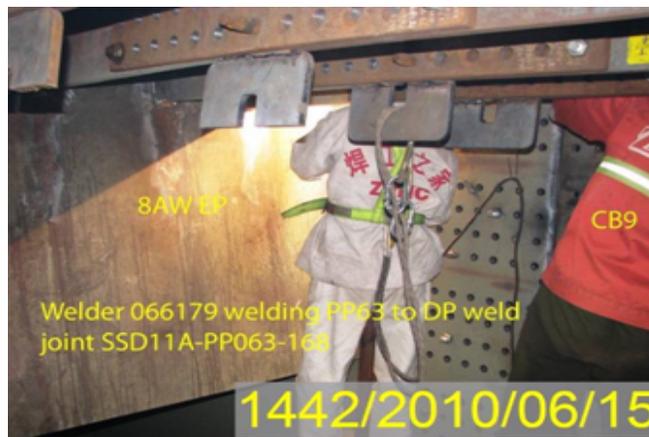
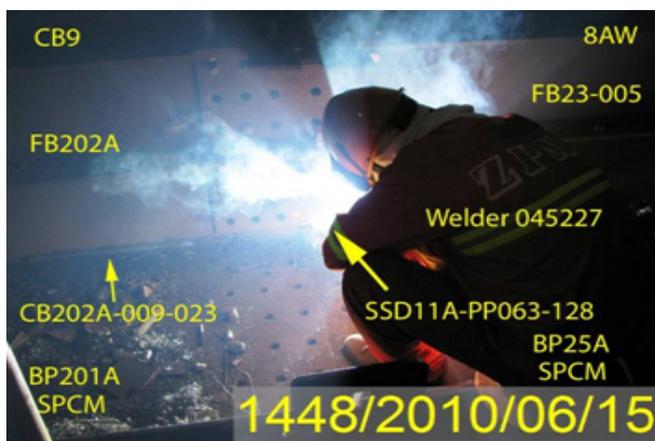
Three (3) ZPMC welders performed welding at the locations noted below without the presence of QC personnel over a duration of 1 hour (approximately 14:00-15:00 Hours). This time frame exceeds the allowable maximum time for QC Inspection coverage as required by Caltrans Special Provision Section 8-3.01.

- Welding was performed on Panel Point 63 to Deck Plate weld joint (Segment 8AW Interior).
- The weld is identified as SSD11A-PP063-168, Non-SPCM
- The weld is a Complete Joint Penetration (CJP).

- Welding was performed on Panel Point 63 to Deck Plate weld joint (Segment 8AE Interior).
- The weld is identified as SSD11A-PP063-166, Non-SPCM
- The weld is a Complete Joint Penetration (CJP).

- Welding was performed on Bottom Plate at Crossbeam CB 9 (interior).
- Bottom plate on CB is identified as BP201; horizontal plate on CB is identified as FB202A
- The welds are identified as CB202A-009-010/023, SPCM
- The weld is a Complete Joint Penetration (CJP).

No QC is available to provide the welding procedure specification (WPS) corresponding to the performed work.

Also, no posted WPS is available in the area. This QA Inspector notified ZPMC personnel that QC is needed in the area. No QC personnel were available in locations noted above prior to 15:00 hours. Subsequently, QA saw a ZPMC QC personnel Li Jia was sitting outside of the Segment 8AE (Bikepath side) while leaving the area.

Propose a resolution for the identified non-conformance with revised procedures to prevent future occurrences. A response for the resolution of this issue is expected within 7 days.
