Contract #: 04-0120F4
 Cty: SF/ALA Rte: 80 PM: 13.2/13.9
 File #: 69.25B

QUALITY ASSURANCE -- NON-CONFORMANCE REPORT

Report No: NCR-000768

Job Name: SAS Superstructure
Document No: 05.03.06-000726

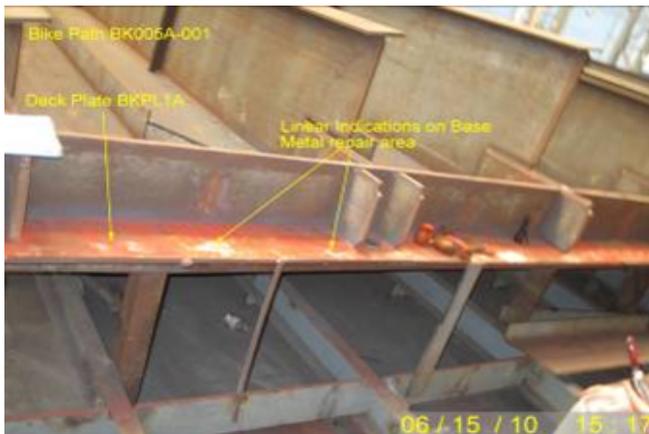
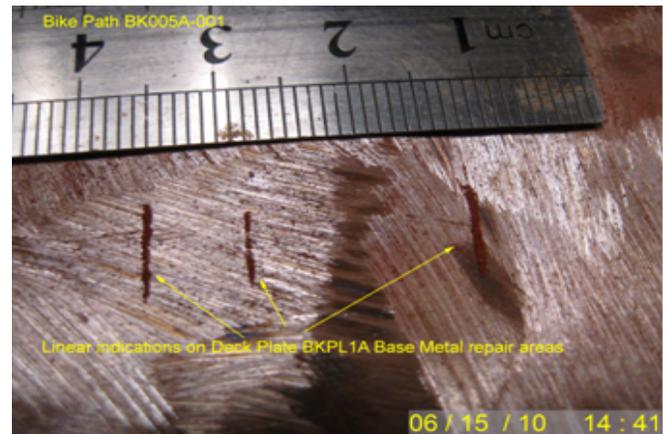
Reference Description: QA found 12 linear indications on the base metal of the Bikepath Top Plate after the contractor's had tested and accepted the repairs

- Twelve (12) linear indications measured approximately 5mm to 11mm in length.
- Indications are found on the Bikepath Top Plate Base Metal Repair Areas at Y locations 810mm, 890mm, 1130mm, 1450mm, 1830mm, 1940mm, and 2160mm measured from the Edge Plate side.
- The Bikepath Top Plate is identified as BKPL1A.
- The Bikepath Top Plate is designated on the contract drawings as a Non Seismic Performance Critical Member (Non SPCM).
- The indications are marked clearly on the Bikepath Top Plate.
- Bike Path BK005A-001 is located in the Fabrication Bay 19.
- The Notice of Witness Inspection (NWIT) Number is 005985. The indication was found within the area previously tested and accepted by ZPMC QC personnel.

NCR has been rescinded as Contractor elected to rescind notification after initial cracks were discovered.

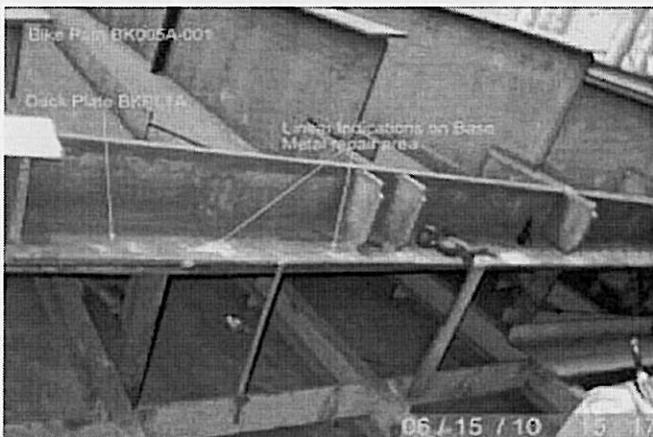
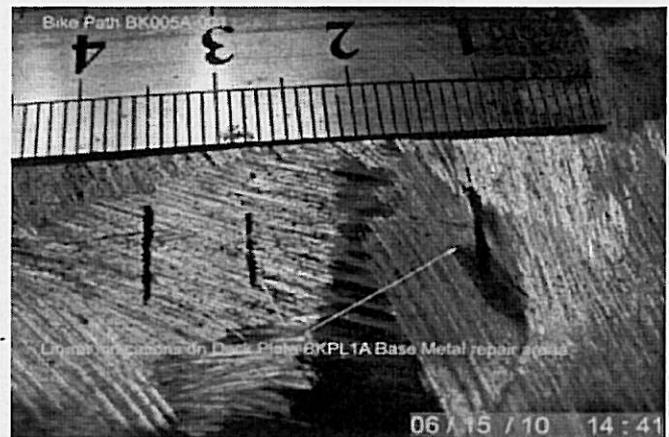
Reference Description: QA found 12 linear indications on the base metal of the Bikepath Top Plate after the contractor's had tested and accepted the repairs

- Twelve (12) linear indications measured approximately 5mm to 11mm in length.
- Indications are found on the Bikepath Top Plate Base Metal Repair Areas at Y locations 810mm, 890mm, 1130mm, 1450mm, 1830mm, 1940mm, and 2160mm measured from the Edge Plate side.
- The Bikepath Top Plate is identified as BKPL1A.
- The Bikepath Top Plate is designated on the contract drawings as a Non Seismic Performance Critical Member (Non SPCM).
- The indications are marked clearly on the Bikepath Top Plate.
- Bike Path BK005A-001 is located in the Fabrication Bay 19.
- The Notice of Witness Inspection (NWIT) Number is 005985. The indication was found within the area previously tested and accepted by ZPMC QC personnel.
