Contract #: 04-0120F4Cty: SF/ALA Rte: 80 PM: 13.2/13.9File #: 69.25B**QUALITY ASSURANCE -- NON-CONFORMANCE REPORT****Location:** Changxing Island, Shanghai, China**Report No:** NCR-000771**Prime Contractor:** American Bridge/Fluor Enterprises, a JV**Date:** 21-Jun-2010**Submitting Contractor:** Zhenhua Port Machinery Company, Ltd (ZPMC), Changxing Island**NCR #:** ZPMC-0733**Type of problem:**

<b>Welding</b>	<b>Concrete</b>	<b>Other</b>	
<b>Welding</b>	<b>Curing</b>	<b>Procedural</b>	<b>Bridge No:</b> 34-0006
<b>Joint fit-up</b>	<b>Coating</b>	<b>Other</b>	<b>Component:</b> FB3121A Floorbeam Lift 13E
<b>Procedural</b>	<b>Procedural</b>	<b>Description:</b>

**Reference Description:** Weld Removal on SPCM Welds without Engineer's Approval**Description of Non-Conformance:**

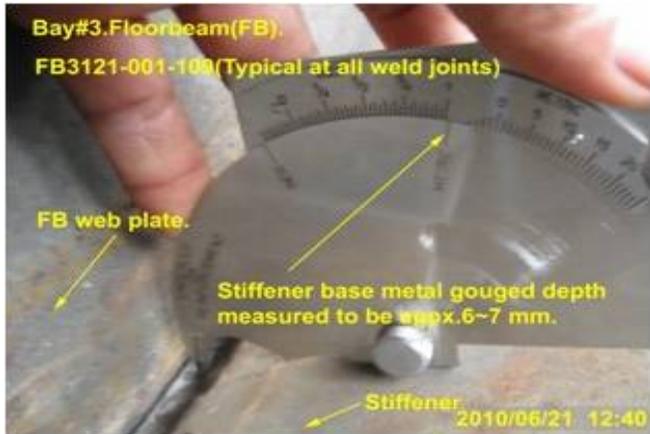
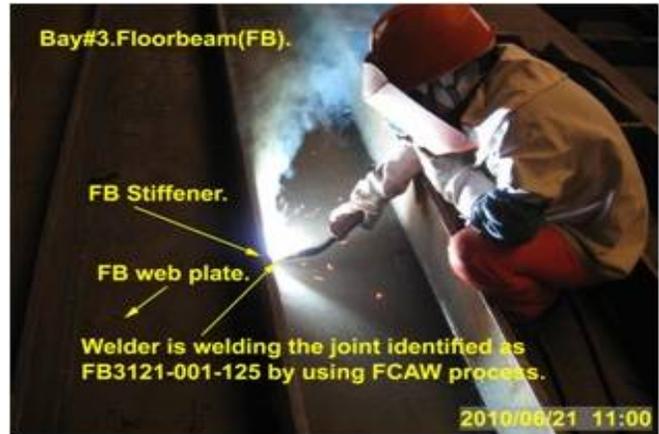
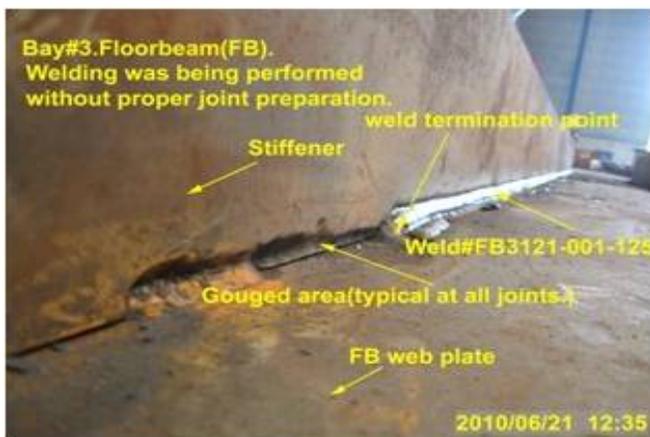
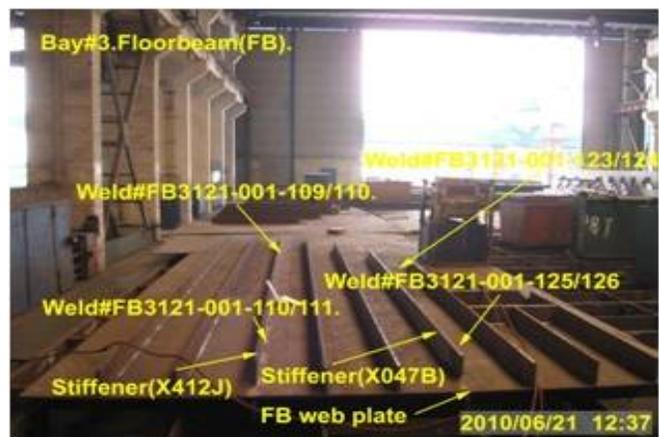
During the Quality Assurance (QA) random in process observations of the fabrication of Orthotropic Box Girder (OBG) Floor beam FB3121A, this QA Inspector discovered the following issues:

- ZPMC removed Seismic Performance Critical Material (SPCM) welds without Engineers approval as required per American Weld Society (AWS) D1.5 2002 section 12.17.3.

- The weld joints are identified as FB3121-001-108, 109, 123 and 124.
- The welds are fillet weld T-joints joining 2 of the stiffeners to the SPCM areas of floor beam FB3121A.

- SPCM web plates are identified as X3406A and X3405A.
- The stiffeners are identified as X3412J and X7047B.
- Additionally this QA Inspector observed ZPMC has refit the two stiffeners and commenced re-welding them to the web plates of this floor beam without properly preparing the weld joints.

- Base metal that was removed from the edges of the stiffeners during the gouging operation has not been repaired and cleaned prior to re-fitting and welding.

- This QA measured the depth of the gouged areas of the edges of the stiffeners to be approximately 6mm.
- OBG FB3121-001 is located in Bay#3.

AWS D1.5 2002 section 3.2.1; "Surfaces and edges to be welded shall be smooth, uniform and free from fins, tears, cracks, and other discontinuities which would adversely affect the quality or strength of the weld."

AWS D1.5 2002 section 3.2.6\_...Where any air carbon arc gouging or cutting is involved, proper arc gouging procedures shall be used to avoid the retention of carbon deposits and material or dross in the areas which are to be welded. Air carbon arc gouged surfaces shall be ground to bright metal.

Section;12.17.4\_All critical repairs to base metal and welds shall be approved by the Engineer prior to beginning the repair and shall be documented giving details of the type of discontinuity and extent of repair.

Perform repairs and subsequent NDT required to verify material quality.

Contractor submitted post repair NDT verifying base metal repairs and replacement welds meet Contract weld quality requirements.

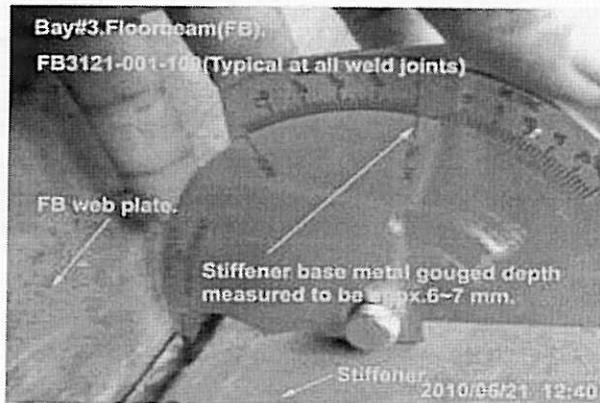
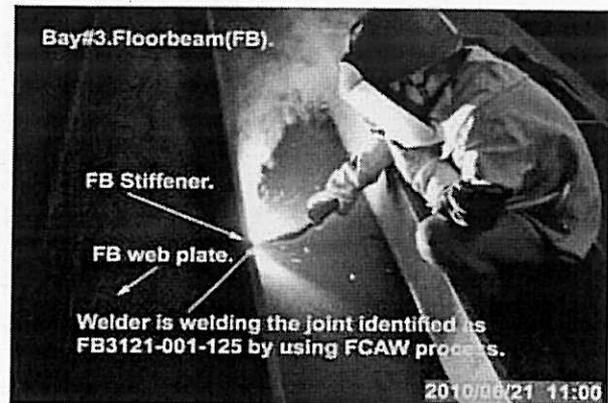
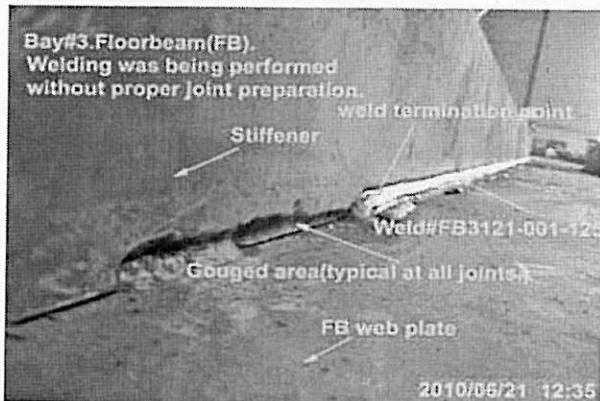
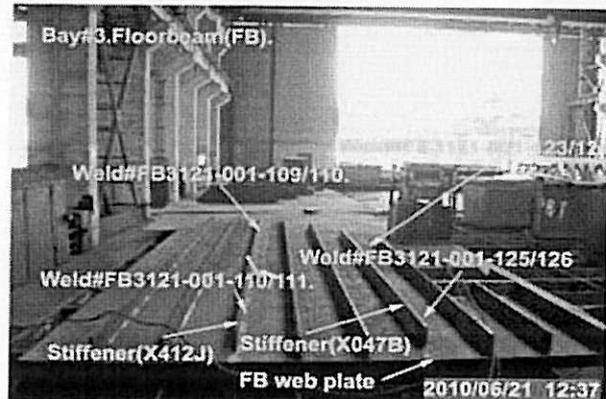
During the Quality Assurance (QA) random in process observations of the fabrication of Orthotropic Box Girder (OBG) Floor beam FB3121A, this QA Inspector discovered the following issues:

- ZPMC removed Seismic Performance Critical Material (SPCM) welds without Engineers approval as required per American Weld Society (AWS) D1.5 2002 section 12.17.3.

- The weld joints are identified as FB3121-001-108, 109, 123 and 124.
- The welds are fillet weld T-joints joining 2 of the stiffeners to the SPCM areas of floor beam FB3121A.

- SPCM web plates are identified as X3406A and X3405A.
- The stiffeners are identified as X3412J and X7047B.
- Additionally this QA Inspector observed ZPMC has refit the two stiffeners and commenced re-welding them to the web plates of this floor beam without properly preparing the weld joints.

- Base metal that was removed from the edges of the stiffeners during the gouging operation has not been repaired and cleaned prior to re-fitting and welding.

- This QA measured the depth of the gouged areas of the edges of the stiffeners to be approximately 6mm.
- OBG FB3121-001 is located in Bay#3.

AWS D1.5 2002 section 3.2.1; "Surfaces and edges to be welded shall be smooth, uniform and free from fins, tears, cracks, and other discontinuities which would adversely affect the quality or strength of the weld."

AWS D1.5 2002 section 3.2.6...Where any air carbon arc gouging or cutting is involved, proper arc gouging procedures shall be used to avoid the retention of carbon deposits and material or dross in the areas which are to be welded. Air carbon arc gouged surfaces shall be ground to bright metal.

Section;12.17.4 All critical repairs to base metal and welds shall be approved by the Engineer prior to beginning the repair and shall be documented giving details of the type of discontinuity and extent of repair.
