Contract #: 04-0120F4  
 Cty: SF/ALA Rte: 80 PM: 13.2/13.9  
 File #: 69.25B

## QUALITY ASSURANCE -- NON-CONFORMANCE REPORT

**Report No:** NCR-000772

**Reference Description:** ZPMC performed weld removal of two SPCM welds without prior Engineer's approval or an approved CWR

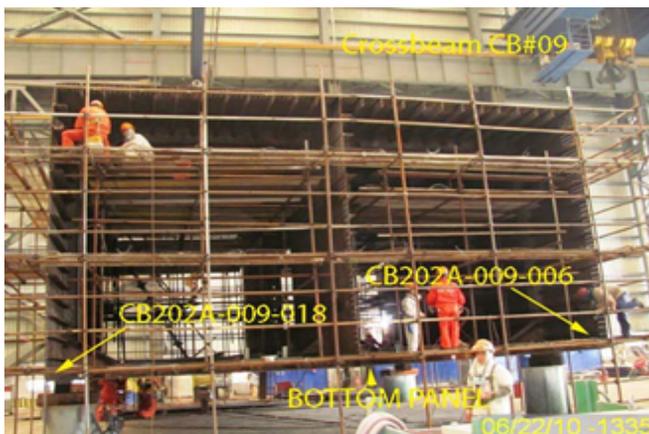
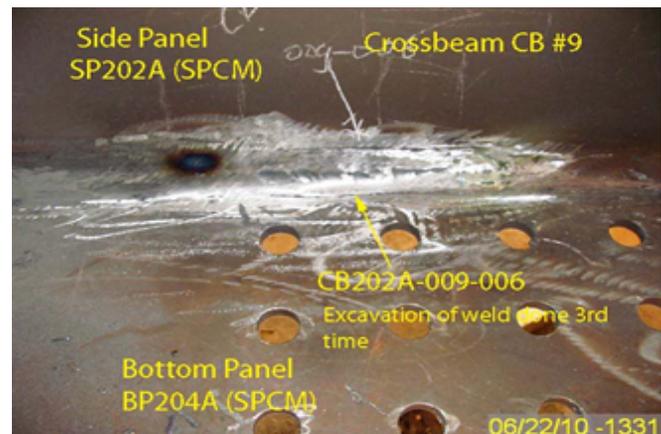
-ZPMC performed 3rd time excavation of Seismic Performance Critical Material (SPCM) welds identified as CB202A-009-018 & 006 without prior Engineer's approval or an approved Critical Weld Repair for this 3rd time repair.

-The welds are Complete Joint Penetration (CJP) joining the SPCM bottom panels to the SPCM side panels.

-The affected panels are identified as bottom panels BP205A and BP204A, Side panels SP202A and SP205A. All are identified as SPCM.

-These welds were previously removed and re-welded on 06/08/10 and 06/14/10 for the purpose of aligning the bottom panel of the crossbeam to the FL3 bottom panel of Orthotropic Box Girder (OBG) Segment 8AE.

-Welds are being excavated and welded today (6/22/10) for the repair of the rejectable Ultrasonic Testing (UT) indications discovered by ZPMC QC UT technicians.

-Cross Beam 9 (CB9) is located in Bay 16.

AWS D1.5 Section 12.17.4 Approval. All critical repairs to base metal and welds shall be approved by the Engineer prior to beginning the repair and shall be documented giving details of the type of discontinuity and extent of repair.

Special provisions- Section 8-3.01: In addition to the provisions in AWS D1.5, Section 3.7.4 and Section 12.17, third-time repairs of welds or base metal, regardless of NDT method, and all repairs of cracks require prior approval of the Engineer.

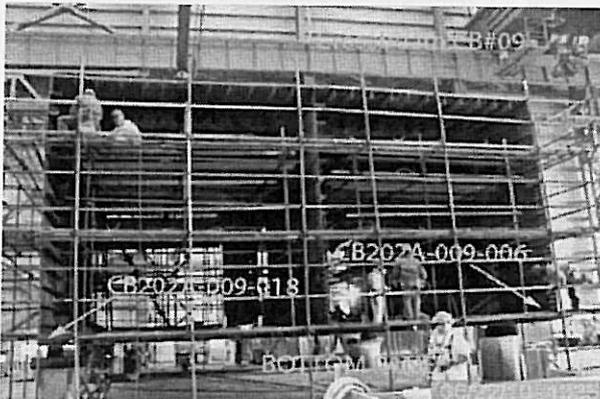
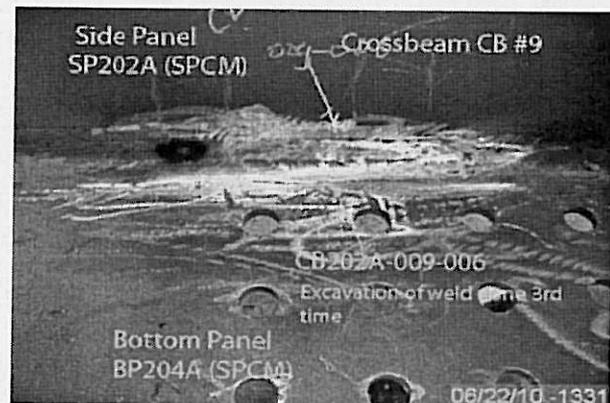
-ZPMC performed 3rd time excavation of Seismic Performance Critical Material (SPCM) welds identified as CB202A-009-018 & 006 without prior Engineer's approval or an approved Critical Weld Repair for this 3rd time repair.

-The welds are Complete Joint Penetration (CJP) joining the SPCM bottom panels to the SPCM side panels.

-The affected panels are identified as bottom panels BP205A and BP204A, Side panels SP202A and SP205A.

-These welds were previously removed and re-welded on 06/08/10 and 06/14/10 for the purpose of aligning the bottom panel of the crossbeam to the FL3 bottom panel of Orthotropic Box Girder (OBG) Segment 8AE.

-Welds are being excavated and welded today (6/22/10) for the repair of the rejectable Ultrasonic Testing (UT) indications discovered by ZPMC QC UT technicians.

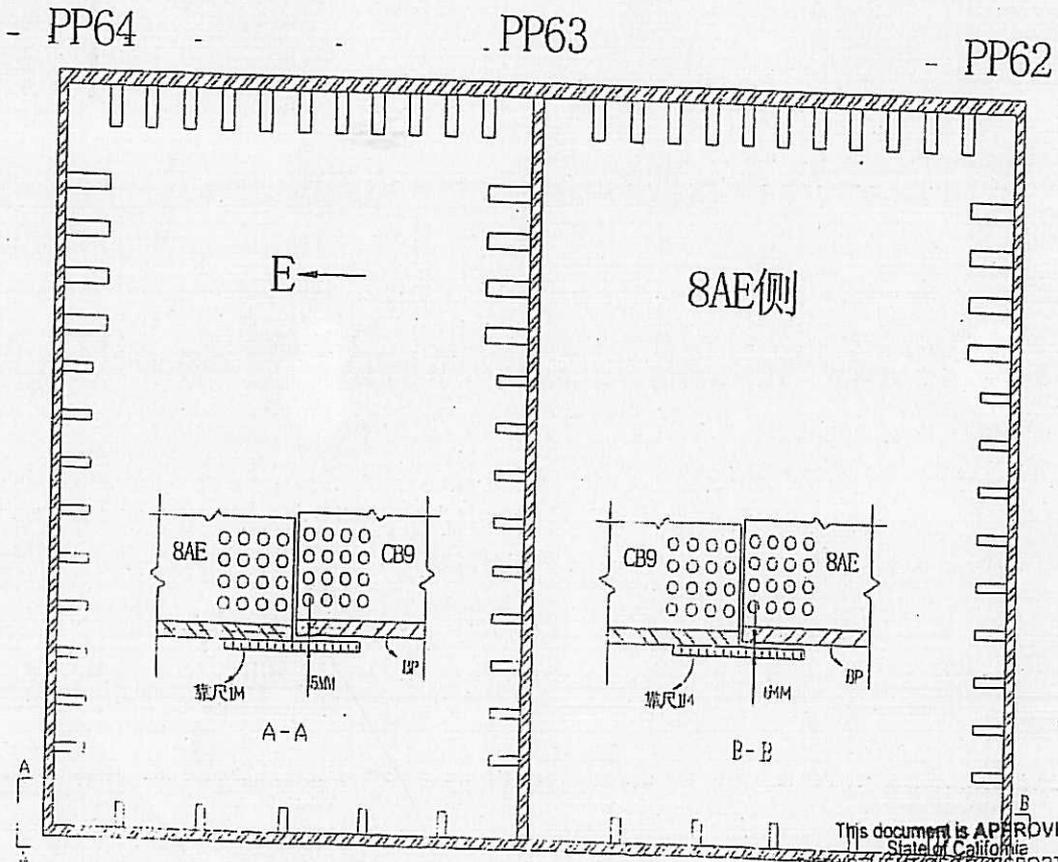
Draft of Welding Discontinuity:

After inspection: the misalignment was found at 8AE and CB9 at PP62,PP64 after repair according to B-WR13530, the detail position and data sees the following draft, the gap was 7-8 mm after gouging, relevant weld ID: CB202A-009-018/006

1. 焊接变形和制作误差;
  2. 工人操作失误, 导致母材损伤.
1. Weld distortion and fabricate error;
  2. Worker operated error caused base metal gouged.

1. QC and CWI should be present to witness the repair, direct and supervise all repair operations during this repair to ensure the repair is per the disposition requirements, and the AWS D1.5 code requirements.
2. Prepare the joint according to the approved WPS and add steel backing according to the attached drawing 1.
3. Notify QA verbally prior to NDT. Perform 100%VT of the repair area.
4. Remove all defects by grinding to ensure all defects are completely removed if defects exist, and repeat "step 3" to assure complete removal of all defects if necessary.
5. Preheat and weld according to the approved WPS to ensure the gap meet requirement.
6. Remove steel backing after welding and grind the weld flush.
7. Notify QA verbally prior NDT. Perform relevant NDT (UT, MT and VT) to the repair area.
