QUALITY ASSURANCE -- NON-CONFORMANCE REPORT

Location: Changxing Island, Shanghai, P.R. China**Report No:** NCR-000773**Prime Contractor:** American Bridge/Fluor Enterprises, a JV**Date:** 22-Jun-2010**Submitting Contractor:** Zhenhua Port Machinery Company, Ltd (ZPMC), Changxing Island**NCR #:** ZPMC-0735**Type of problem:**

Reference Description: QA found an UT Indication after the contractor's had tested and accepted a weld on the Suspender Bracket for Segment 7EW

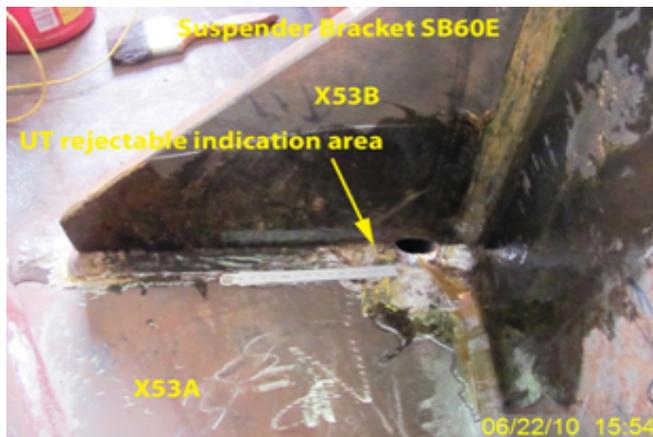
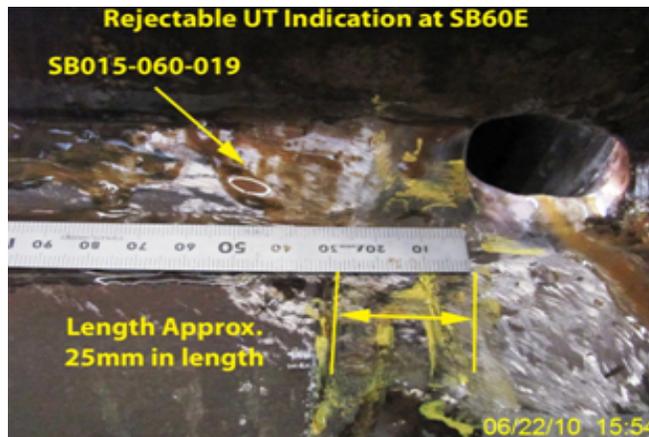
During the Quality Assurance (QA) Ultrasonic Testing (UT) review of welds located on Orthotropic Box Girder (OBG) Suspender Bracket SB60E, this QA Inspector discovered the following issues:

- One (1) class "A" rejectable longitudinal linear indication measuring approximately 25mm in length.
- The indication dBs rating is a +4.
- Material thickness is 20mm.
- The depth of the indication is approximately 14mm.
- The weld is identified as SB015-060-019 (Segment 7EW).
- The weld is Complete Joint Penetration (CJP) "T" joint.
- The weld is joining between X53A to X53B.
- The weld is designated as a Non Seismic Performance Critical Material (Non SPCM).
- The indication is clearly marked on or near the weld.
- The Y distance for this indication is 5 mm from cope hole.
- Suspender Bracket SB60E is located at Bay#19.

The Notice of Witness Inspection (NWIT) No. is 006035. The indication is located within the area previously tested and accepted by ZPMC Quality Control (QC) personnel. As per the contract documents, ZPMC's QC personnel are required to perform hundred (100%) percent UT inspection of this weld.

AWS D1.5-02 Section 6; Table 6.3: specifies a class "A" indication as having a rating of 10dbs and under for material thicknesses 8mm through 20mm.

Propose a resolution for the identified non-conformance with revised procedures to prevent future occurrences. A response for the resolution of this issue is expected within 7 days.

ZPMC has repaired the weld identified in the NCR and is providing NDT documentation to show the weld is acceptable. As stated in ZPMC's letter of response, ZPMC QA has discussed this issue with the head of the NDT Department, who is will address the issue through greater oversight by supervisors. ZPMC requests closure of this NCR.

The NDT documentation submitted and the preventive measures taken by the Contractor are acceptable. This NCR is considered closed.

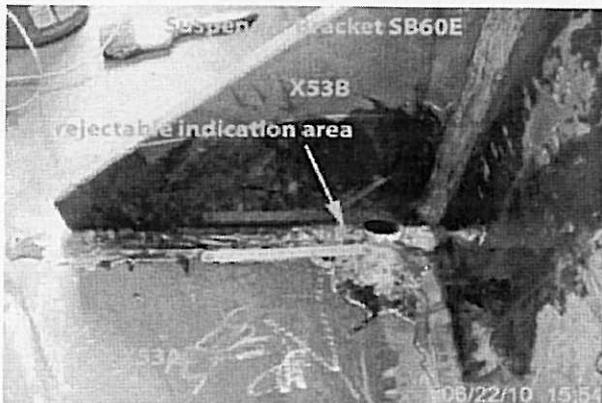
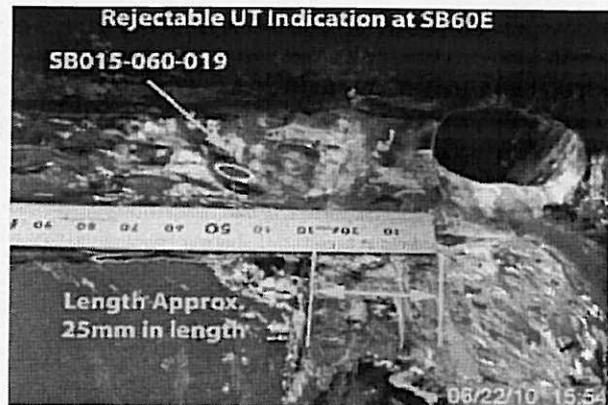
During the Quality Assurance (QA) Ultrasonic Testing (UT) review of welds located on Orthotropic Box Girder (OBG) Suspender Bracket SB60E, this QA Inspector discovered the following issues:

- One (1) class "A" rejectable longitudinal linear indication measuring approximately 25mm in length.
- The indication dBs rating is a +4.
- Material thickness is 20mm.
- The depth of the indication is approximately 14mm.
- The weld is identified as SB015-060-019 (Segment 7EW).
- The weld is Complete Joint Penetration (CJP) "T" joint.
- The weld is joining between X53A to X53B.
- The weld is designated as a Non Seismic Performance Critical Material (Non SPCM).
- The indication is clearly marked on or near the weld.
- The Y distance for this indication is 5 mm from cope hole.
- Suspender Bracket SB60E is located at Bay#19.

The Notice of Witness Inspection (NWIT) No. is 006035. The indication is located within the area previously tested and accepted by ZPMC Quality Control (QC) personnel. As per the contract documents, ZPMC's QC personnel are required to perform hundred (100%) percent UT inspection of this weld.

AWS D1.5-02 Section 6; Table 6.3: specifies a class "A" indication as having a rating of 10dbs and under for material thicknesses 8mm through 20mm.

Repair said indication and perform NDT required to verify weld quality.

Contractor supplied post repair NDT documentation verifying weld conforms with Contract weld quality requirements. An internal NCR was also issued by ZPMC in regards to this issue.
