Contract #: 04-0120F4Cty: SF/ALA Rte: 80 PM: 13.2/13.9File #: 69.25B**QUALITY ASSURANCE -- NON-CONFORMANCE REPORT****Location:** Changxing Island, P.R. China**Report No:** NCR-000774**Prime Contractor:** American Bridge/Fluor Enterprises, a JV**Date:** 25-Jun-2010**Submitting Contractor:** Zhenhua Port Machinery Company, Ltd (ZPMC), Changxing Island**NCR #:** ZPMC-0736**Type of problem:**

Reference Description: QA discovered three rejectable UT indications inside areas already inspected and accepted by QC.

Dear: Mr. Charles Kanapicki
Job Name: SAS Superstructure

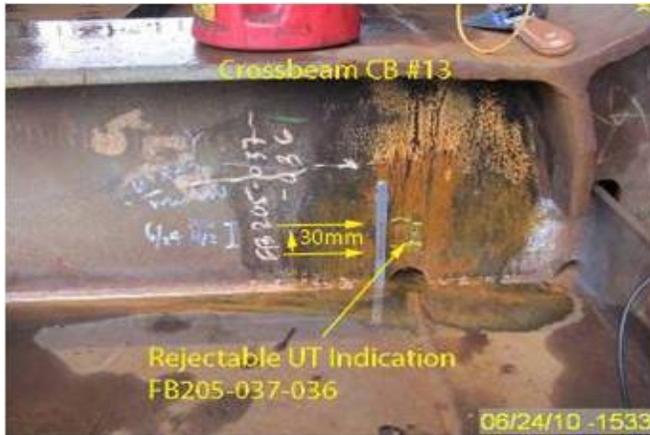
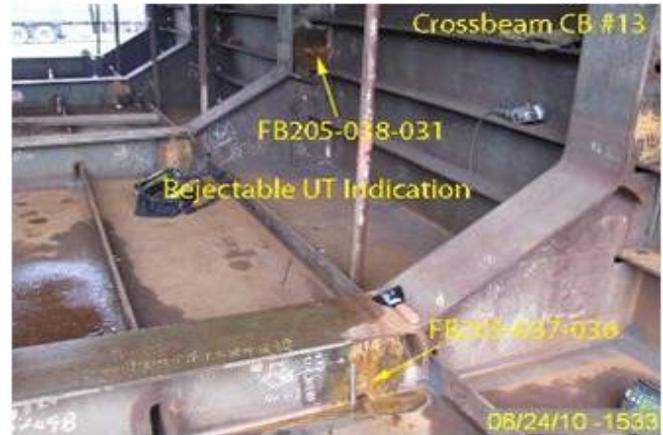
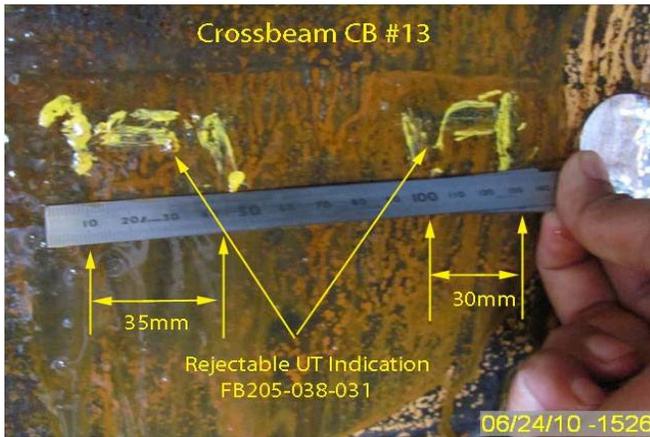
During Quality Assurance Ultrasonic Testing (UT) review of welds located in Crossbeam CB13, this Quality Assurance (QA) Inspector discovered three rejectable UT indications. Specific details pertaining to the nature and location of said indications are as follows:

-Two of these indications were discovered in the Complete Joint Penetration (CJP) weld identified as FB205-038-031.

-The indications found in weld joint FB205-038-031 were measured to be 35mm and 30mm located at depths of approximately 8mm and 9mm with decibel ratings of +1dB and +7dB respectively.

-The third indication was discovered in the CJP weld identified as FB205-0387-036.

-The indication found in weld joint FB205-037-036 was measured to have a length of 30mm located at a depth of approximately 6mm with a decibel rating of +6dB.

-These indications are clearly marked on or near the weld.

tested and accepted by ZPMC Quality Control (QC) personnel. As per the contract documents, ZPMC's QC personnel are required to perform hundred (100%) percent UT inspection of this weld.

AWS D1.5-02 Section 6; Table 6.3 specifies a class "A" indication as having a rating of 10dbs and under for material thicknesses 8mm through 20mm.

ZPMC has issued an internal NCR and discussed this issue with the NDT Department head to reduce future occurrences. The indications have been tested, repaired and found to be acceptable. ZPMC is submitting the repair report and the NDT after to show that it is acceptable. Based on this ZPMC requests closure of this NCR..

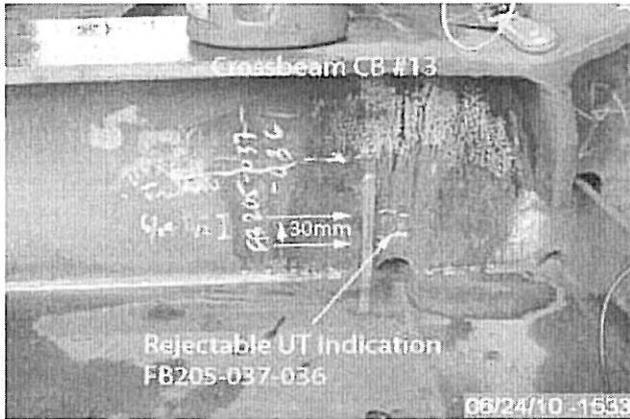
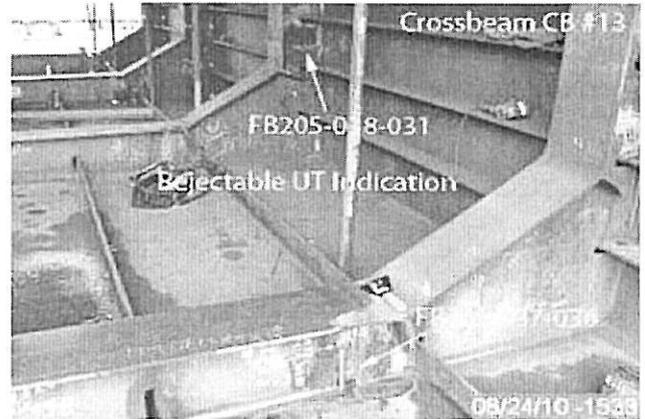
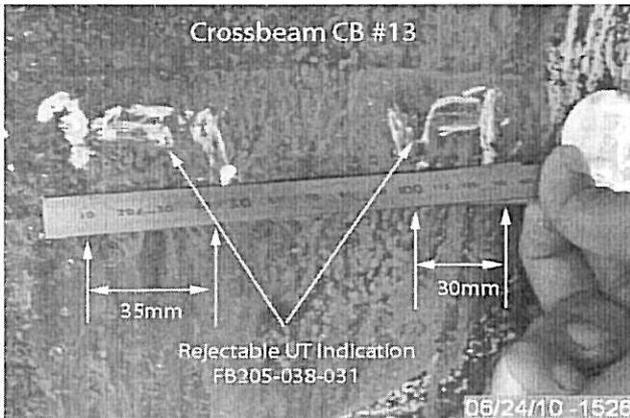
During Quality Assurance Ultrasonic Testing (UT) review of welds located in Crossbeam CB13, this Quality Assurance (QA) Inspector discovered three rejectable UT indications. Specific details pertaining to the nature and location of said indications are as follows:

-Two of these indications were discovered in the Complete Joint Penetration (CJP) weld identified as FB205-038-031.

-The indications found in weld joint FB205-038-031 were measured to be 35mm and 30mm located at depths of approximately 8mm and 9mm with decibel ratings of +1dB and +7dB respectively.

-The third indication was discovered in the CJP weld identified as FB205-0387-036.

-The indication found in weld joint FB205-037-036 was measured to have a length of 30mm located at a depth of approximately 6mm with a decibel rating of +6dB.

-These indications are clearly marked on or near the weld.

tested and accepted by ZPMC Quality Control (QC) personnel. As per the contract documents, ZPMC's QC personnel are required to perform hundred (100%) percent UT inspection of this weld.

AWS D1.5-02 Section 6; Table 6.3 specifies a class "A" indication as having a rating of 10dbs and under for material thicknesses 8mm through 20mm.

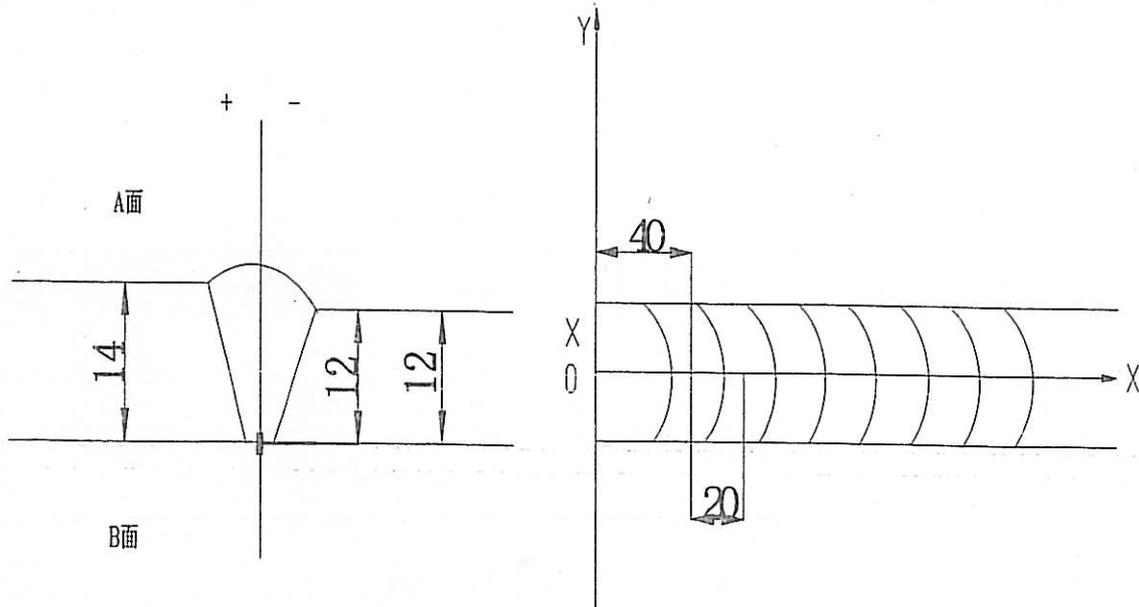
WELD NUMBER: FB205-037-036

Rejected indication found by ultrasonic inspection is less than the maximum allowance aggregate length.

(UT探伤发现的缺陷总长度小于最大允许长度。) FB205-037-036

1、焊道未及时处理干净。

1. Did not clear the weld pass completely in time.

1. Gouge or grind from nearer side from metal edge ($D \leq 0.65T$, "D" is depth of defects, "T" is thickness of metal) to remove all defects;

2. Follow repair WPS for joint preparation, preheat, and weld deposit;

3. Verify with VT no defects remain in the weld joint prior to welding;

4. Grind the repaired area flush with base metal or the adjacent weld;

5. Check the welds according to the working drawings.

1. Improve monitoring of welding and interpass cleaning.

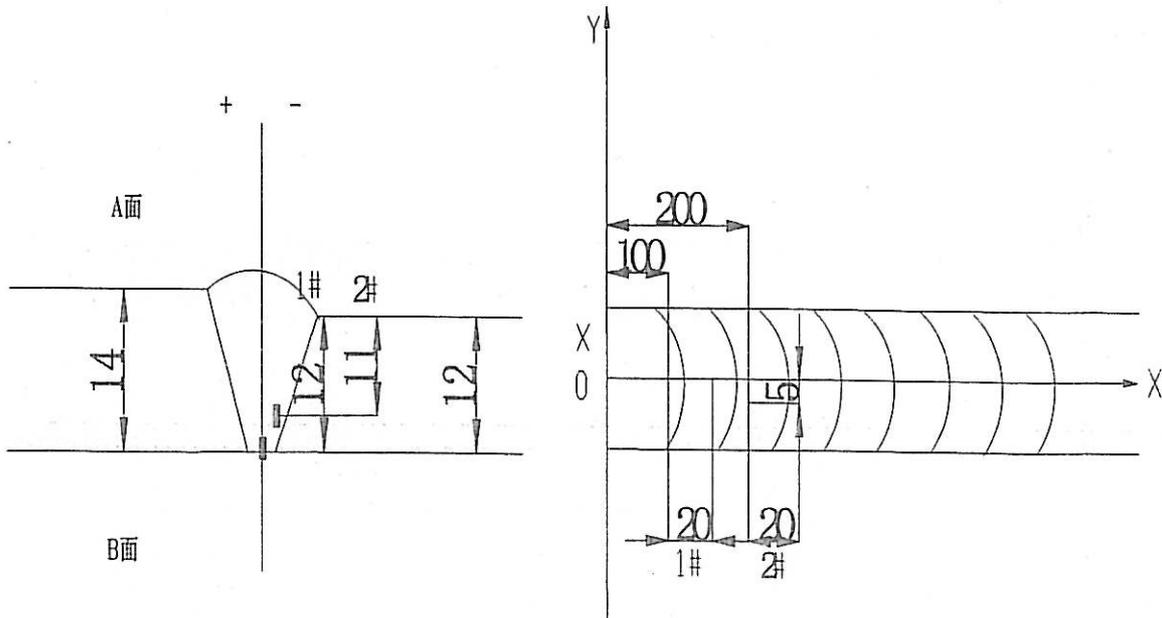
WELD NUMBER: FB205-038-031

Rejected indication found by ultrasonic inspection is less than the maximum allowance aggregate length.

(UT探伤发现的缺陷总长度小于最大允许长度。) FB205-038-031

1、焊道未及时处理干净。

1. Did not clear the weld pass completely in time.

1. Gouge or grind from nearer side from metal edge ($D \leq 0.65T$, "D" is depth of defects, "T" is thickness of metal) to remove all defects;
2. Follow repair WPS for joint preparation, preheat, and weld deposit;
3. Verify with VT no defects remain in the weld joint prior to welding;
4. Grind the repaired area flush with base metal or the adjacent weld;
5. Check the welds according to the working drawings.

1. Improve monitoring of welding and interpass cleaning.
