Contract #: 04-0120F4
 Cty: SF/ALA Rte: 80 PM: 13.2/13.9
 File #: 69.25B

QUALITY ASSURANCE -- NON-CONFORMANCE REPORT

Report No: NCR-000778

Reference Description: Missed MT Longitudinal & Transverse Cracks by QC - Suspender Bracket SB48W

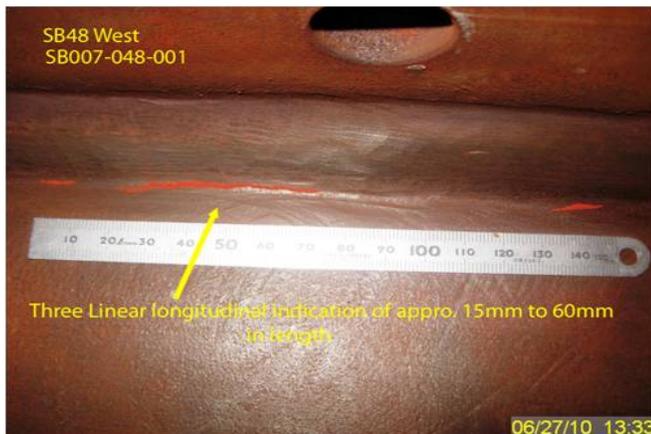
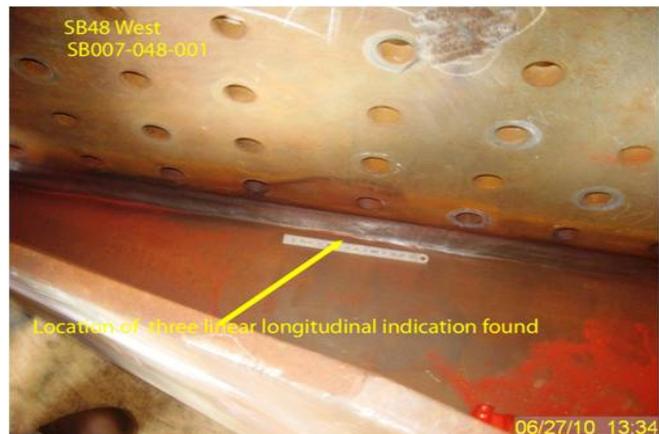
During the Quality Assurance Magnetic particle Testing (MT) review of welds located on OBG Suspender bracket SB48W, QA discovered the following issues:

- Three linear longitudinal crack indications that measured approximately 15mm to 60mm in length.
- The weld is identified as SB007-048-001
- The weld is a complete joint penetration (CJP) connecting the Deck plate to the Flange.
- Ten linear transverse crack indications that measured approximately 3mm to 6mm in length.
- The weld is identified as SB007-048-032.
- The weld is a Fillet weld connecting the Bottom plate to Bearing plate.
- OBG suspender bracket SB007-048-001 is located in BAY#19.
- The indications are clearly marked on the material on/near the weld.
- The Notice of Witness Inspection Number (NWIT) is 006064.
- The indications are located within the area that has been previously tested and accepted by ZPMC Quality Control (QC) personnel.

AWS D1.5 (02) Section 6.26.2 – “Welds that are subject to MT in addition to visual inspection shall have no cracks.

Repair said indications and perform NDT required to verify weld quality.

Contractor supplied post repair NDT documentation verifying weld conforms with Contract weld quality requirements. An internal NCR was also issued by ZPMC in regards to this issue.

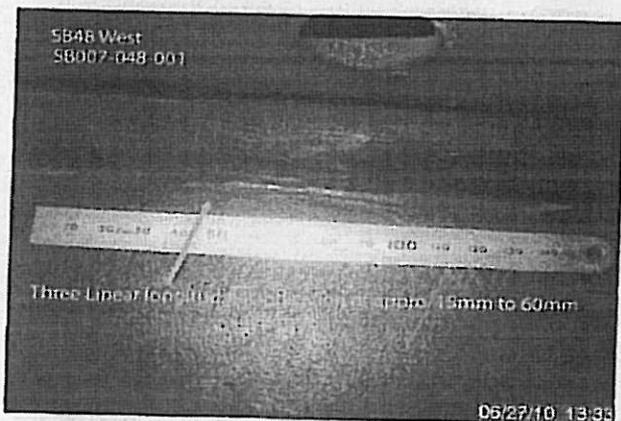
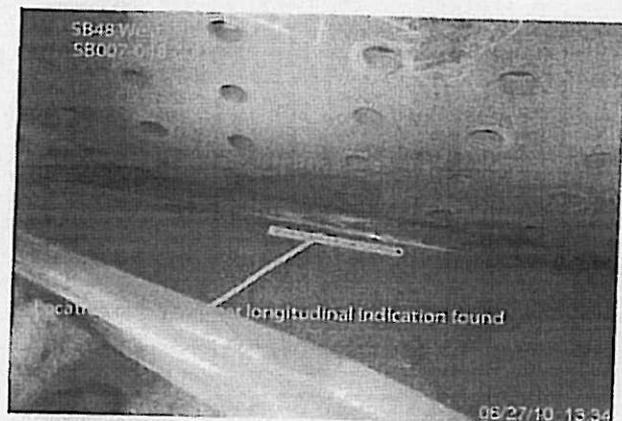
During the Quality Assurance Magnetic particle Testing (MT) review of welds located on OBG Suspender bracket SB48W, QA discovered the following issues:

- Three linear longitudinal crack indications that measured approximately 15mm to 60mm in length.
- The weld is identified as SB007-048-001
- The weld is a complete joint penetration (CJP) connecting the Deck plate to the Flange.
- Ten linear transverse crack indications that measured approximately 3mm to 6mm in length.
- The weld is identified as SB007-048-032.
- The weld is a Fillet weld connecting the Bottom plate to Bearing plate.
- OBG suspender bracket SB007-048-001 is located in BAY#19.
- The indications are clearly marked on the material on/near the weld.
- The Notice of Witness Inspection Number (NWIT) is 006064.
- The indications are located within the area that has been previously tested and accepted by ZPMC Quality Control (QC) personnel.

AWS D1.5 (02) Section 6.26.2 – “Welds that are subject to MT in addition to visual inspection shall have no cracks.
