Contract #: 04-0120F4Cty: SF/ALA Rte: 80 PM: 13.2/13.9File #: 69.25B**QUALITY ASSURANCE -- NON-CONFORMANCE REPORT****Location:** Changxing Island, Shanghai, China**Report No:** NCR-000780**Prime Contractor:** American Bridge/Fluor Enterprises, a JV**Date:** 29-Jun-2010**Submitting Contractor:** Zhenhua Port Machinery Company, Ltd (ZPMC), Changxing Island**NCR #:** ZPMC-0742**Type of problem:**

Reference Description: Missed UT Indication Discovered by QA**Description of Non-Conformance:**

Job Name: SAS Superstructure

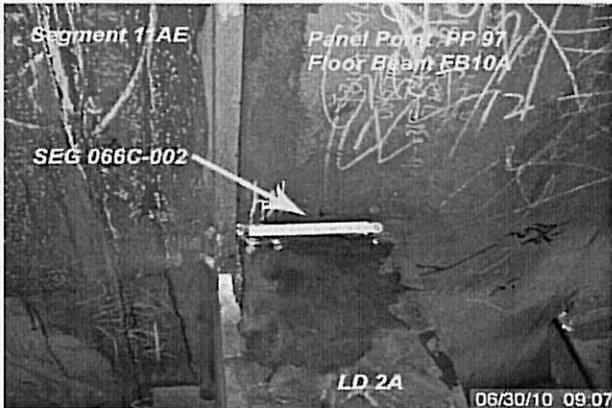
During the Quality Assurance Ultrasonic Testing (UT) verification of welds located on Segment 11AE, QA discovered the following issue:

- One (1) Class "A" rejectable indication measuring approximately 30 mm in length.
- The weld is a Complete Joint Penetration (CJP) 'T' joint single bevel groove weld joining the Longitudinal Diaphragm (LD2A) Flange, to the Floor beam FB10A Web, on the West side of Panel Point 97.
- The indication db rating was (+3).
- The thickness of the LD flange plate is 25 mm.
- Depth of the indication is 21 mm.
- The "Y" location is approximately 10mm measured from end of the flange.
- The weld is identified as SEG066C-002.
- The indication is clearly marked near the weld.
- Segment 11AE is located in the segment repair yard south of the fabrication bay 14.
- This weld joint is designated as Non Seismic Performance Critical Weld Member (Non-SPCM).

The Notice of Witness Inspection Number (NWIT) is 006079. The indication is located within the area that has been previously tested and accepted by ZPMC Quality Control (QC) personnel.

AWS D1.5-2002, Section 6, Table 6.3. Specifies a class A indication as having a decibel rating of (+8) and lower for weld thicknesses 21mm through 38mm.

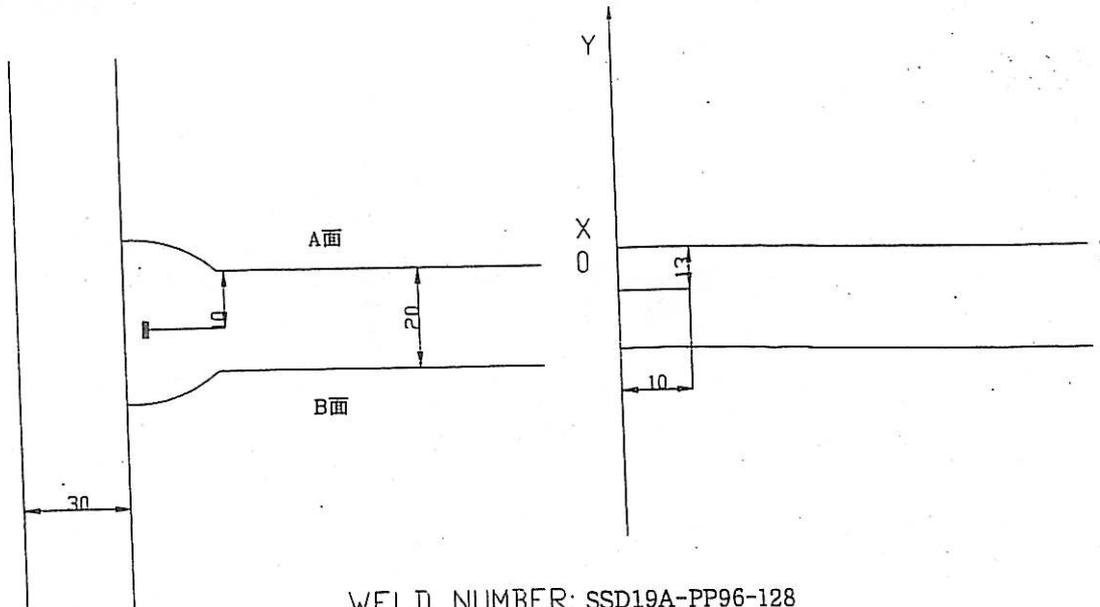
WELD NUMBER: SSD19A-PP96-128

Rejected indication found by ultrasonic inspection is less than the maximum allowance aggregate length.

1、焊道未及时处理干净。

1. Did not clear the weld pass completely in time.

1. Gouge or grind from nearer side from metal edge ($D \leq 0.65T$, "D" is depth of defects, "T" is thickness of metal) to remove all defects;

2. Follow repair WPS for joint preparation, preheat, and weld deposit;

3. Verify with VT no defects remain in the weld joint prior to welding;

4. Grind the repaired area flush with base metal or the adjacent weld;

5. Perform UT inspection to the weld along with 50mm on each end of the repair area;

1. Improve monitoring of welding and interpass cleaning.
