Contract #: 04-0120F4Cty: SF/ALA Rte: 80 PM: 13.2/13.9File #: 69.25B**QUALITY ASSURANCE -- NON-CONFORMANCE REPORT****Location:** Changxing Island, Shanghai, China**Report No:** NCR-000781**Prime Contractor:** American Bridge/Fluor Enterprises, a JV**Date:** 30-Jun-2010**Submitting Contractor:** Zhenhua Port Machinery Company, Ltd (ZPMC), Changxing Island**NCR #:** ZPMC-0743**Type of problem:****Welding****Concrete****Other****Welding****Curing****Procedural****Bridge No:** 34-0006**Joint fit-up****Coating****Other****Component:** SEG11AE, PP97 LD2A flange to FB10A**Procedural****Procedural****Description:****Reference Description:** Missed UT Indication**Description of Non-Conformance:**

Dear: Mr. Charles Kanapicki
Attention: Mr. Thomas Nilsson Project/Fabrication Manager
Subject: NCR No. ZPMC-0743

Job Name: SAS Superstructure
Document No: 05.03.06-000739

Component: SEG11AE, PP97 LD2A flange to FB10A

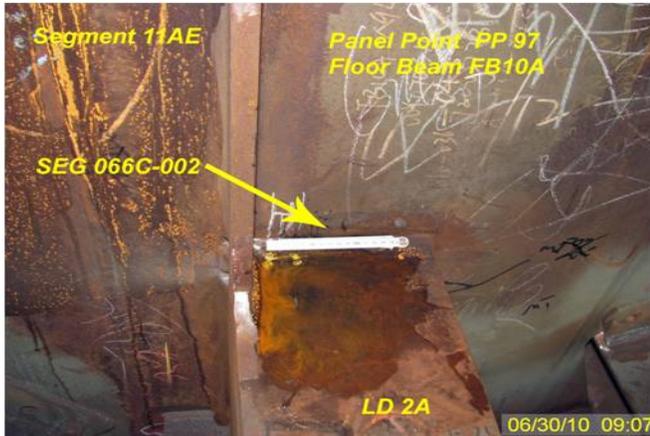
During the Quality Assurance Ultrasonic Testing (UT) verification of welds located on Segment 11AE, QA discovered the following issue:

- One (1) Class "A" rejectable indication measuring approximately 30 mm in length.
- The weld is a Complete Joint Penetration (CJP) 'T' joint single bevel groove weld joining the Longitudinal Diaphragm (LD2A) Flange, to the Floor beam FB10A Web, on the West side of Panel Point 97.
- The indication db rating was (+3).
- The thickness of the LD flange plate is 25 mm.
- Depth of the indication is 21 mm.
- The "Y" location is approximately 10mm measured from end of the flange.
- The weld is identified as SEG066C-002.
- The indication is clearly marked near the weld.
- Segment 11AE is located in the segment repair yard south of the fabrication bay 14.
- This weld joint is designated as Non Seismic Performance Critical Weld Member (Non-SPCM).

The Notice of Witness Inspection Number (NWIT) is 006079. The indication is located within the area that has been previously tested and accepted by ZPMC Quality Control (QC) personnel.

AWS D1.5-2002, Section 6, Table 6.3. Specifies a class A indication as having a decibel rating of (+8) and lower for weld thicknesses 21mm through 38mm.

ZPMC has repaired the missed indication and is providing the weld repair report and NDT performed after the repair to show it is acceptable. ZPMC QA has discussed this issue with their NDT Department head to reduce missed indications in UT by ensuring inspectors are not over tasked to perform inspections too quickly. Based on this ZPMC requests closure of this NCR.

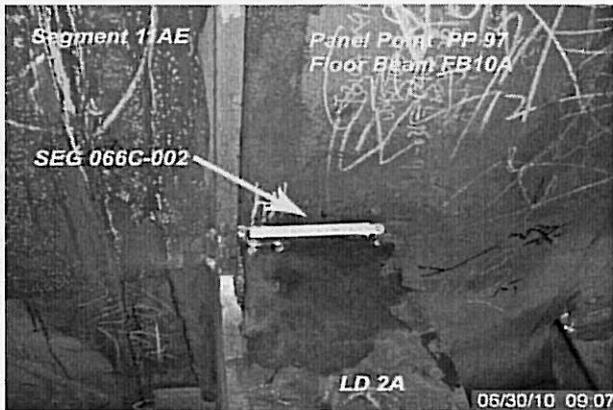
During the Quality Assurance Ultrasonic Testing (UT) verification of welds located on Segment 11AE, QA discovered the following issue:

- One (1) Class "A" rejectable indication measuring approximately 30 mm in length.
- The weld is a Complete Joint Penetration (CJP) 'T' joint single bevel groove weld joining the Longitudinal Diaphragm (LD2A) Flange, to the Floor beam FB10A Web, on the West side of Panel Point 97.
- The indication db rating was (+3).
- The thickness of the LD flange plate is 25 mm.
- Depth of the indication is 21 mm.
- The "Y" location is approximately 10mm measured from end of the flange.
- The weld is identified as SEG066C-002.
- The indication is clearly marked near the weld.
- Segment 11AE is located in the segment repair yard south of the fabrication bay 14.
- This weld joint is designated as Non Seismic Performance Critical Weld Member (Non-SPCM).

The Notice of Witness Inspection Number (NWIT) is 006079. The indication is located within the area that has been previously tested and accepted by ZPMC Quality Control (QC) personnel.

AWS D1.5-2002, Section 6, Table 6.3. Specifies a class A indication as having a decibel rating of (+8) and lower for weld thicknesses 21mm through 38mm.

Repair said indication and perform NDT required to verify weld quality.

Contractor supplied post repair NDT documentation verifying weld is in conformance with Contract weld quality requirements. Contractor has also taken action directly with NDT Technicians to avoid similar issues in the future.

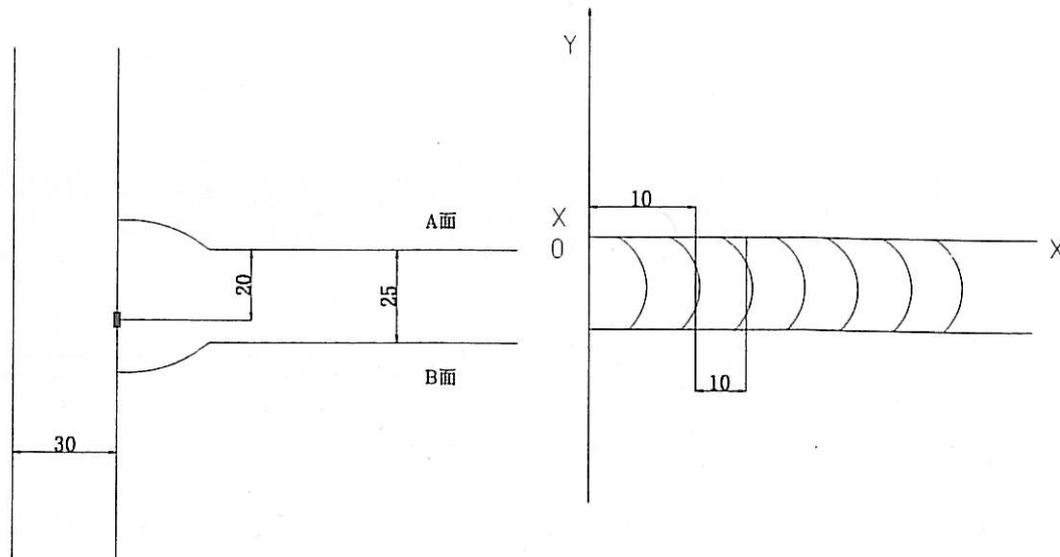
WELD NUMBER: SEG066C-002

(Description of welding discontinuity): Rejected indication found by ultrasonic inspection is less than the maximum allowance aggregate length.

Caused:

1. Did not clear the weld pass completely in time.

1. Gouge or grind from nearer side from metal edge ($D \leq 0.65T$, "D" is depth of defects, "T" is thickness of metal) to remove all defects;

2. Follow repair WPS for joint preparation, preheat, and weld deposit;

3. Grind the repaired area flush with base metal or the adjacent weld;

4. Check the welds according to the working drawings.

1. Improve monitoring of welding and interpass cleaning.
